PROPERTY INSPECTION REPORT

192 Barranca Terrace, Sunnyvale, CA 94086

August 13, 2025

File #: 20250813-24

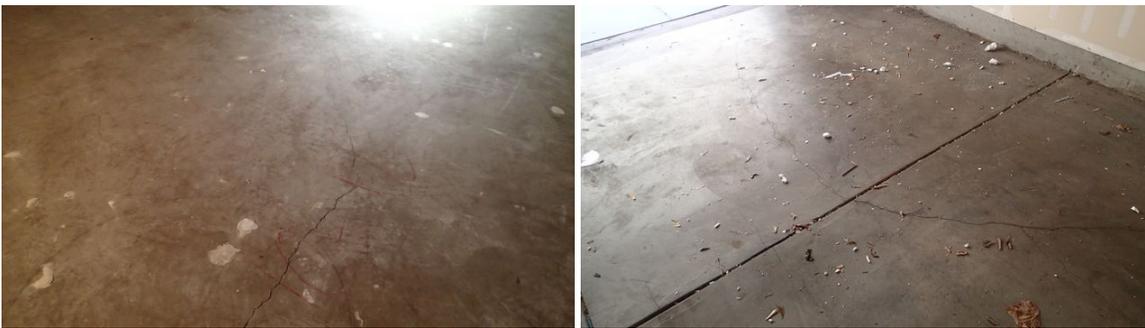
Note: Major cracks (displacement larger than a 1/4 inch in width) were observed in the concrete floor. The classification of major is any crack that is 1/4" in width or greater. There was no major movement or settlement observed. This should be monitored.

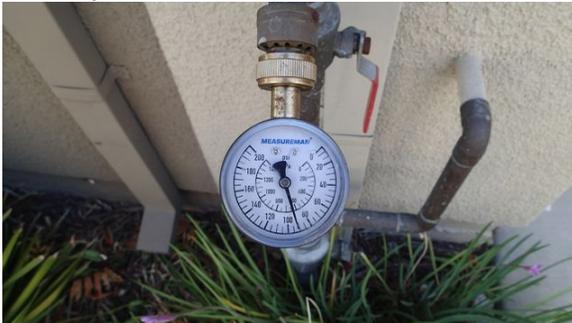
- Water flow throughout the home was above average.
- Water pressure was tested at an outdoor sillcock and found to be 90 pounds per square inch. A regulator was not installed or visible. With too little water pressure, showering, rinsing dishes and even a glass of water can be a major annoyance. On the other hand, dishwashers, clothes washers and other household appliances can be damaged by water pressure exceeding 80 psi, and high pressure can void an appliance warranty as well.

1. **Further Evaluation/Correct:** The water pressure was noted to be above 80 pounds per square inch (PSI). Check for a regulator (not visible) and/or correct as necessary. Modern standards call for a pressure regulator to be installed along with an associated expansion device to protect the building pipes and fixtures (from valve/faucet leakage and solenoid valve failures) when the supply pressure exceeds 80 PSI.

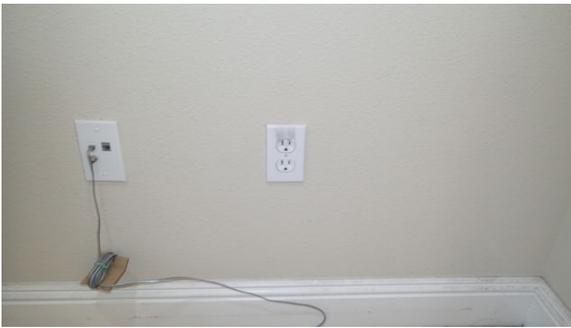
1. **Further Evaluation:** Evidence of a scorched outlet was noted in the second floor hallway.

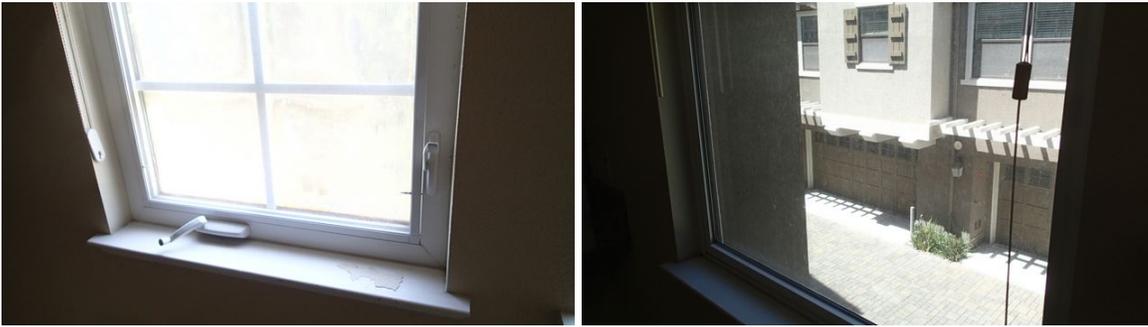
1. **Repair:** Condensation was noted in this thermopane which will reduce visibility and the insulating capability of the window. To restore visibility and regain the insulating capability, repair or replacement of this window is required. Areas noted: bedrooms, living room and kitchen

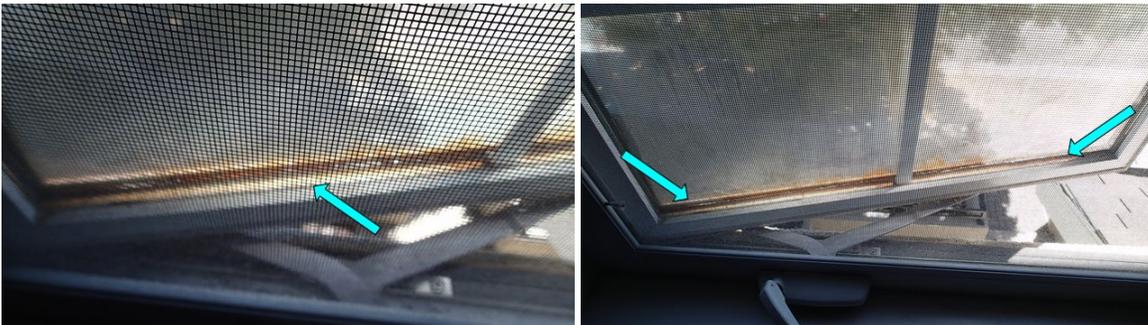
2. **Further Evaluation:** There was weathering noted to the window glazing/frame in the rear bedroom.

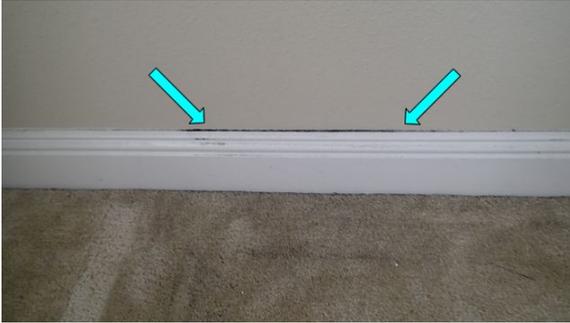
1. **Repair:** There was black staining observed to the wall in the . It is beyond the scope of the inspection to identify this type of material. Recommend to remove/clean.

Stain was cleaned on 08.20.2025.

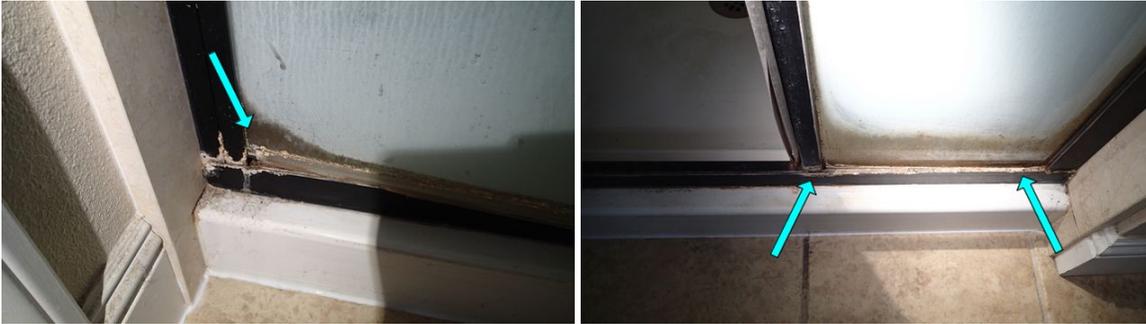
1. **Repair:** There were signs of rust and water leaking through the glass enclosure in the master bathroom. See termite report.

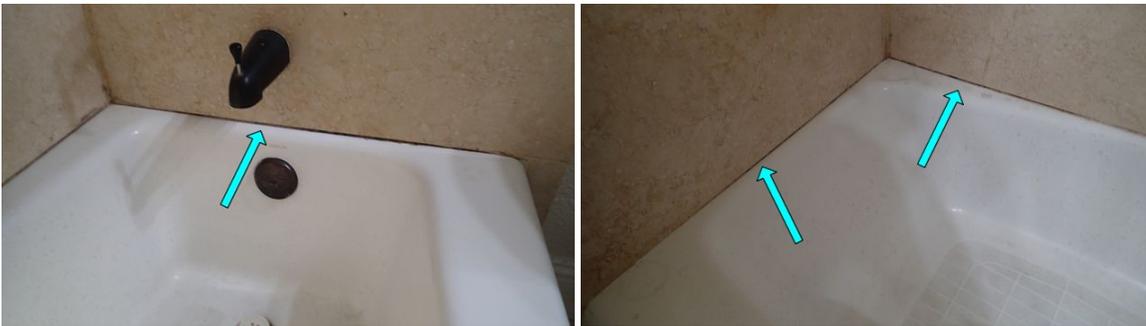
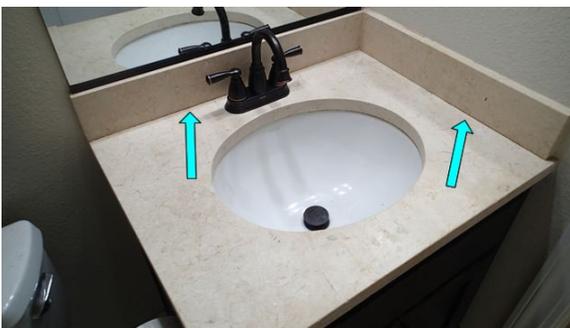
2. **Repair:** Loose and/or missing caulk noted around the tub fixtures and sink in the third floor hall bathroom. See termite report.

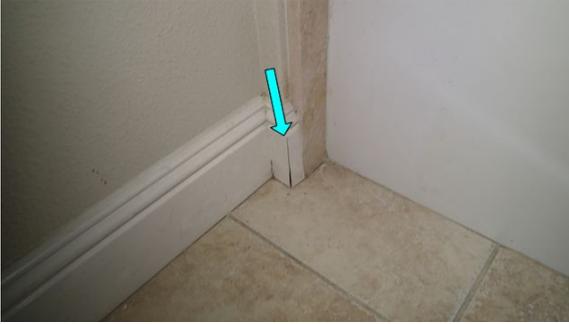
3. **Repair:** The baseboard in the third floor hall bathroom was delaminated or swollen from excessive moisture. See termite report.

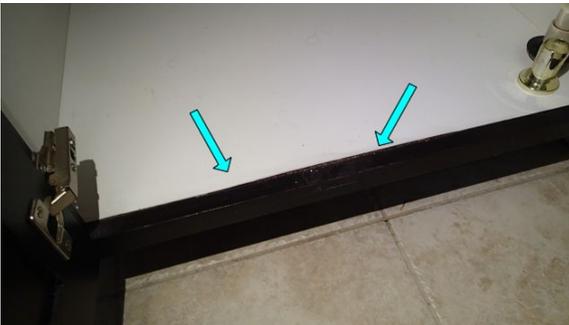
4. **Repair:** The vanity shelf noted in the third floor hall bathroom was delaminated or swollen from excessive moisture. See termite report.

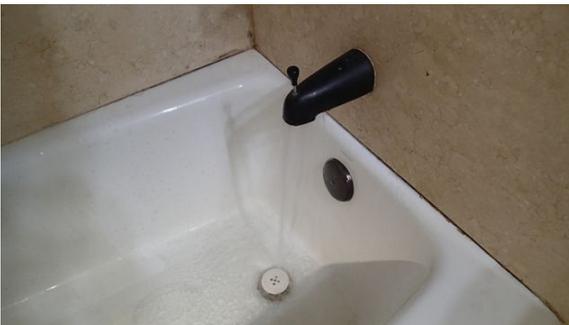
Note: A diverter leak was noted at the tub in the third floor hall bathroom. Repair or replace the diverter to minimize water loss. See also termite report.

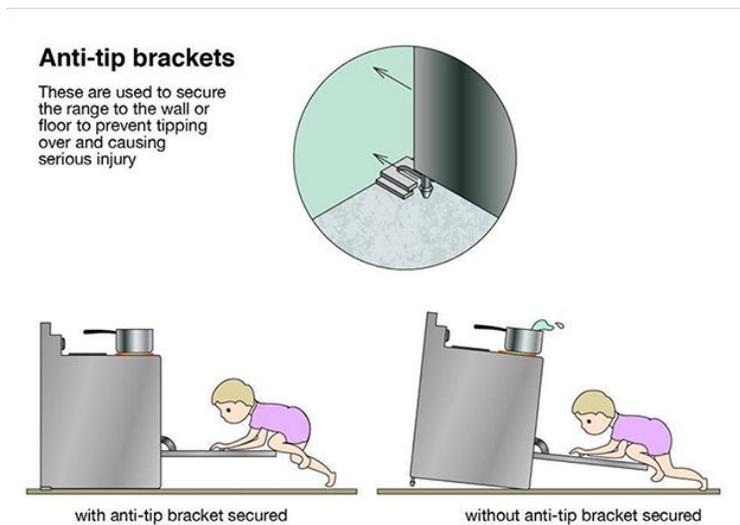
1. **Safety:** There was no anti-tipping device installed on the stove/oven. Cooking ranges can tilt forward when too much pressure is applied to an open oven door. This can result in injury from a tipped range or from hot food/liquids falling from the range top.

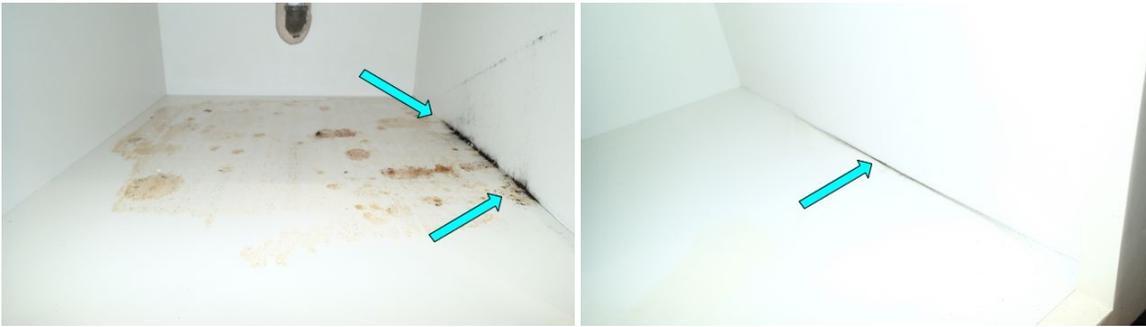
2. **Repair/Further Evaluation:** There was black staining/water stains observed to the sheetrock in the sink cabinet. It is beyond the scope of the inspection to identify this type of material. Recommend to remove/clean. See also termite report. **Stain was cleaned on 08.20.2025.**

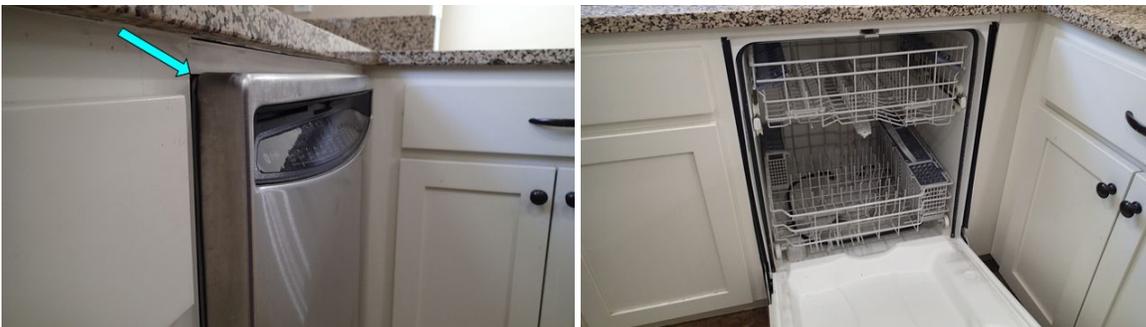
3. **Repair:** The dishwasher appliance did not close properly; therefore could not be operated.

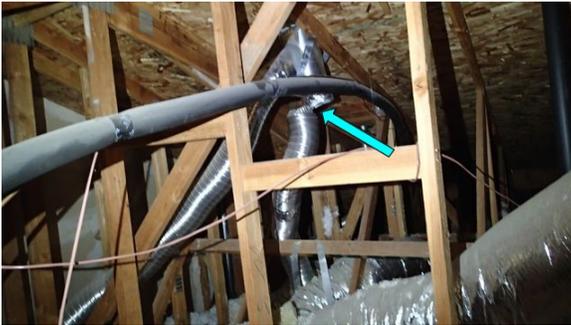
1. **Repair:** The exhaust vent from the bathroom was disconnected.

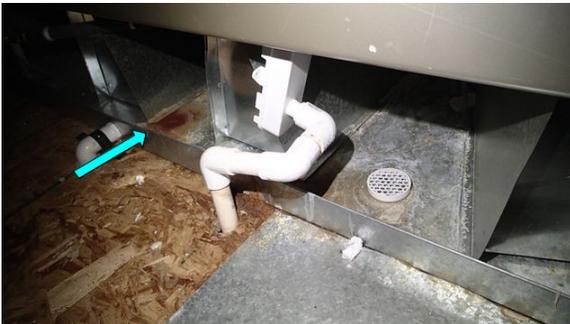
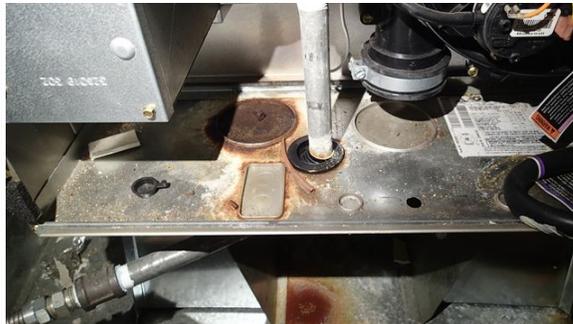
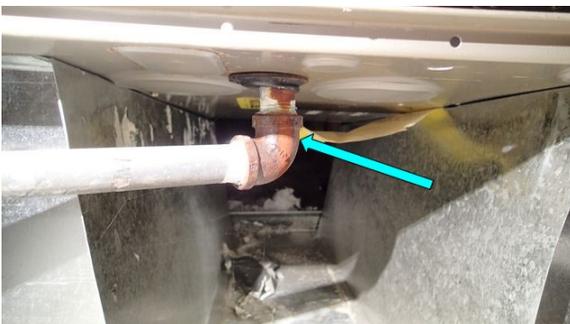
1. **Repair:** The furnace and auxiliary/secondary drain pan under the coil housing had evidence of leaking condensation and rust build-up. This is causing rust to the adjacent gas line and would indicate that the cooling equipment may be in need of repair. Auxiliary/secondary drain pans that hold water, are discolored, rusted or damaged may result in water damage or other defects.

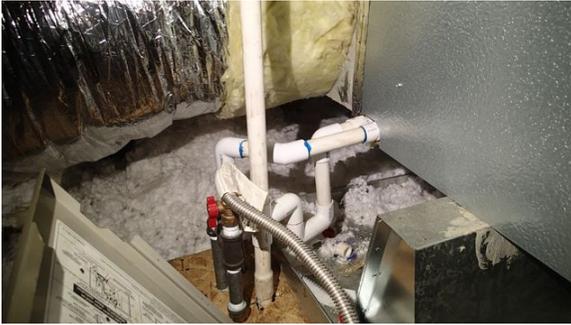
2. **Repair:** There was no vent or trap observed on the secondary condensate drain line. This should be installed or a float/kill-switch to prevent loss of heated/conditioned air.

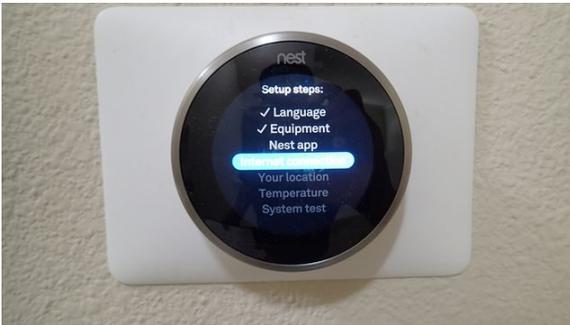
3. **Further Evaluation:** The thermostat in the hallway was not set-up yet and therefore the unit could not be tested.

Listing agent turned on the heater and AC on 08.23.2025 around 1:01PM

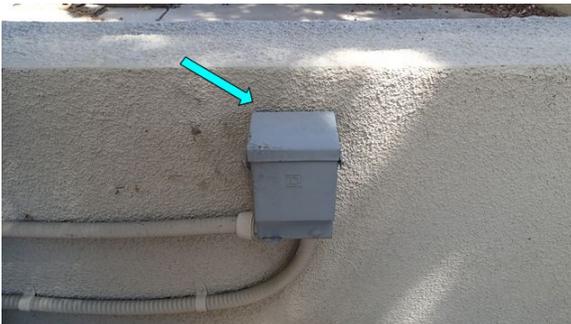
1. **Repair:** There was loose/missing caulking observed at the back wall of the breaker panel.

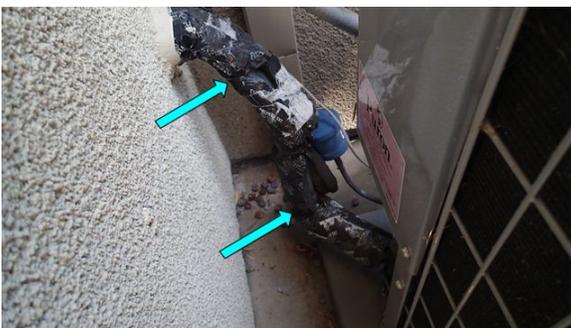
2. **Repair:** The insulation on the suction line was worn, missing, and/or damaged. This can cause the cooling system to lose efficiency. New insulation should be installed.

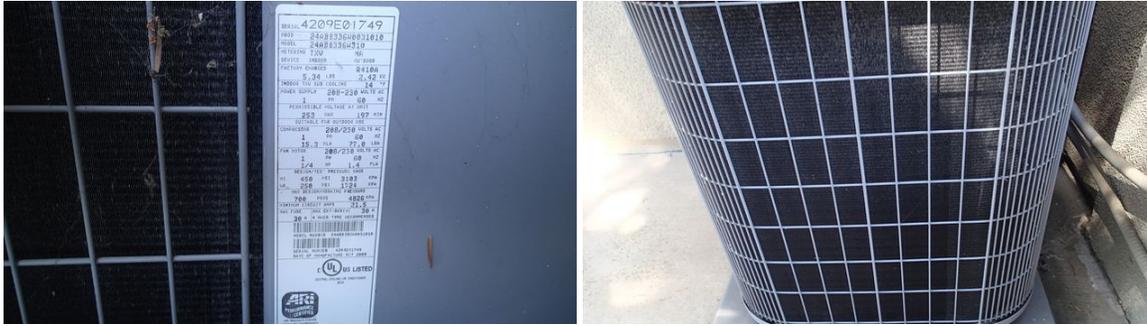
☑ Note: Coil fins on the air conditioner were noted to be damaged. Damaged fins reduce air flow and heat transfer, adversely affecting system performance, comfort and costs.
