256 E. Charleston Road  
Palo Alto, CA, 94306

680311

# HOME INSPECTION REPORT

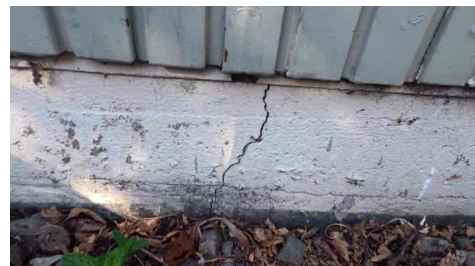
Photo 13

1. Vertical cracking was observed in the exposed exterior portions of the slab foundation left wall of the structure indicating movement and/or settlement of the structure may have occurred. The rate of movement cannot be predicted during a one-time inspection. A thorough evaluation of this condition is beyond our qualifications. For additional information we recommend contacting a licensed foundation contractor for further evaluation.

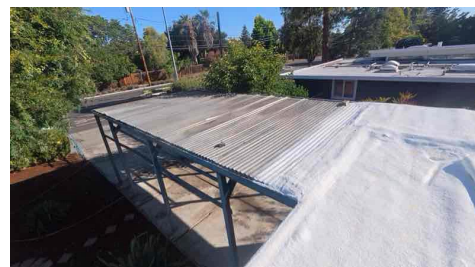
Photo 01

2. Repairs to the carport roof covering are recommended. Damaged, loose or missing roofing material should be repaired or replaced. All roof penetrations should be examined and sealed as necessary. For further evaluation of the condition of the roof we recommend you consult a licensed roofing contractor.

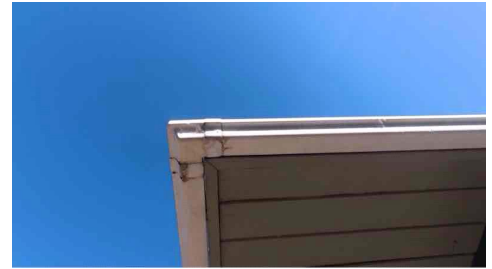
Photo 18

3. Leaks were noted in the downspouts and/or gutters at the rear and right. During wet weather conditions these areas are more obvious and during dry weather conditions they are noted from the stains at the areas where the leaks have occurred. We recommend all leaks be repaired.

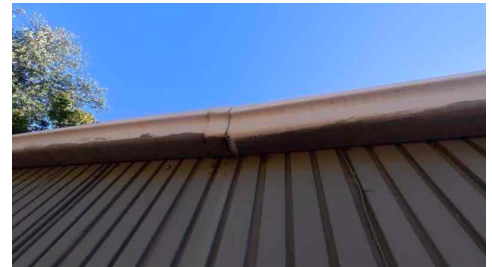
Photo 26

4. Loose gutters at the right area should be repaired or replaced.

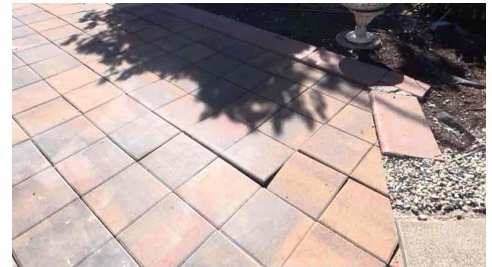
Photo 19

5. The rear right and rear middle patio surface has cracked, heaved, or uneven sections that create a potential trip hazard. We recommend addressing these conditions to improve safety and prevent potential injuries.

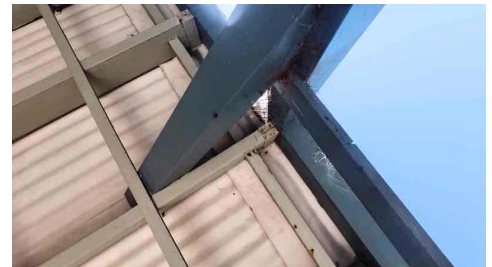
Photo 35

6. Evidence of water damage was noted at the carport wood members. Consult a licensed structural pest control company regarding necessary repairs.

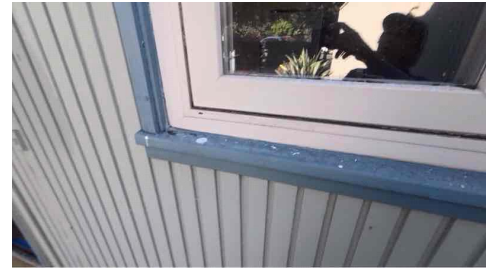
Photo 07

7. The window at the front, left and rear wall shows evidence of water damage to the sill/jamb. We recommend the advice and services of a general contractor and/or structural pest control company regarding repairs.  
([See Photo 7](#)) ([See Photo 12](#)) ([See Photo 17](#))

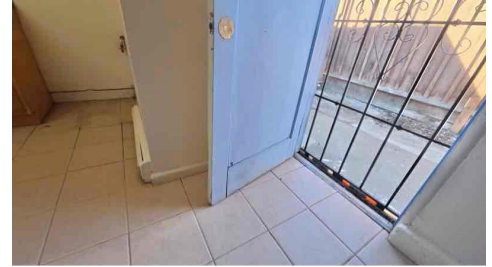
Photo 51

8. Water damage was noted at the right wall door. We recommend the services of a licensed general contractor and/or structural pest control company regarding repairs.  
([See Photo 51](#))

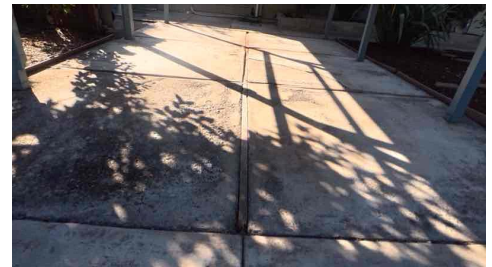
Photo 09

9. The driveway has cracked, heaved, or uneven sections, creating a potential trip hazard. We recommend repairing or resurfacing the affected areas to improve safety and prevent further deterioration.  
([See Photo 9](#))

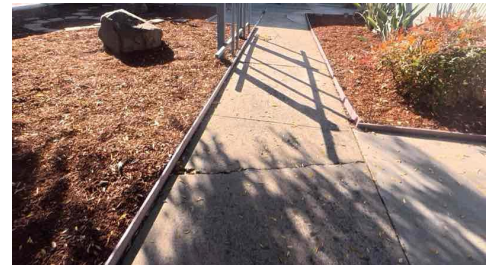
Photo 04

10. The cracked, heaved, or uneven walkway sections at the front, left and right pose a potential trip hazard. We recommend corrective action to improve safety and reduce the risk of injury. A qualified contractor should assess the affected areas and perform necessary repairs to ensure a level walking surface.  
([See Photo 4](#)) ([See Photo 5](#)) ([See Photo 8](#))

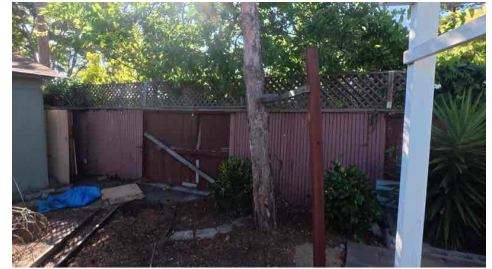
Photo 20

11. The wood fencing at the rear and left of the property is in need of repairs.

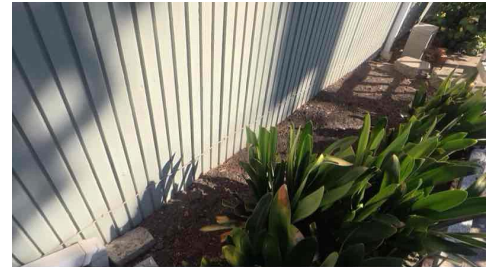
Photo 15

12. Wood/soil contact at the base of the wood siding at the rear wall should be eliminated. If rotted or damaged siding is found consult a licensed structural pest control operator regarding repairs.

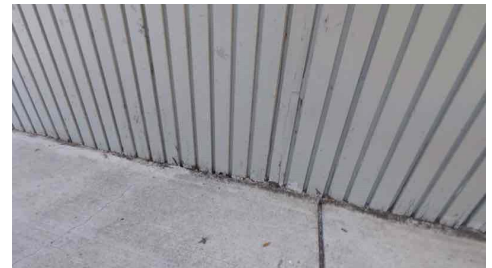
Photo 02

13. Water damage was observed to the wood siding at the front, rear and left exterior walls. We recommend the services of a licensed general contractor and/or structural pest control company.

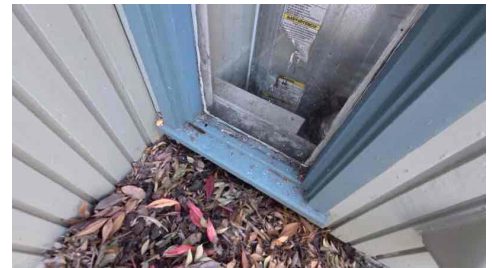
Photo 06

14. Water damage was observed to the exterior trim at the front right window, rear wall and window, right wall door. We recommend the services of a licensed general contractor and/or structural pest control company.

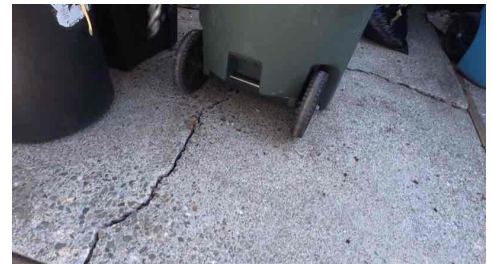
Photo 11

15. The concrete is badly cracked at the front left and rear middle patio. The cracks could be sealed for a better appearance and to prevent moisture intrusion. Replacement will ultimately be necessary.

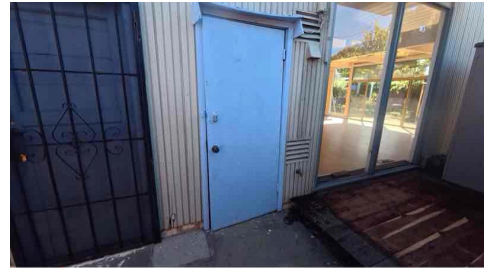
Photo 32

16. Loose and/or damaged hardware was noted at the water heater closet door. We recommend that hinges, knobs, latches and strike plates be adjusted or replaced to restore full operation.  
([See Photo 32](#))

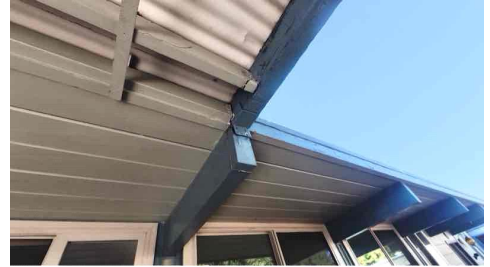
Photo 34

17. Water damage was observed to the beam ends at the front eaves. We recommend the services of a licensed general contractor and/or structural pest control company.  
([See Photo 34](#))

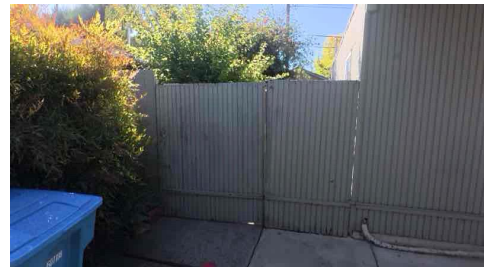
Photo 10

18. The fence posts are loose at the front left area. We recommend all loose, damaged or deteriorated posts be reinforced or replaced as necessary.  
([See Photo 10](#))

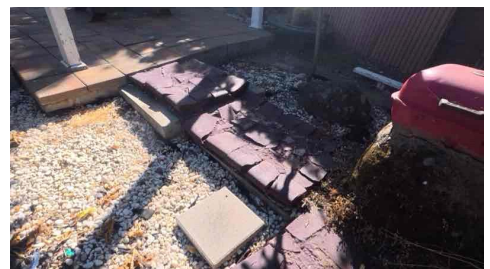
Photo 22

19. The steps at the rear appear to be non-conforming. This could create a potential fall hazard. We recommend the services of a licensed general contractor.  
([See Illustration 3R](#)) ([See Photo 22](#)) ([See Photo 33](#))

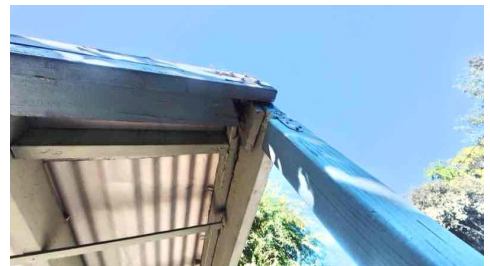
Photo 38

20. The metal hardware at the carport is loose, deteriorated/rusted and in this condition are prone to failure. We recommend the hardware be replaced.  
([See Photo 38](#))

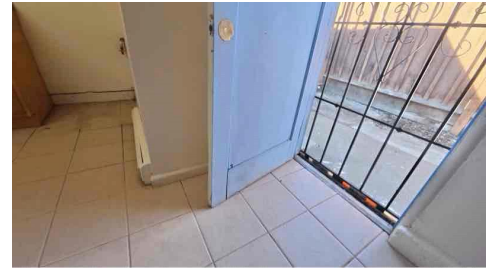
Photo 51

21. The exterior door at the right wall is not a solid core exterior grade. Although the door may be functional, we recommend replacing the door for security reasons. Hollow core or interior grade doors do not meet this requirement.  
([See Illustration 3W](#)) ([See Photo 51](#))

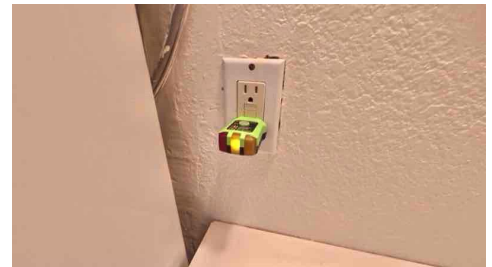
Photo 47

22. Ungrounded "3-prong" outlets at various locations in the ADU should be improved. A grounded cable or ground wire could be installed at these outlets, the outlet labeled as ungrounded or the original "2-prong" receptacle could be reinstalled. Based upon our inspection of a representative number of outlets, we recommend testing of every outlet. Repairs or rewiring are recommended at all deficient locations. For additional information we recommend a licensed electrician be consulted.  
([See Illustration 4O](#)) ([See Photo 47](#)) ([See Photo 52](#))

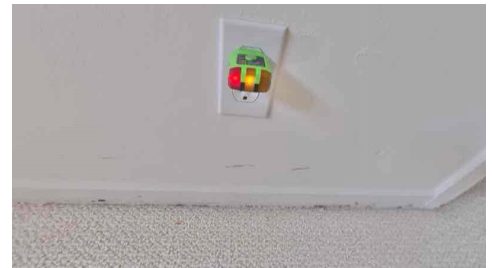
Photo 58

23. The outlet at the master bedroom has reversed polarity, i.e. the hot and neutral connection inside the outlet are wired backwards. This outlet and the circuit should be investigated and corrected. Based upon our inspection of a representative number of outlets, we recommend testing of every outlet at a later date. Repairs or rewiring are recommended at all deficient locations.  
([See Illustration 4M](#)) ([See Photo 58](#))

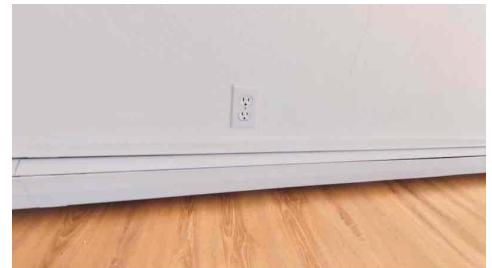
Photo 57

24. The location of the outlets over the baseboard heater at various locations can present a safety issue. We recommend the outlets be moved/relocated.  
([See Photo 57](#))

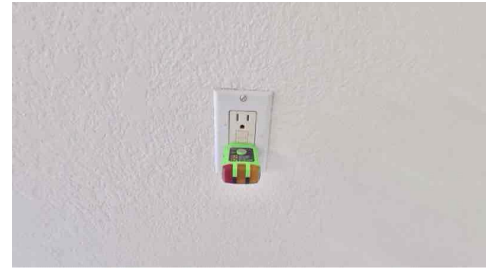
Photo 46

25. During our inspection and subsequent testing of electrical outlets we noted that a "GFCI" outlet in the ADU dining room has tripped however we could not find the outlet to reset, possibly due to owner storage or unknown location of the "GFCI". We recommend consultation with the owner in regards to this inaccessible "GFCI" and to reset the unit for full use of all outlets.

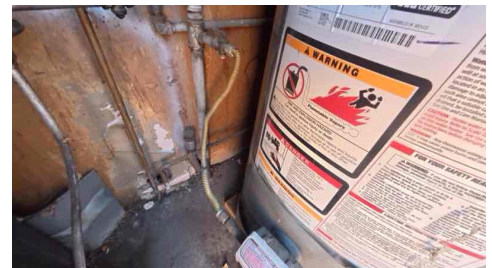
Photo 31

26. The gas line/connector at the water heater is flexible and made of brass. Brass is no longer approved for this use because it is prone to deterioration. We recommend the gas line/connectors be replaced with a line/connector meeting present standards.

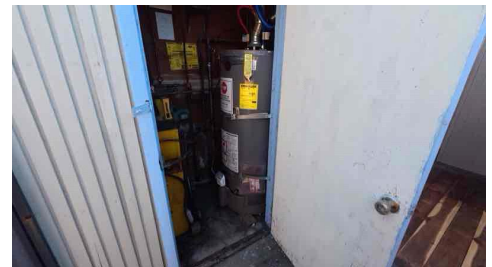
Photo 28

27. The water heater seismic straps are loose, this will allow movement of the tank in an earthquake. We recommend tightening the straps and/or adding bracing between the tank and wall to improve safety.

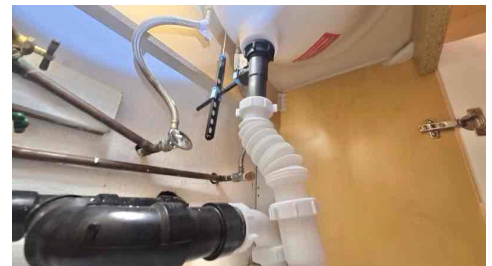
Photo 49

28. The sink drain at the ADU hall bathroom is leaking. We recommend all leaks be repaired.

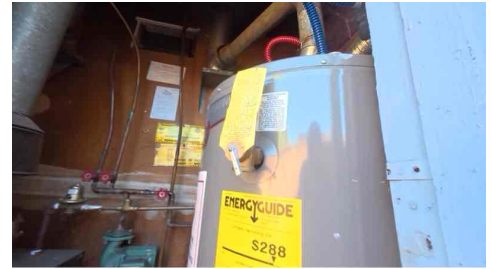
Photo 27

29. The temperature and pressure relief valve for the water heater lacks a proper discharge pipe. We recommend the installation of approved piping to an approved location.

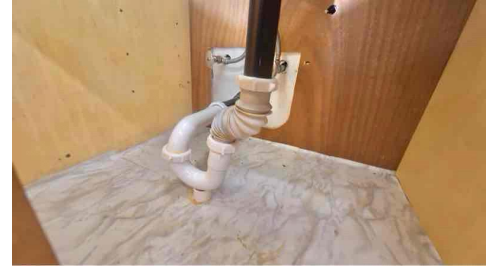
Photo 45

30. A plastic corrugated flex material has been used at the ADU kitchen and hall bathroom sink drain. This is not an approved configuration. We recommend an approved drain be installed.

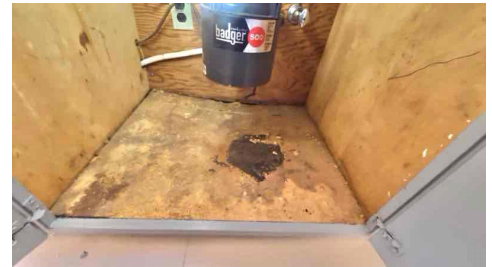
Photo 43

31. The base and/or side of the kitchen cabinet sink shelf is water damaged. We recommend the services of a licensed structural pest control operator for investigation of this condition.

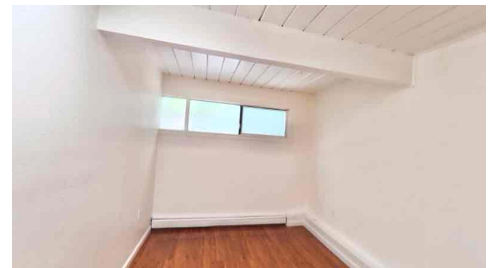
Photo 53

32. The height or size of the window in the ADU bedrooms does not conform to proper standards for egress. We recommend contacting the local building department to confirm if this installation conforms to specifications for escape openings in bedrooms.

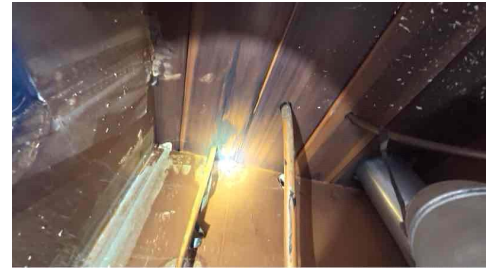
Photo 29

33. The ceiling at the water heater closet, house main entrance hall closets and living room shows evidence of water stains. It is recommended that the source of these stains be identified and corrected and the surface be refinished.  
([See Photo 29](#)) ([See Photo 39](#)) ([See Photo 60](#))

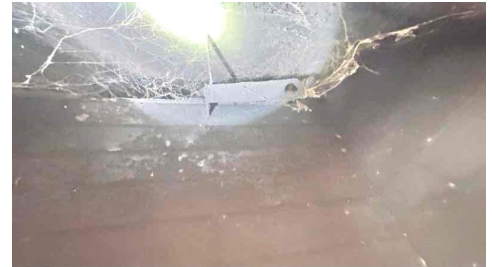
Photo 56

34. The fireplace damper is damaged and/or not operational. We recommend it be repaired or replaced.  
([See Photo 56](#))

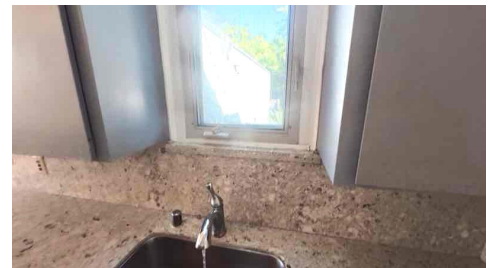
Photo 41

35. Hardware is damaged or missing at the kitchen windows. We recommend a general tune-up of the windows as necessary to restore their proper function.  
([See Photo 41](#))

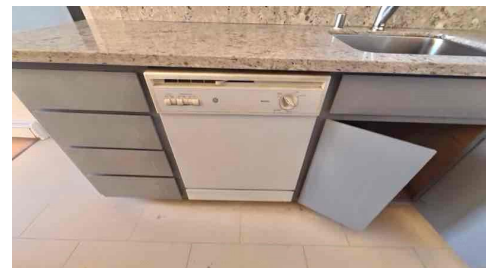
Photo 42

36. At the time of our inspection the dishwasher was inoperative or did not respond to normal operating controls. For attention to the conditions noted and/or cost estimates, if necessary, we recommend the advice of a qualified appliance technician.  
([See Photo 42](#))

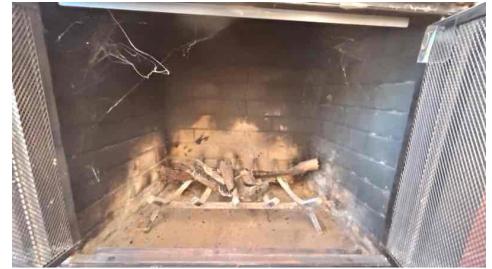
Photo 55

37. The interior of the fireplace firebox should be repaired where the bricks or mortar are heavily eroded, loose, or cracked. We recommend the advice and servicing of a licensed masonry contractor or fireplace specialist.  
([See Photo 55](#))

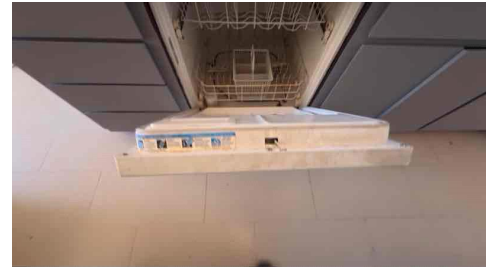
Photo 44

38. The latch at the dishwasher door is loose or damaged. We recommend it be repaired or replaced by a qualified appliance technician.  
([See Photo 44](#))

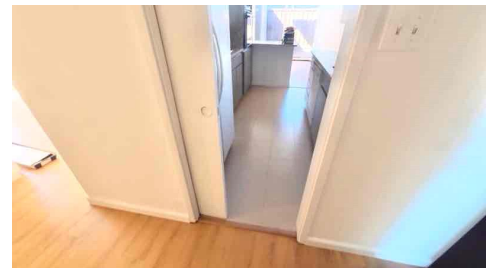
Photo 40

39. The interior door knob, latch or hinge hardware is missing at the kitchen. We recommend all missing hardware be replaced to restore full operation.  
([See Photo 40](#))

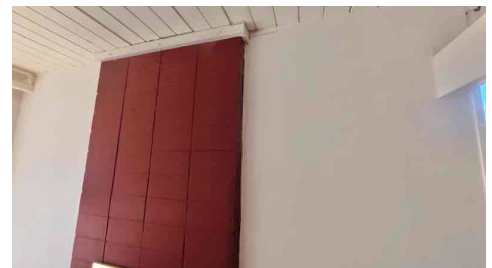
Photo 59

40. The wall in the living room is bulging and/or loose. It is recommended that the source of the bulging/loose wall be identified and corrected by the appropriate trades person.  
([See Photo 59](#))

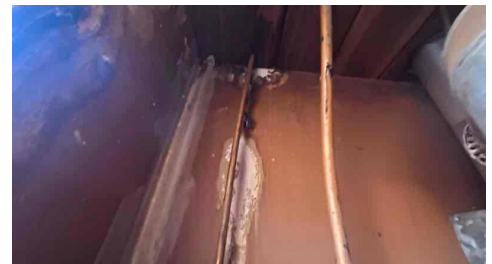
Photo 30

41. The wall at the water heater closet shows evidence of water stains. It is recommended that the source of the moisture be identified and corrected and the surface be repaired and refinished to restore its appearance.  
([See Photo 30](#))
