256 E. Charleston Road  
Palo Alto, CA, 94306

680311

## Roof Inspection Report

**256 E. Charleston Road, Palo Alto**

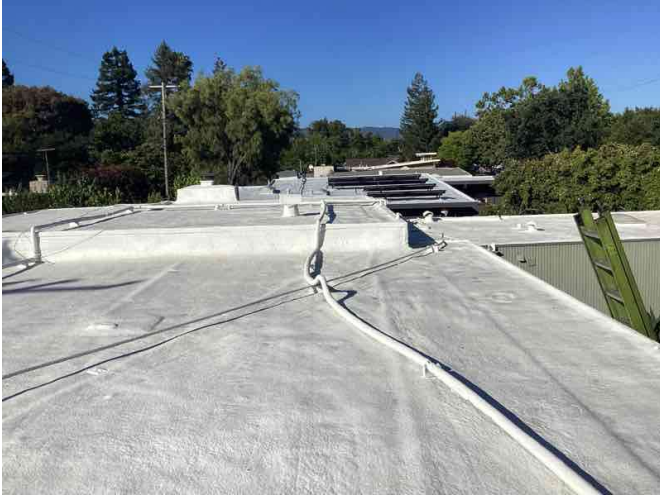
**Photo 01**

1. Main roof, pictured.  
[\(See Photo 1\)](#)
2. The roof drainage system is inadequate at isolated areas. This condition is allowing water to pond on the roofs surface. However, does not appear to affect the performance of the roof at this time. Area's should be monitored for future performance.  
[\(See Photo 2\)](#) [\(See Photo 3\)](#) [\(See Photo 4\)](#)
