256 E. Charleston Road  
Palo Alto, CA, 94306

680311

## WOOD DESTROYING PESTS AND ORGANISM INSPECTION REPORT

| General Description: <b>This is a one story single family dwelling with wood and brick exterior.</b> | | | | Inspection Tag Posted: <b>Utility closet</b> | |

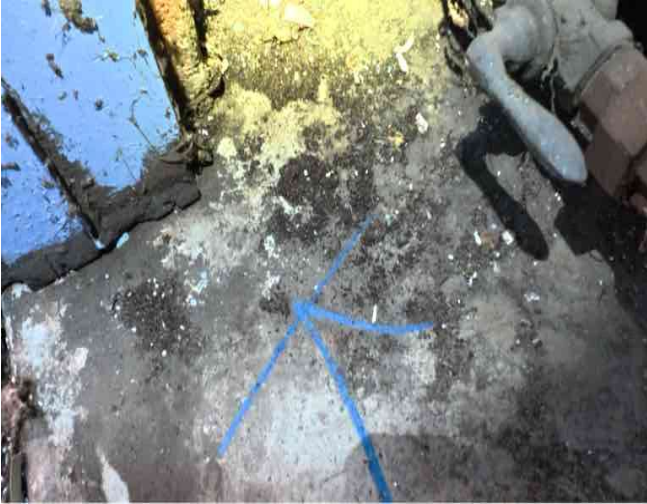
Photo 01

**1L.** FINDING: Drywood termite pellets were evident at the utility closet, exterior and interior, as indicated on the diagram. This property has been fumigated in the past.  
[\(See Photo 1\)](#) [\(See Photo 3\)](#) [\(See Photo 20\)](#)

RECOMMENDATION: Remove or mask over all accessible termite pellets to aid in future inspections.  
*Estimated Cost*

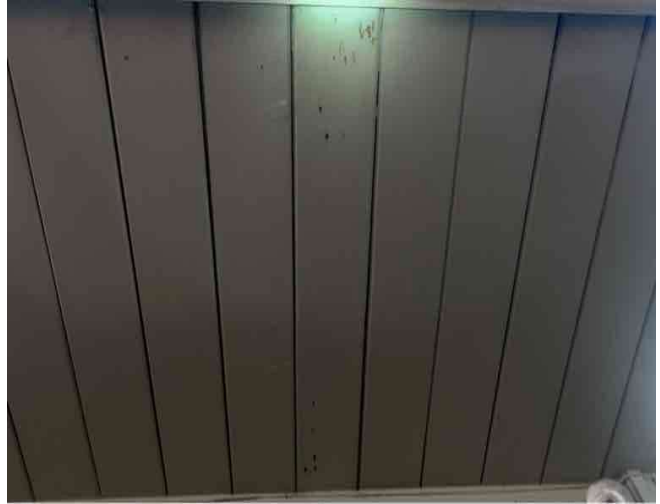
Photo 02

- 1A.** FINDING: The roof sheathing as indicated on the diagram is damaged by drywood termites.  
([See Photo 2](#))

RECOMMENDATION: Remove and replace the damaged wood members to correct this condition. This *Estimated Cost* bid does not include replacement of roof covering. After our repairs have been performed the owner is advised to contact a licensed roofing contractor.

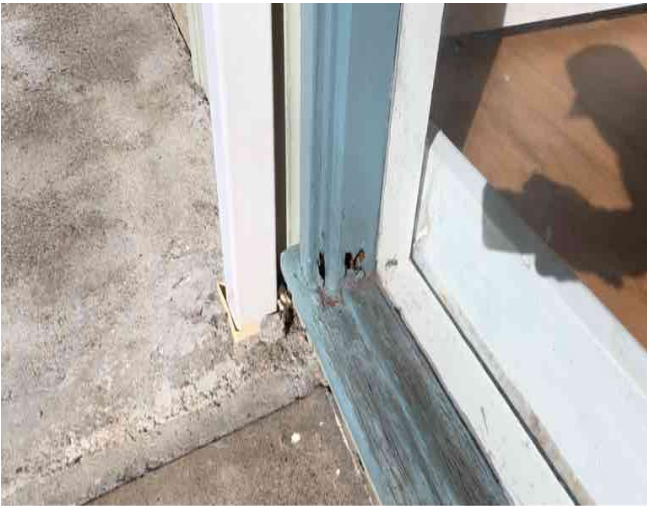
Photo 03

- 1B.** FINDING: The jamb and trim have been damaged by drywood termites at the rear window. Refer to item 1L for recommendations to control contributing infestation.  
([See Photo 3](#))

RECOMMENDATION: Remove and replace all the damaged wood members. If any damage is found to *Estimated Cost* extend into any enclosed areas a supplemental report and bid will be issued.

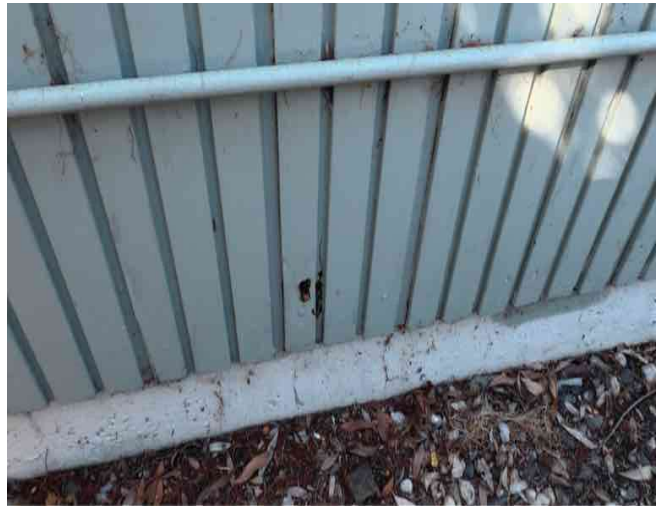
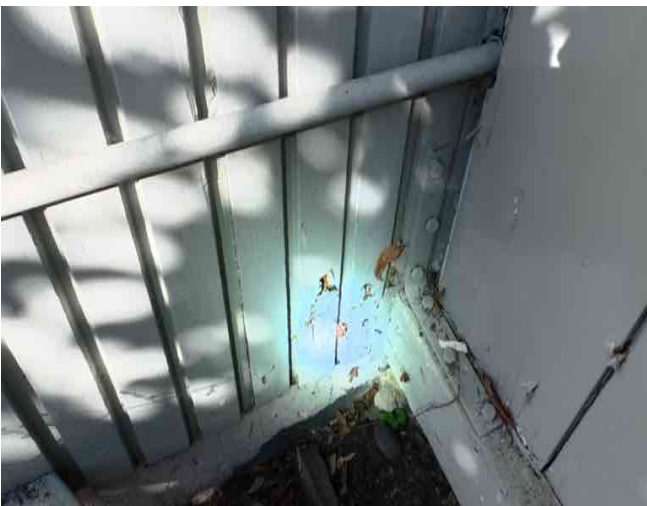
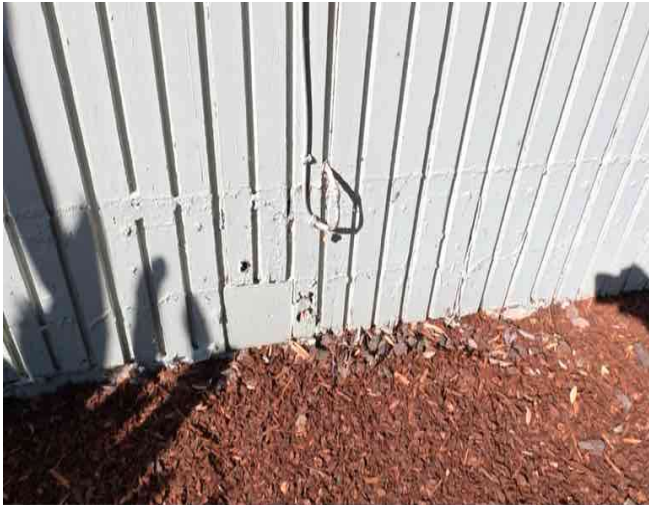
- 1C.** FINDING: The siding has been damaged by fungus at one or more locations. The contributing moisture source appears to be exposure to the weather.  
([See Photo 4](#)) ([See Photo 5](#)) ([See Photo 9](#))

RECOMMENDATION: Remove and replace all the damaged wood members. If any damage is found to *Estimated Cost* extend into any enclosed areas a supplemental report and bid will be issued.

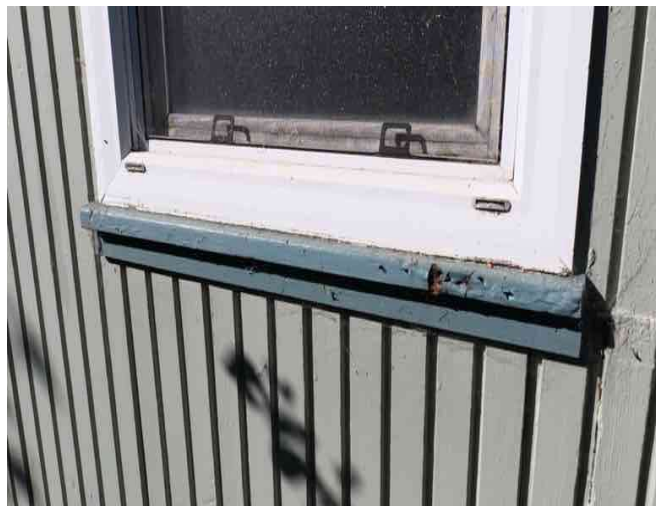
Photo 06

- 1D.** FINDING: The window sill at the left side was found to be damaged by fungus.  
([See Photo 6](#))

RECOMMENDATION: Remove and replace the damaged window sill to correct this condition. The *Estimated Cost* contributing moisture source appears to be exposure to the weather.

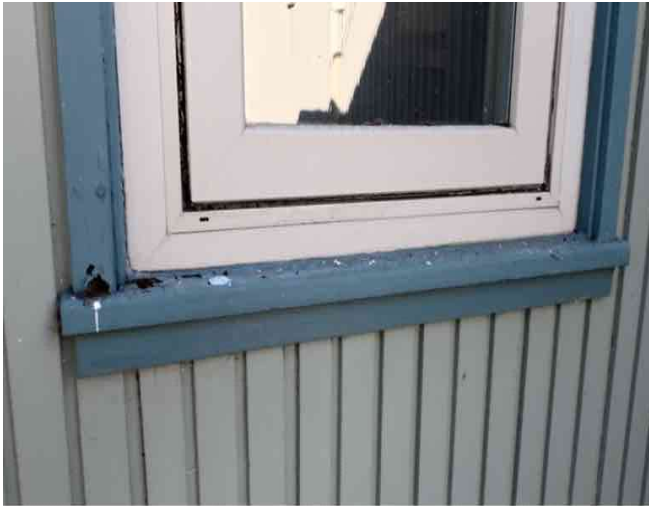
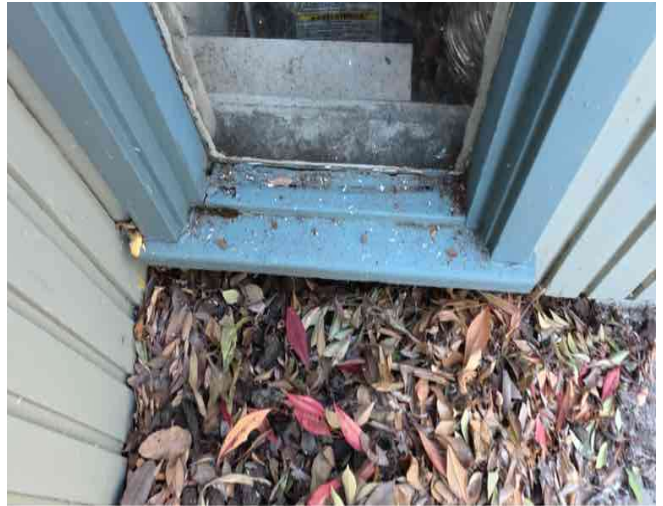
- 1E.** FINDING: The trim and sill have been damaged by fungus at the front windows. The contributing moisture source appears to be exposure to the weather.  
([See Photo 7](#)) ([See Photo 8](#))

RECOMMENDATION: Remove and replace all the damaged wood members. If any damage is found to *Estimated Cost* extend into any enclosed areas a supplemental report and bid will be issued.

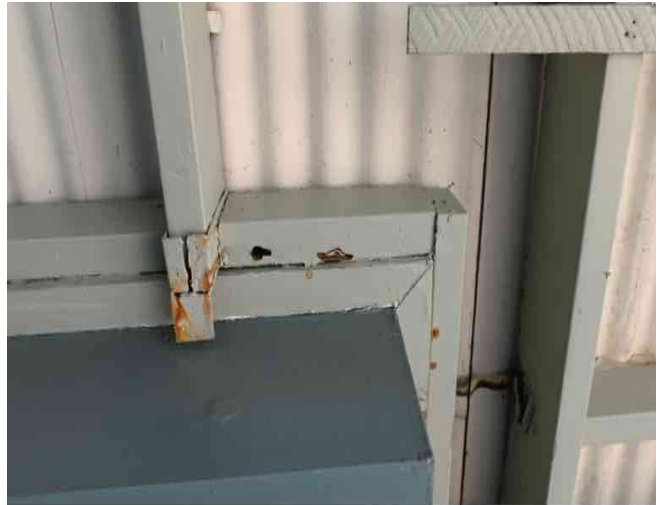
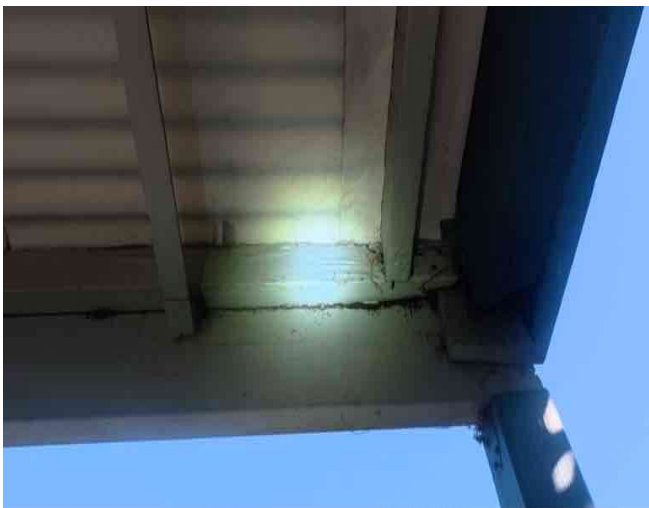
- 1F.** FINDING: The ledger boards at the carport are damaged by fungus. The contributing moisture source appears to have been caused by a failure of the roof covering and/or exposure to weather.  
[\(See Photo 10\)](#) [\(See Photo 11\)](#)

RECOMMENDATION: Remove and replace the damaged wood members to correct this condition.  
*Estimated Cost*

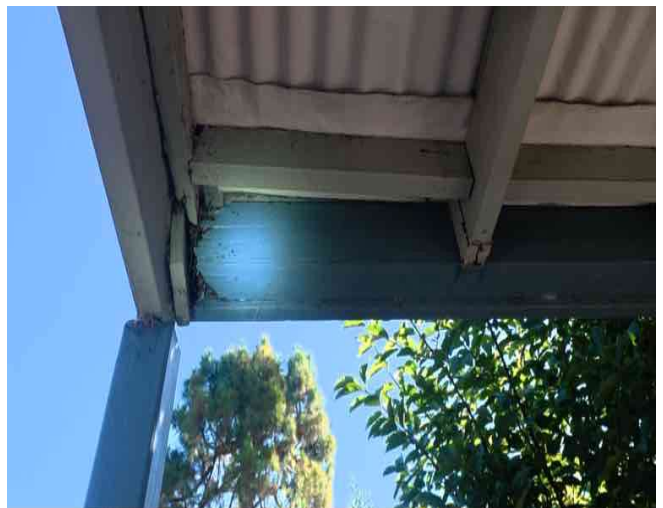
Photo 12

- 1G.** FINDING: The end of the support beam has been damaged by fungus at the carport. The contributing moisture source appears to have been caused by a failure of the roof covering and/or exposure to weather.  
[\(See Photo 12\)](#)

RECOMMENDATION: Remove and replace the damaged end of the beam. If damage were to extend into inaccessible areas or if the damage extends beyond what can be repaired, a supplemental report will be issued with additional findings and recommendations.  
*Estimated Cost*

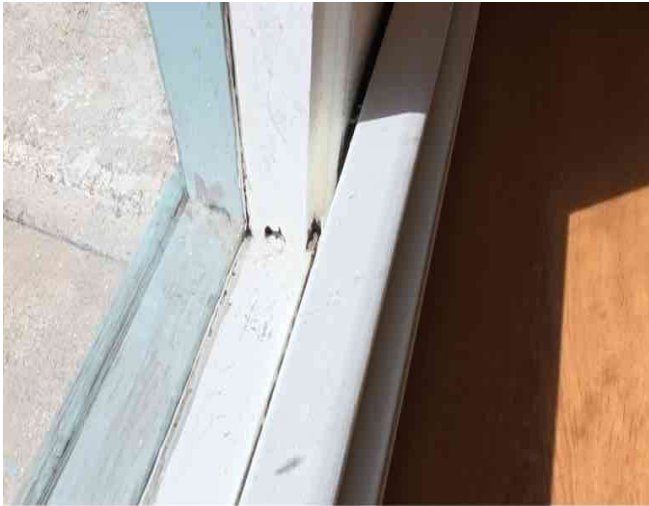
*Photo 13*

- 1H.** FINDING: The window sash has been damaged by drywood termites at the living room. This damage appears to be minor.  
[\(See Photo 13\)](#)

RECOMMENDATION: Hollow out this area and fill the void with an appropriate wood filler.  
*Estimated Cost*

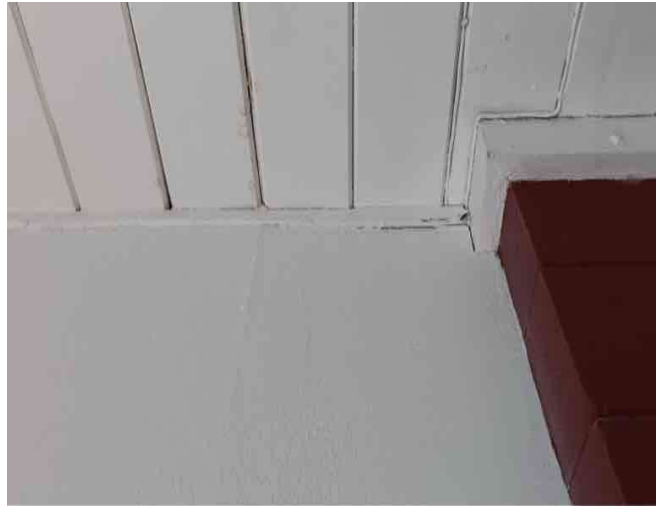
*Photo 14*

- 1I.** FINDING: The trim has been damaged by drywood termites at the living room adjacent to the fireplace. Refer to item 1L for recommendations to control contributing infestation.  
[\(See Photo 14\)](#)

RECOMMENDATION: Remove and replace all the damaged wood members. If any damage is found to extend into any enclosed areas a supplemental report and bid will be issued.  
*Estimated Cost*

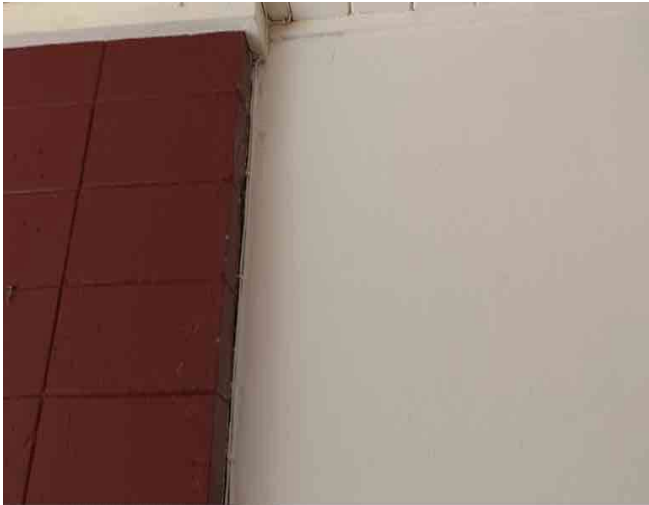
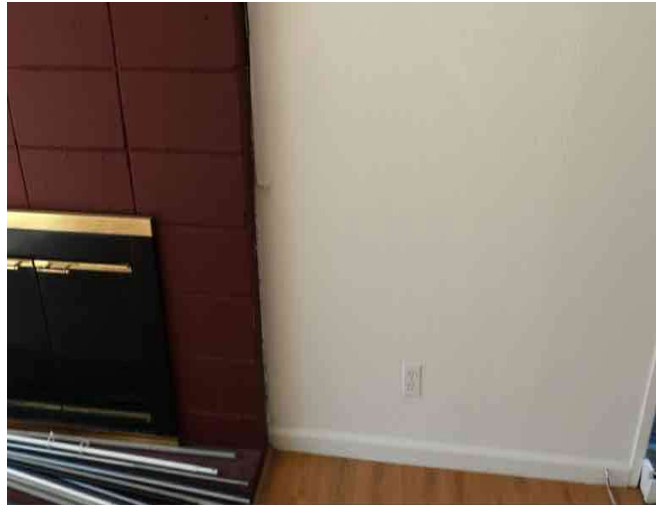
- 1J.** FINDING: The sheetrock at the living room wall at the right side of the fireplace was found to be damaged by fungus.  
[\(See Photo 15\)](#) [\(See Photo 16\)](#)

RECOMMENDATION: Remove the sheetrock in this area to allow for further inspection. Issue a supplemental report with all findings and bids. Note: If no additional findings are made HomeGuard will reinstall sheetrock in this area.  
*Estimated Cost*

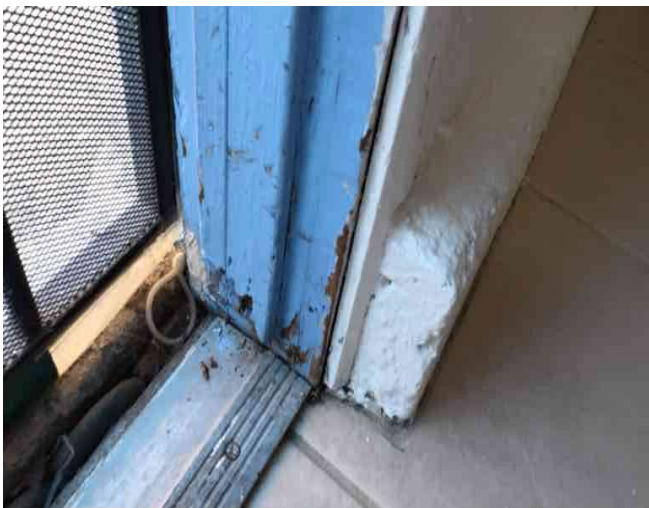
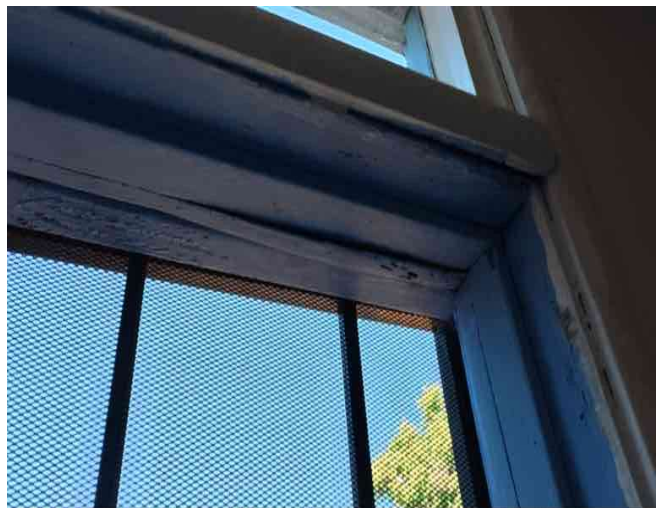
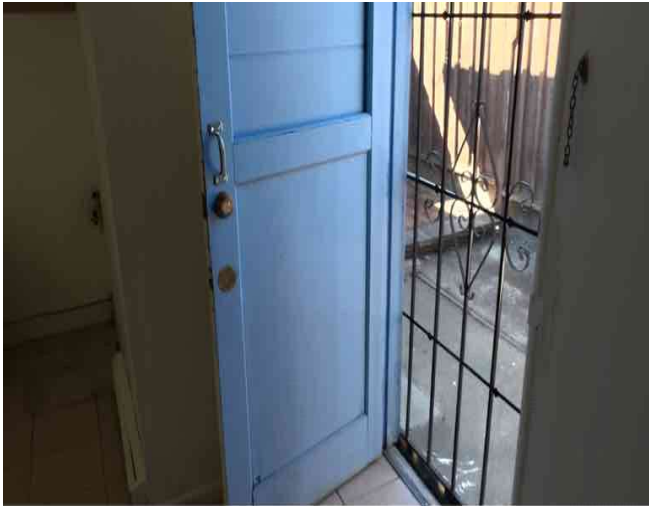
**1K.** FINDING: The converted garage door and jambs were found to be damaged by fungus. It appears the damage is a result of exposure to the weather.  
[\(See Photo 17\)](#) [\(See Photo 18\)](#) [\(See Photo 19\)](#)

RECOMMENDATION: Supply and install a new pre-hung door and jambs to correct this condition. Note:  
*Estimated Cost* The existing door knob and dead bolt if any will be re-installed in the new door unless prior arrangements are made. We at HomeGuard Incorporated are upgrade experts and can provide proposals that include upgraded fixtures, and doors or any other option you may desire. This bid is based on the installation of a readily available door of similar size. An exact match of the existing door may not be possible. If a more exact match is desired, additional fees may apply. Please note that if a special order door is needed to complete this item, there could be a three week delay in getting a replacement door.
