HOME INSPECTION REPORT

26854 Grandview Avenue, Hayward

672252

March 5, 2026

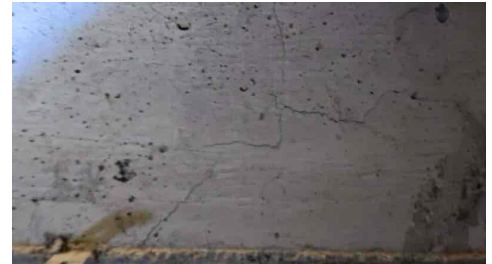
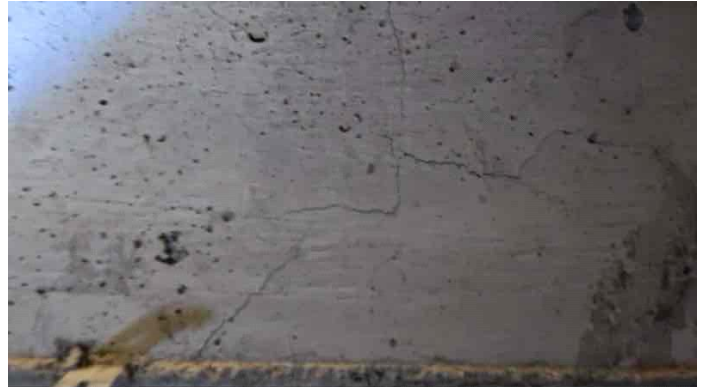
Photo 18

1. A horizontal crack was observed in the intermediate foundation wall at the rear left of the structure. Horizontal cracks may result from various factors, including foundation wall movement or stress. In some cases, they can also be caused by the expansion of reinforcing steel due to moisture intrusion, particularly when near the edge of the formwork used during construction. This condition may indicate a potential defect or developing concern. A thorough evaluation is beyond the scope of this visual inspection. We recommend further assessment by a licensed foundation contractor to determine the cause and whether any repairs are warranted. (See Photo 18)

- ! 1. A horizontal crack was observed in the intermediate foundation wall at the rear left of the structure. Horizontal cracks may result from various factors, including foundation wall movement or stress. In some cases, they can also be caused by the expansion of reinforcing steel due to moisture intrusion, particularly when near the edge of the formwork used during construction. This condition may indicate a potential defect or developing concern. A thorough evaluation is beyond the scope of this visual inspection. We recommend further assessment by a licensed foundation contractor to determine the cause and whether any repairs are warranted. (See Photo 18)

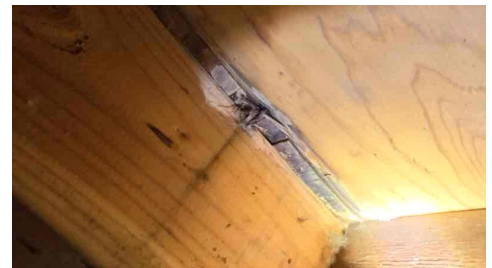
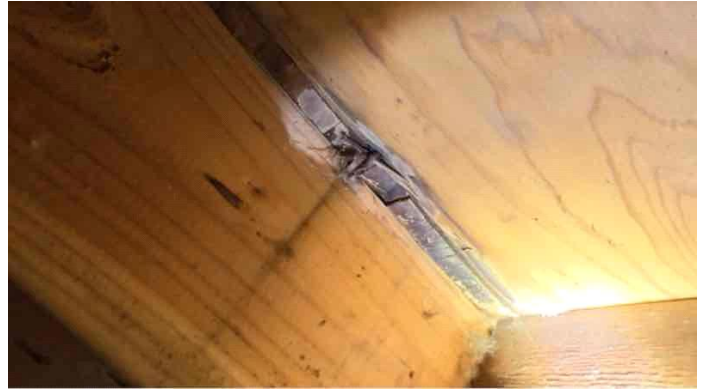
Photo 16

2. The wood members under the rear show evidence of water damage. We recommend the services of a licensed structural pest control operator for investigation of this condition. (See Photo 16) (See Photo 17)

- ! 3. The wood members under the rear show evidence of water damage. We recommend the services of a licensed structural pest control operator for investigation of this condition. (See Photo 16) (See Photo 17)

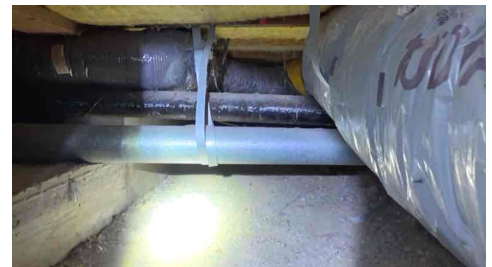
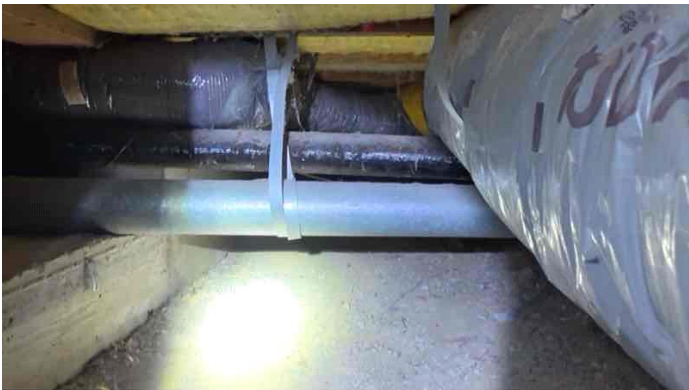
Photo 19

3. Due to the lack of clearance between the ground and ducting, plumbing, and/or floor joist/girders, portions of the crawl space were not inspected. With access and an opportunity for a complete inspection, conditions in need of attention may be discovered. We recommend further inspection when a minimum of 16 inches between the ground and any obstructions is provided. (See Photo 19)

Due to the lack of clearance between the ground and ducting, plumbing, and/or floor joist/girders, portions of the crawl space were not inspected. With access and an opportunity for a complete inspection, conditions in need of attention may be discovered. We recommend further inspection when a minimum of 16 inches between the ground and any obstructions is provided. (See Photo 19)

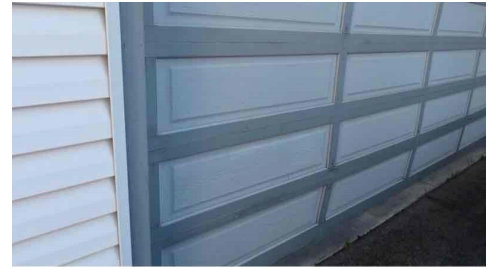
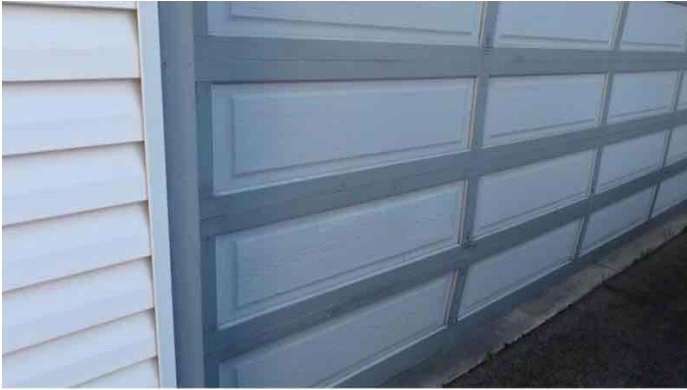
Photo 01

4. The main garage door is water damaged. We recommend the services of a licensed general contractor and/or structural pest control company regarding repairs. (See Photo 1)

- ! 1. The main garage door is water damaged. We recommend the services of a licensed general contractor and/or structural pest control company regarding repairs. (See Photo 1)

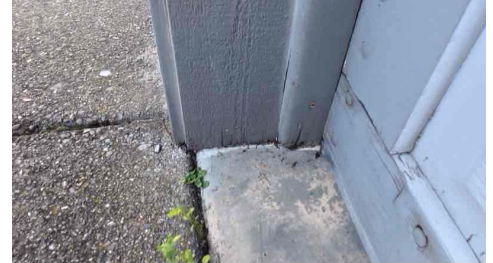
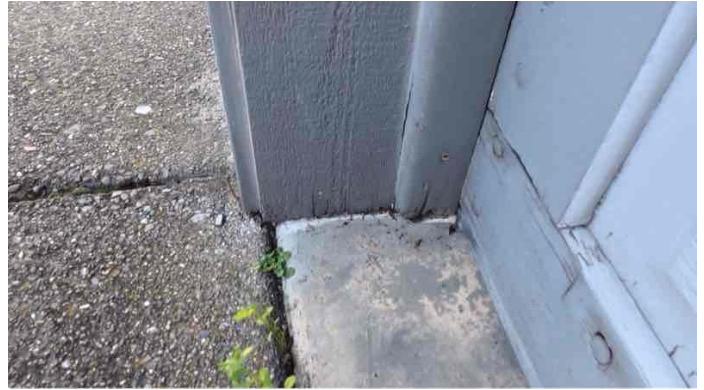
Photo 02

5. The main garage door jamb and/or trim shows evidence of water damage. We recommend the services of a licensed general contractor and/or structural pest control company regarding repairs. (See Photo 2)

- ! 2. The main garage door jamb and/or trim shows evidence of water damage. We recommend the services of a licensed general contractor and/or structural pest control company regarding repairs. (See Photo 2)

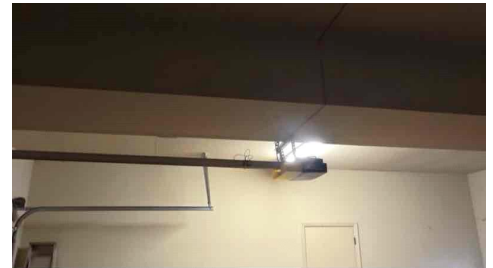
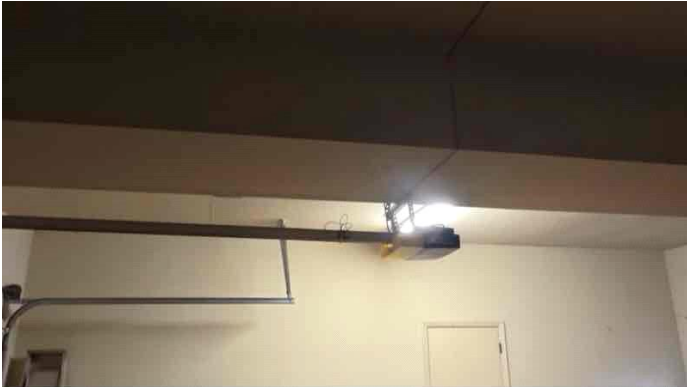
Photo 09

6. The automatic reverse safety feature of the garage door opener did not activate when the door made contact with a 2x2-inch block placed under the center of the door during testing. This feature is an important safety requirement designed to prevent injury or damage if an obstruction is present. The photo-eye sensors were tested separately and found to be operational. We recommend that the garage door opener be adjusted, repaired, or replaced as necessary to restore proper function of the automatic reverse mechanism. A qualified garage door service technician should evaluate and correct this condition for improved safety. (See Illustration 3V) (See Photo 9)

- ! 3. The automatic reverse safety feature of the garage door opener did not activate when the door made contact with a 2x2-inch block placed under the center of the door during testing. This feature is an important safety requirement designed to prevent injury or damage if an obstruction is present. The photo-eye sensors were tested separately and found to be operational. We recommend that the garage door opener be adjusted, repaired, or replaced as necessary to restore proper function of the automatic reverse mechanism. A qualified garage door service technician should evaluate and correct this condition for improved safety. (See Illustration 3V) (See Photo 9)

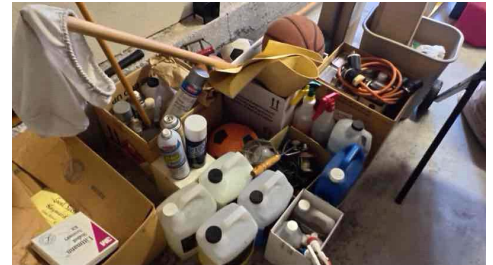
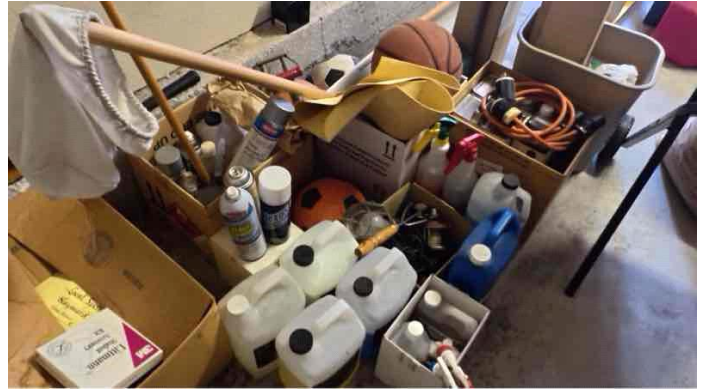
Photo 08

7. Storage of personal belongings within the interior of the garage prevented a full visual inspection of the area. Therefore, the area was not fully inspected. With removal of all personal items and a complete inspection, conditions in need of attention may be discovered. (See Photo 8)

Storage of personal belongings within the interior of the garage prevented a full visual inspection of the area. Therefore, the area was not fully inspected. With removal of all personal items and a complete inspection, conditions in need of attention may be discovered. (See Photo 8)

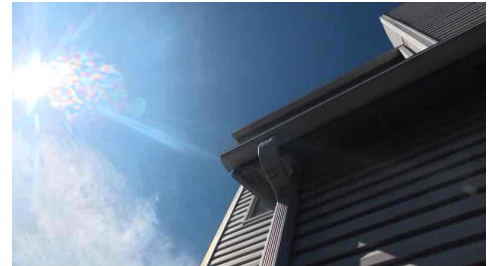
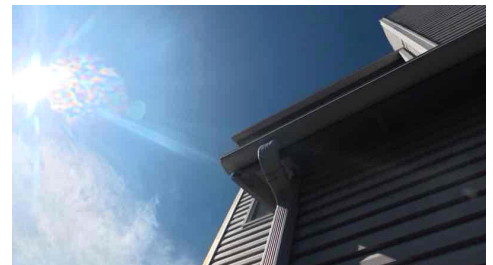
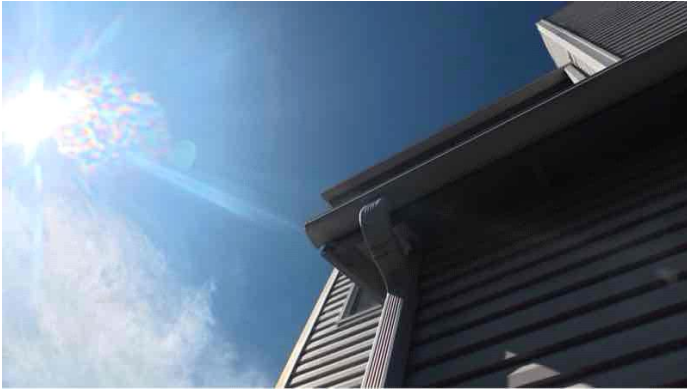
Photo 07

8. Water damage was observed to the rafters at the left side. We recommend the services of a licensed general contractor and/or structural pest control company. (See Photo 7)

9. Water damage was observed to the fascia at the side. We recommend the services of a licensed general contractor and/or structural pest control company. (See Photo 7)

- ! 4. Water damage was observed to the rafters at the left side. We recommend the services of a licensed general contractor and/or structural pest control company. (See Photo 7)

- ! 5. Water damage was observed to the fascia at the side. We recommend the services of a licensed general contractor and/or structural pest control company. (See Photo 7)

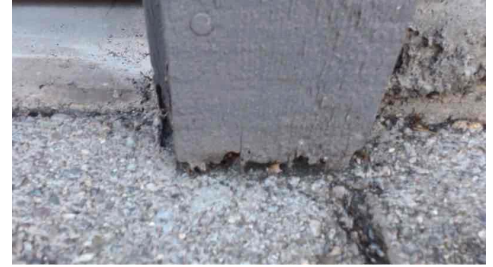
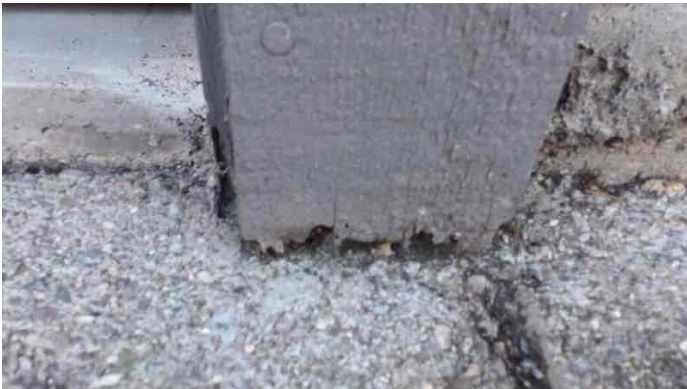
Photo 05

10. Water damage was observed to the exterior trim at the left side. We recommend the services of a licensed general contractor and/or structural pest control company. (See Photo 5)

- ! 6. Water damage was observed to the exterior trim at the left side. We recommend the services of a licensed general contractor and/or structural pest control company. (See Photo 5)

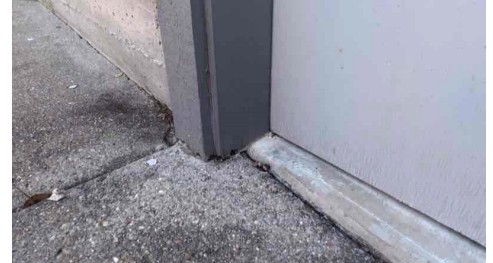
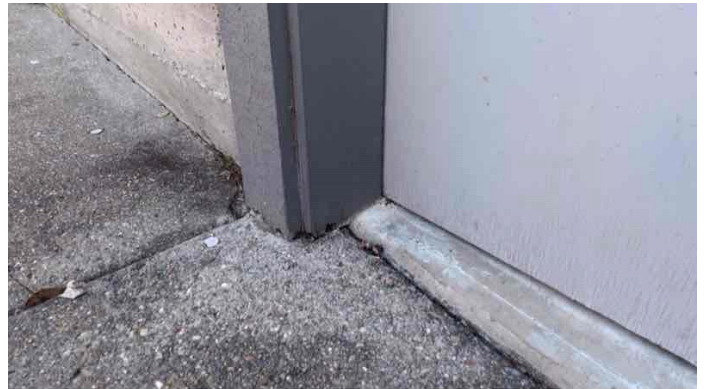
Photo 06

11. Water damage was noted at the left side door jamb. We recommend the services of a licensed general contractor and/or structural pest control company. (See Photo 6)

- ! 7. Water damage was noted at the left side door jamb. We recommend the services of a licensed general contractor and/or structural pest control company. (See Photo 6)

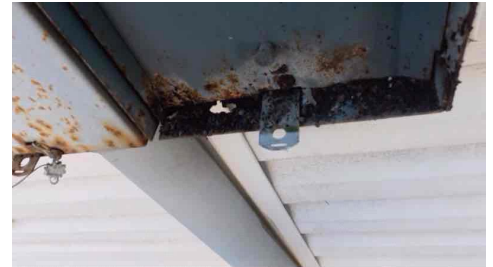
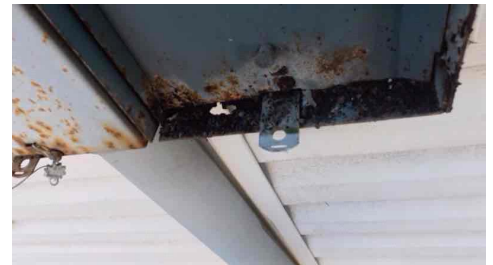
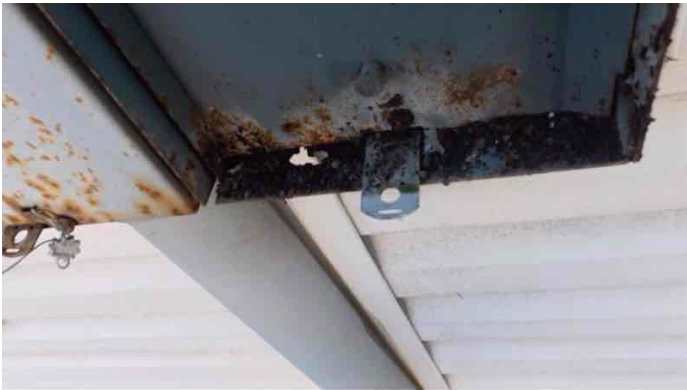
Photo 03

12. The main electrical panel was obstructed and inaccessible at the time of our inspection. We recommend the circuitry and wiring in the panel be inspected by a licensed electrical contractor when the obstructions/storage is removed. (See Photo 3)

13. The main electrical panel bus bar, circuit breakers and/or hardware are worn out or damaged to a point where major repairs or replacement of the entire panel may be required. We recommend further evaluation of the panel and related equipment by a licensed electrician. (See Illustration 4T) (See Photo 3) (See Photo 4)

- ! 1. The main electrical panel was obstructed and inaccessible at the time of our inspection. We recommend the circuitry and wiring in the panel be inspected by a licensed electrical contractor when the obstructions/storage is removed. (See Photo 3)
- ! 2. The main electrical panel bus bar, circuit breakers and/or hardware are worn out or damaged to a point where major repairs or replacement of the entire panel may be required. We recommend further evaluation of the panel and related equipment by a licensed electrician. (See Illustration 4T) (See Photo 3) (See Photo 4)

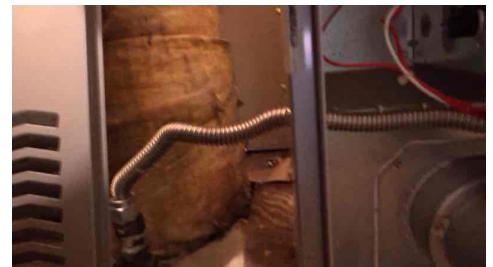
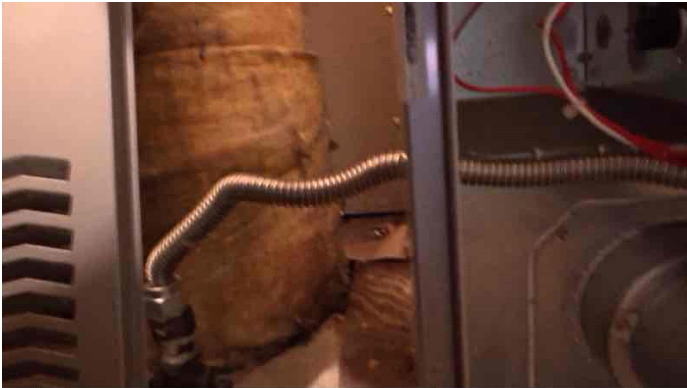
Photo 11

14. We noted a flexible gas line running through the furnace metal housing. We recommend consideration be given to installing rigid piping at the penetration of the housing and the installation of flexible supply piping at the exterior of the furnace. (See Photo 11)

- ! 1. We noted a flexible gas line running through the furnace metal housing. We recommend consideration be given to installing rigid piping at the penetration of the housing and the installation of flexible supply piping at the exterior of the furnace. (See Photo 11)

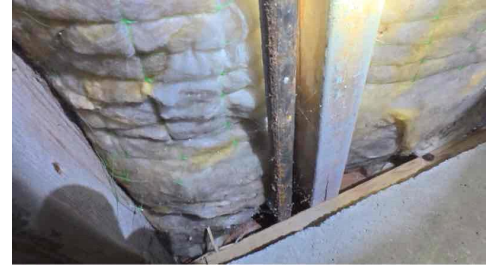
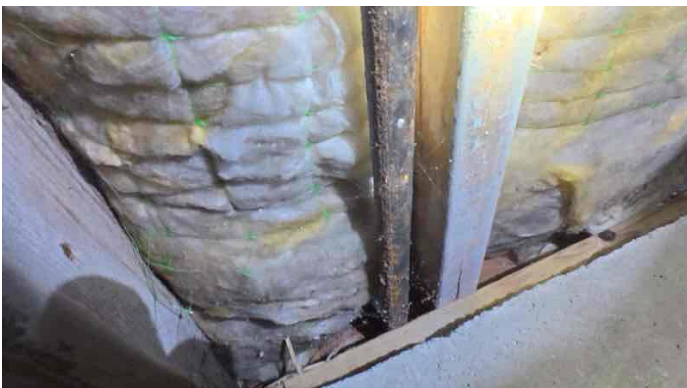
Photo 13

15. There is evidence of heavy corrosion and rust on the exterior of the exposed and accessible metal gas supply piping at the crawlspace. This section of piping should be replaced as necessary. (See Photo 13)

- ! 1. There is evidence of heavy corrosion and rust on the exterior of the exposed and accessible metal gas supply piping at the crawlspace. This section of piping should be replaced as necessary. (See Photo 13)
- ! 2. The water heater/furnace exhaust vent was found to be disconnected or loose. This condition poses a health and safety hazard, as it can lead to the improper venting of combustion gases—including carbon monoxide—into the home. We recommend evaluation and repair by a licensed plumbing contractor to ensure the exhaust vent is properly reconnected, securely sealed, and effectively venting combustion gases to the exterior, in compliance with safety standards. (See Photo 10)

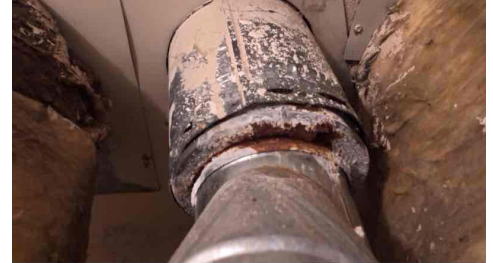
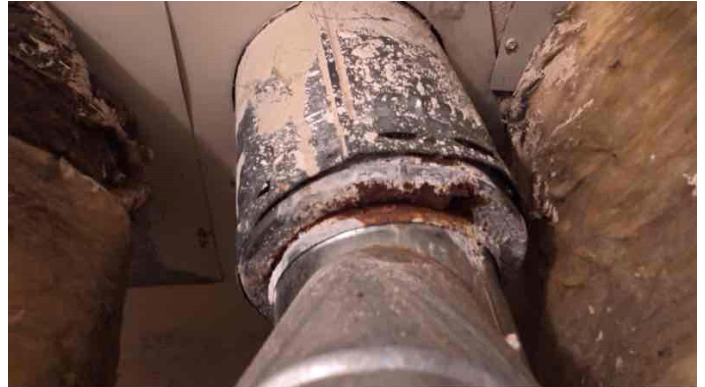
Photo 10

16. The water heater/furnace exhaust vent was found to be disconnected or loose. This condition poses a health and safety hazard, as it can lead to the improper venting of combustion gases—including carbon monoxide—into the home. We recommend evaluation and repair by a licensed plumbing contractor to ensure the exhaust vent is properly reconnected, securely sealed, and effectively venting combustion gases to the exterior, in compliance with safety standards. (See Photo 10)

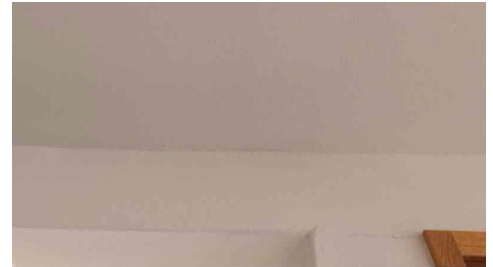
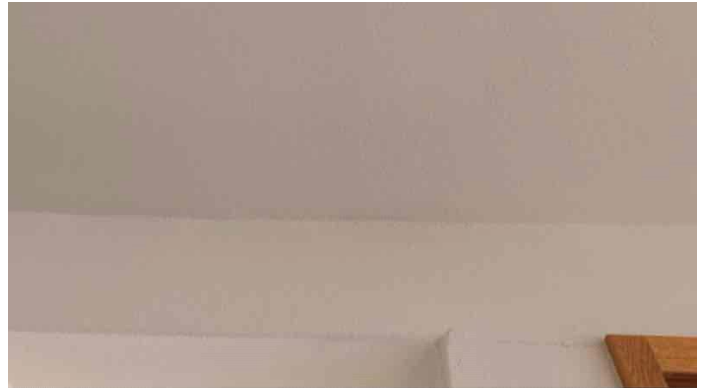
Photo 12

17. The ceiling at the master bedroom shows evidence of water stains. It is recommended that the source of these stains be identified and corrected and the surface be refinished. (See Photo 12)

- ! 1. The ceiling at the master bedroom shows evidence of water stains. It is recommended that the source of these stains be identified and corrected and the surface be refinished. (See Photo 12)

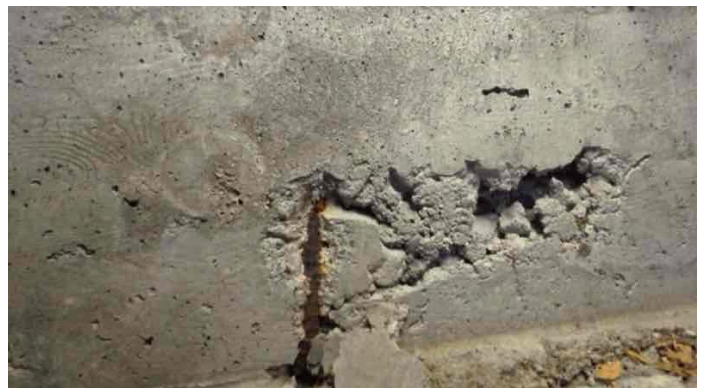
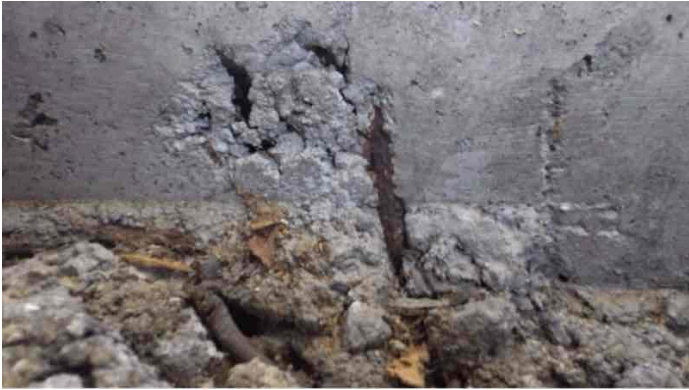
2. There is exposed reinforcing steel or anchor bolt at the left side of the foundation as noted from the crawl space. We recommend all exposed steel be covered with material such as epoxy to prevent rust and subsequent foundation damage. (See Photo 14) (See Photo 15)
