Roof Inspection Report

26854 Grandview Avenue, Hayward

Rafael Castaneda
March 5, 2026
Reg No. HIS-103464-SP

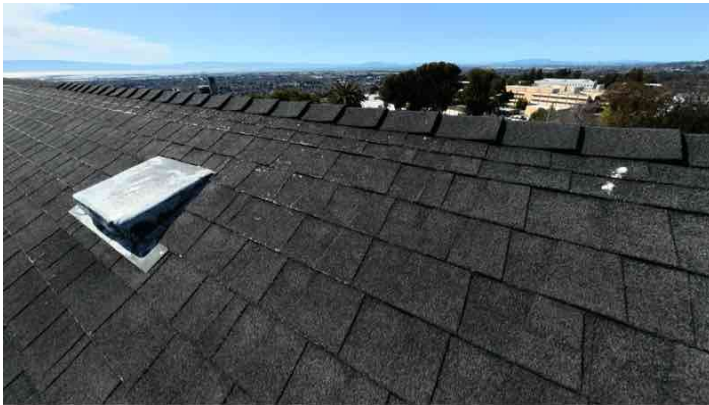
Photo 01

1. The shingles protective granules are breaking loose exposing the shingle panels to 'burnout' and subsequent leakage. (See Photo 1) (See Photo 2) (See Photo 4)
2. There are damaged shingles in the field. (See Photo 3)
3. The plumbing vent flashing(s) are not adequately sealed at the collars. (See Photo 5)
4. We noted missing and/or broken vent covers. (See Photo 6)
5. The chimney flashing is not properly secured and is pulling up and away from the roof's surface. (See Photo 7)
6. There are damaged ridge caps. (See Photo 10)
7. Prior repairs at the chimney area are evident; this would suggest that problems have been experienced in the past. Repaired areas should be monitored. HomeGuard does not warranty repairs performed by others. (See Photo 8) (See Photo 9)
8. The roof appears to be vulnerable to leakage and is beyond practical repair.

The roof appears to be vulnerable to leakage and is beyond practical repair. If a bid for a new roof is desired please contact HomeGuard Incorporated for re-roofing options.
