WOOD DESTROYING PESTS AND ORGANISM INSPECTION REPORT

Building No. 26854	Street Grandview Avenue	City Hayward	ZIP 94542	Date of Inspection 3/5/2026	Number of Pages Page 1 of 13
<div style="display: flex; align-items: center; justify-content: center;">

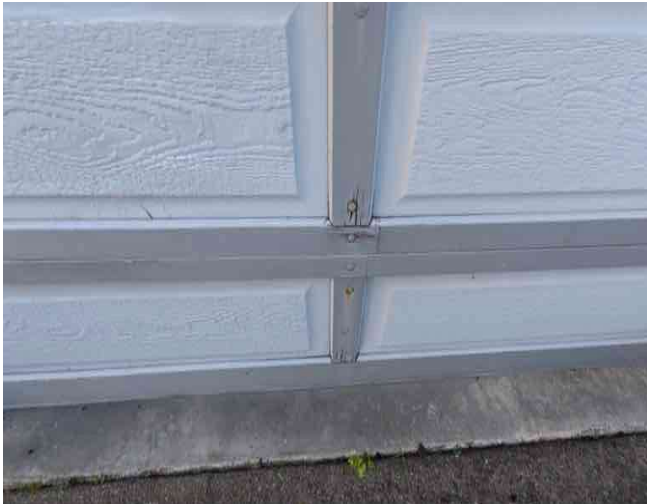
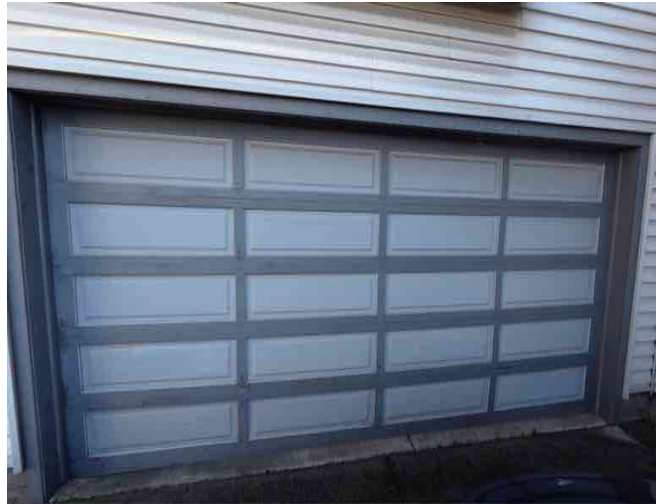
1A. FINDING: The main garage door was found to be damaged by fungus. It appears the damage is a result of exposure to the weather. (See Photo 1) (See Photo 2)

RECOMMENDATION: Remove and replace this door with a white non-insulated roll up garage door.

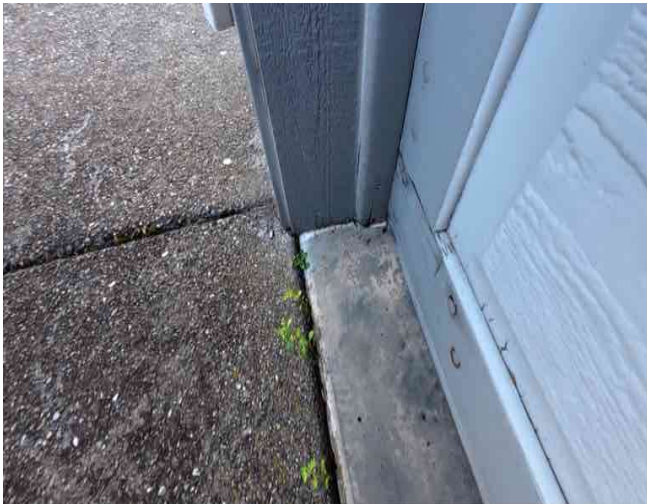
Photo 03

1B. FINDING: The main garage door jamb at the left side was found to be fungus damaged. (See Photo 3)

RECOMMENDATION: Remove and replace the door jamb to correct this condition. The contributing *Estimated Cost* moisture source appears to be exposure to the weather.

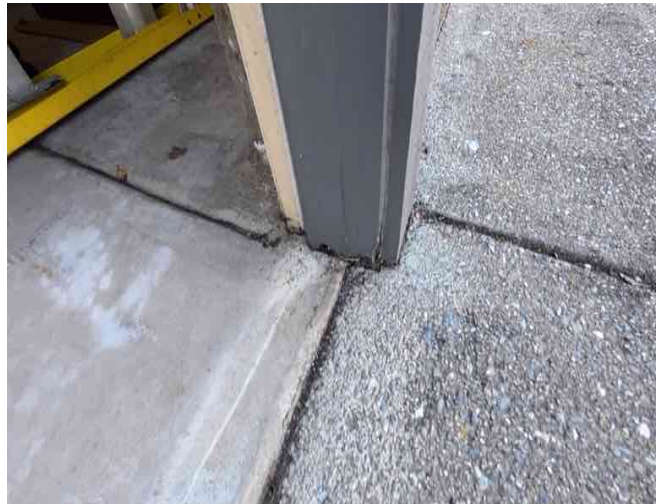
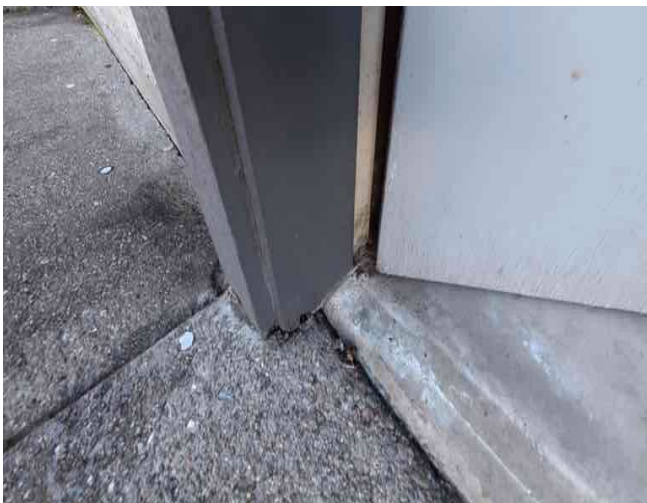
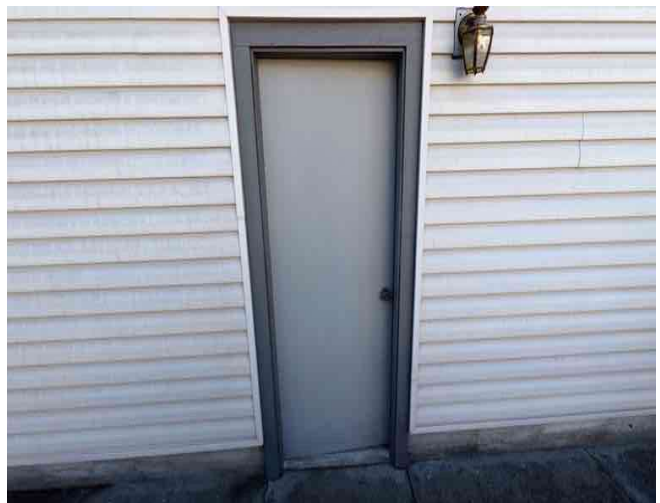
1C. FINDING: The garage man door jambs were found to be damaged by fungus. It appears the damage is a result of exposure to the weather. (See Photo 4) (See Photo 5) (See Photo 6)

RECOMMENDATION: Supply and install a new pre-hung door and jambs to correct this condition. Note:

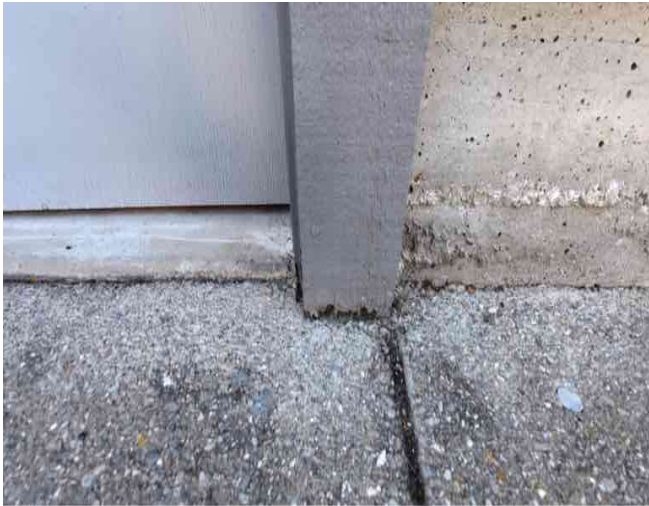
Photo 07

1D. FINDING: The trim has been damaged by fungus where indicated on the diagram. The contributing moisture source appears to be exposure to the weather. (See Photo 7)

RECOMMENDATION: Remove and replace all the damaged wood members. If any damage is found to *Estimated Cost* extend into any enclosed areas a supplemental report and bid will be issued.

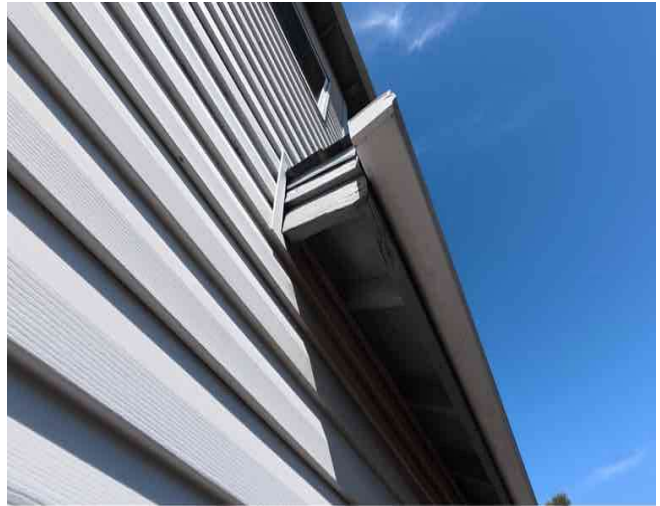
Photo 08

1E. FINDING: The fascia has been damaged by fungus and drywood termites where indicated on the diagram. The contributing moisture source appears to have been caused by a failure of the roof covering and/or exposure to weather. (See Photo 8) (See Photo 9)

1F. FINDING: The barge rafter(s) as indicated on the diagram are damaged by fungus. The contributing moisture source appears to be exposure to the weather. (See Photo 8) (See Photo 9)

RECOMMENDATION: Remove and replace the damaged fascia to correct this condition. This bid *Estimated Cost* includes repair of the roof covering if disturbed by our repairs. If existing gutters need to be removed to perform the repairs then our bid also includes reinstallation of original gutters. If it becomes necessary or desirable to install new gutters this will be done only if authorized and at an additional cost. The guarantees on the roof covering are limited to the areas where the repairs were performed.

RECOMMENDATION: Remove and replace a section of the damaged barge rafter(s) to correct this *Estimated Cost* condition. This bid includes repair of the roof covering if disturbed by our repairs. If existing gutters need to be removed to perform the repairs then our bid also includes reinstallation of original gutters. If it becomes necessary or desirable to install new gutters this will be done only if authorized and at an additional cost. The guarantees on the roof covering are limited to the areas where the work was performed.

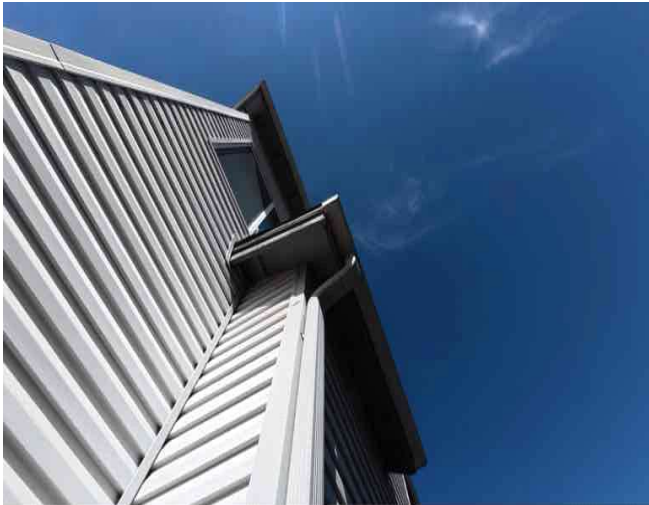
Photo 09

1G. FINDING: Drywood termite pellets were evident at the roof eaves, as indicated on the diagram. This property has been treated in the past. (See Photo 9)

RECOMMENDATION: Remove or mask over all accessible termite pellets and return in 30 to 45 days to *Estimated Cost* further inspect this area for evidence of activity. Upon completion of the further inspection, we will issue a supplemental report listing all findings, recommendations, and bids.

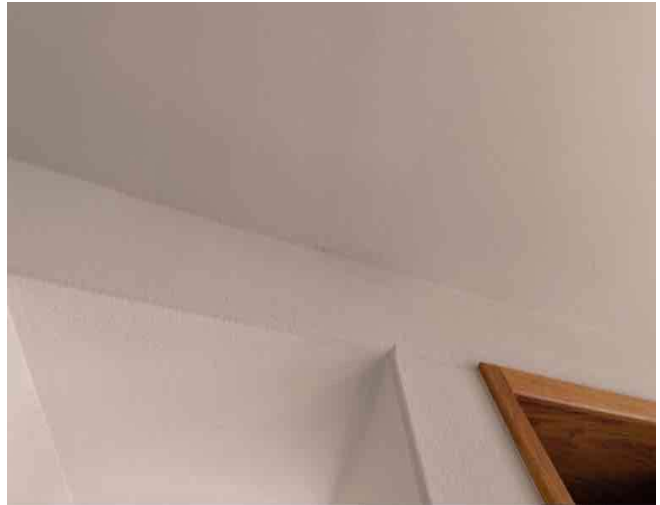
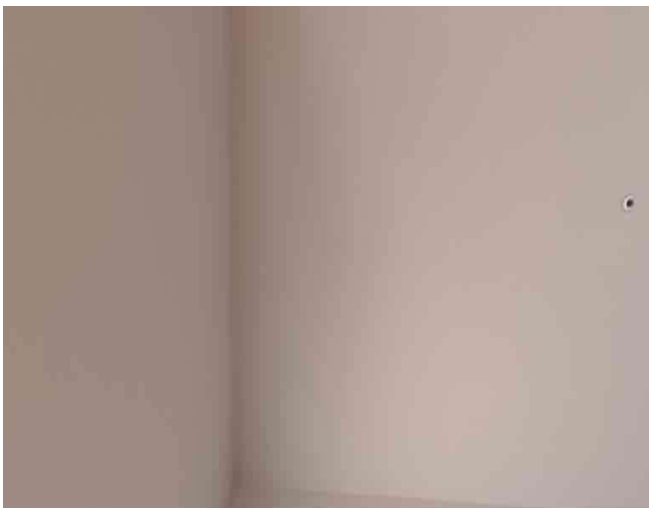
3A. FINDING: Water stains were noted on the ceiling in the master bedroom. (See Photo 10)
(See Photo 11)

RECOMMENDATION: Open this area to determine the source of these stains and if any damage exists.

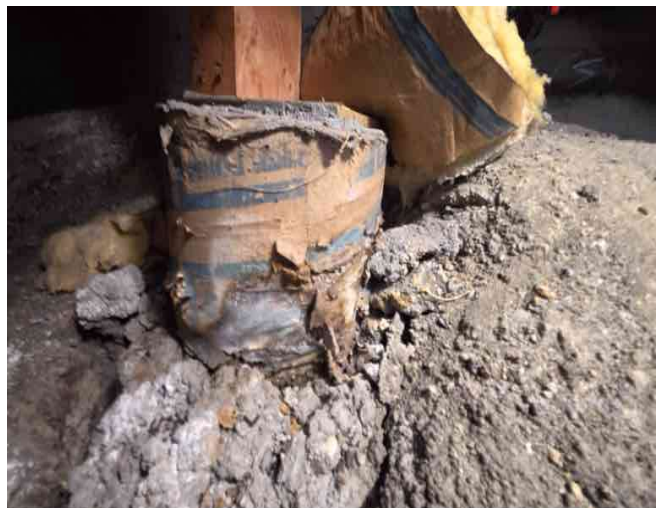
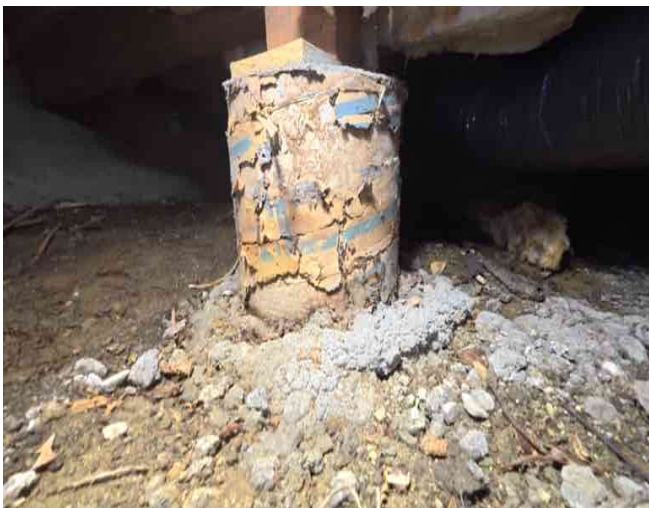
1H. FINDING: There is cellulose debris in earth contact in the substructure area and evidence of subterranean termites was noted in the cellulose debris. (See Photo 12) (See Photo 17)

RECOMMENDATION: Remove the cellulose debris of a size that can be raked from the substructure *Estimated Cost* area.

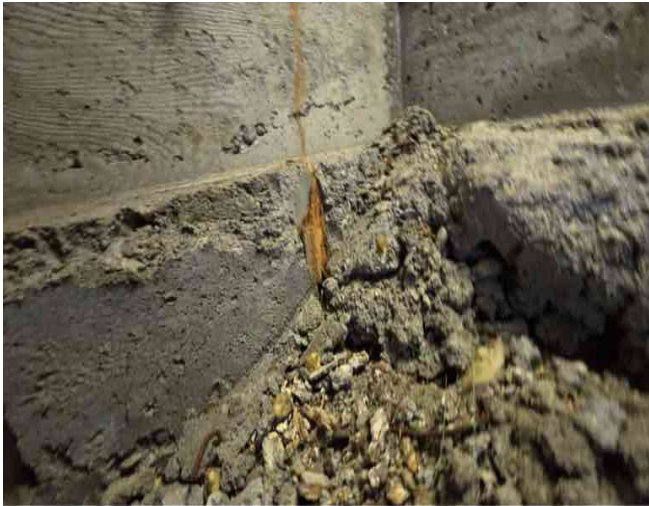
Photo 13

1I. FINDING: There are subterranean termite infested form boards in earth contact in the substructure area. (See Photo 13)

RECOMMENDATION: Remove as much of the form boards as practical and chemically treat the *Estimated Cost* remainder with Termidor HE (Fipronil:5-amino-1-(2,6-dichloro-4-(trifluoromethyl)phenyl)-4-((1,8,5)-trifluoromethyl)sulfinyl)-1-H-pyrazole-3-carbonitrile. NOTE: In order to perform this treatment the property must be vacated during the treatment and three hours after the treatment is performed.

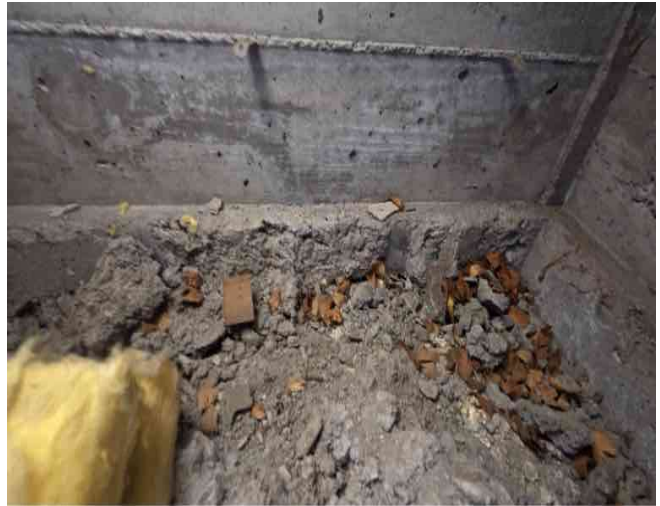
Photo 14

2F. FINDING: There is cellulose debris in earth contact in the substructure area. (See Photo 14)

RECOMMENDATION: Remove cellulose debris of a size that can be raked from the substructure area.

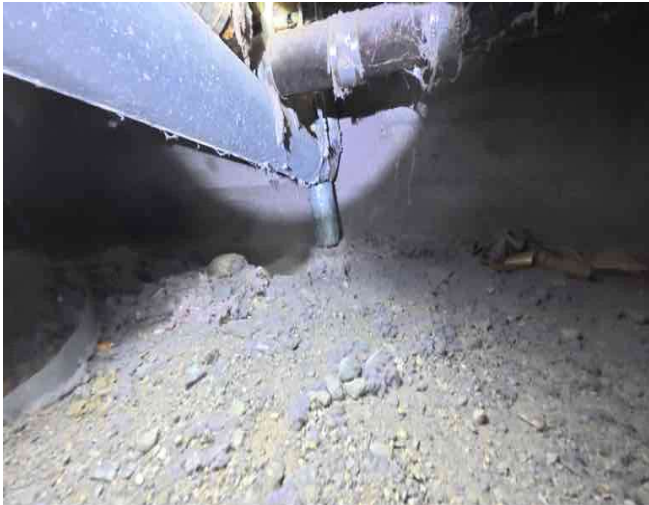
Photo 15

2G. FINDING: The clothes dryer is vented into the substructure area. This is an excessive moisture condition. (See Photo 15)

RECOMMENDATION: The owner will need to contact the appropriate trades to make repairs to this item.

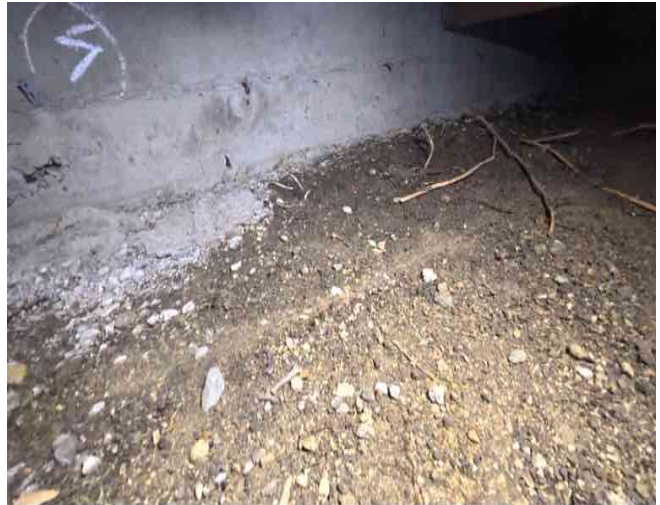
Photo 16

2H. FINDING: The substructure area soil was crawlspace where indicated on the diagram. (See Photo 16)

RECOMMENDATION: The owner should engage the services of the appropriate tradesperson to check this condition and make any repairs deemed necessary.

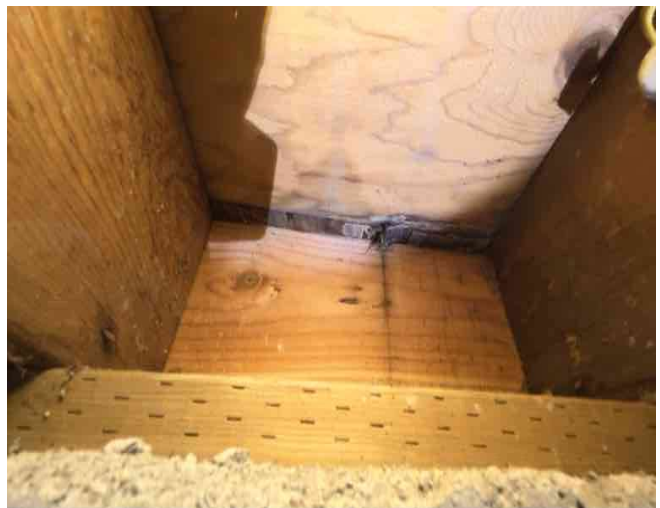
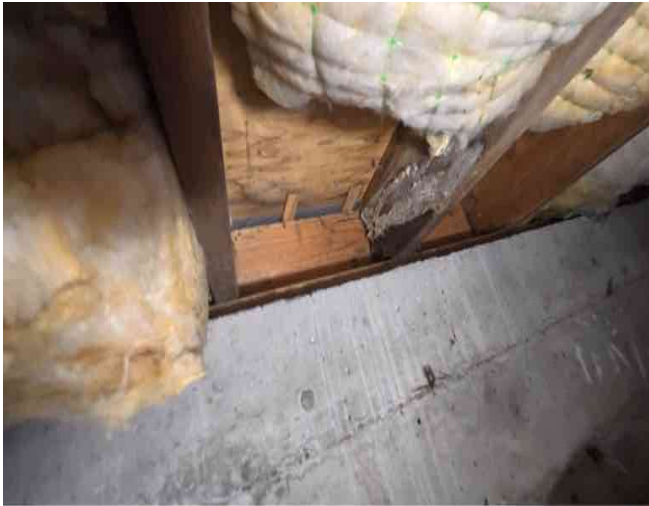
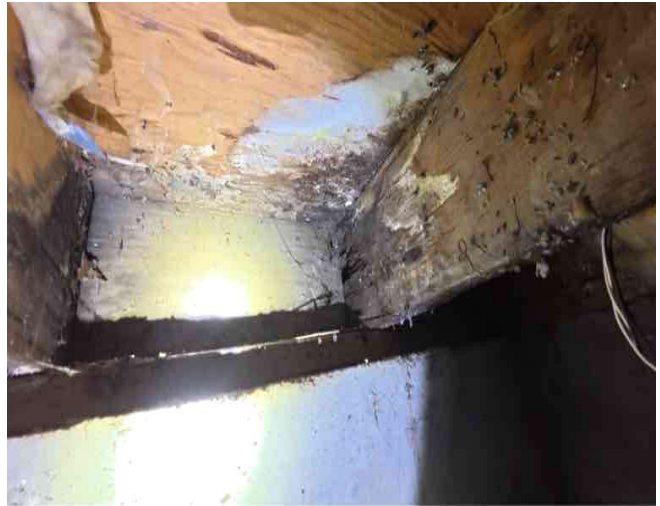
1J. FINDING: The subfloor was insulated. This conceals the wood members of the substructure. Further inspection is recommended. Active infection or infestation was noted in the area. (See Photo 18) (See Photo 19) (See Photo 20)

RECOMMENDATION: Remove the insulation from the perimeter of the structure and at all water pipe penetrations or from areas where fungus was noted. Inspect the exposed wood members, and issue a supplemental report listing all findings, recommendations, and bids. Reinstall the insulation where removed upon completion.

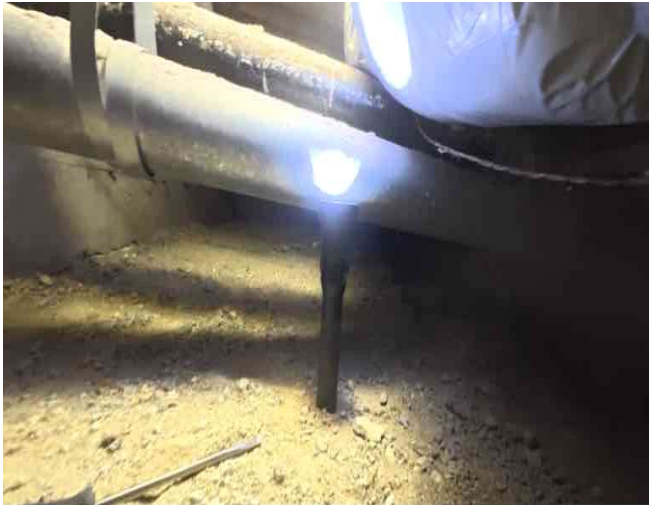
Photo 21

3B. FINDING: A portion of the subarea was noted to be inaccessible due to insufficient clearance between the soil and the ducting. (See Photo 21)

RECOMMENDATION: Excavate trenches under the ducting to allow further inspection of these areas. All

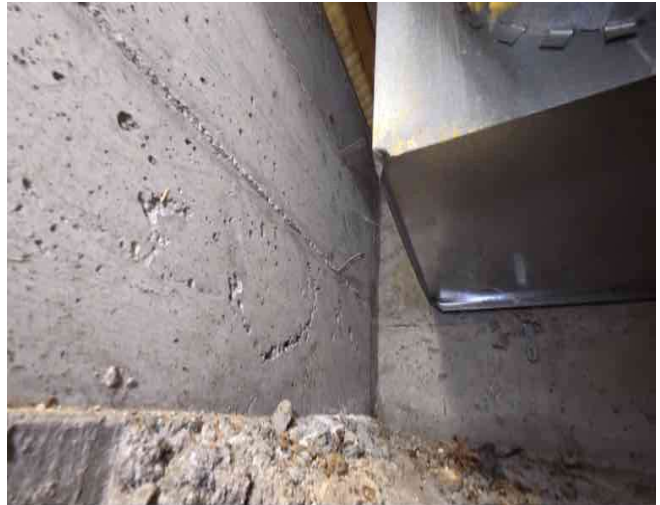
Photo 22

1K. FINDING: There is evidence of subterranean termite migratory tubes however this property was treated in the past. (See Photo 22)

RECOMMENDATION: Break down and brush away all subterranean termite migratory tubes. Return to the property in 30 to 45 days to further inspect to determine if this infestation is active. All findings recommendations for treatments and bids will be issued in a supplemental report.
