Sewer Lateral Inspection Report

26854 Grandview Avenue, Hayward

This is a sewer lateral for a single family residential dwelling. The pipe is 4 inches in size, 35 feet in length, constructed of cast iron and clay. The pipe is at a depth of 1 feet at the building, and 4 feet at the main (public) sewer line. This sewer lateral connects with the main (public) sewer with a Wye type connection. The main (public) sewer is constructed of clay. This sewer lateral serves 1 structure.

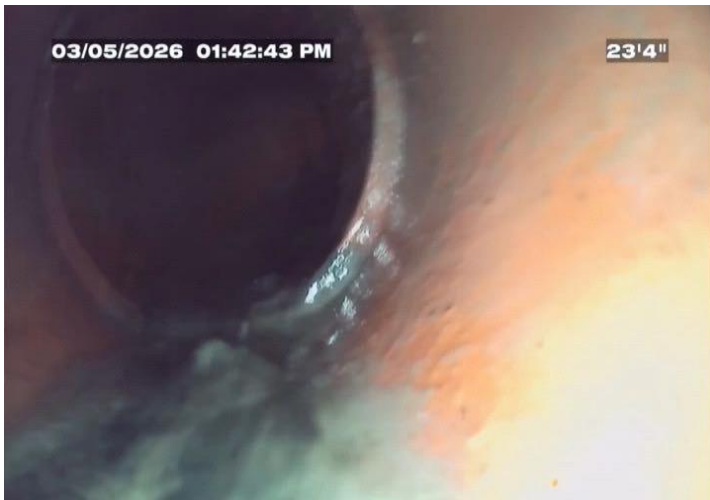
Photo 1

Distance	Code	Remarks	Photo
19 feet	CP	clay to cast iron	3
21 feet	JOS	joint offset small	2
24 feet	JOS	joint offset small	1

1. At 24 and 21 feet, the pipe joint has a small offset.
2. The pipe material changed as noted in the inspection log, cast iron and clay are currently in use.
3. The sewer lateral was found to contain material(s) that are no longer used in the construction of the pipe. Although it may not be required, we do recommend the cast iron portions be replaced with plastic piping to prevent further maintenance or repair to these areas in the future.
