INSPECTION REPORT IN ACCORDANCE WITH CALIFORNIA CIVIL CODE SECTION 5551

For Woodlake Association
900 Peninsula Avenue,
San Mateo, CA 94401

Fifteen Buildings – 974 Units

April 19, 2023

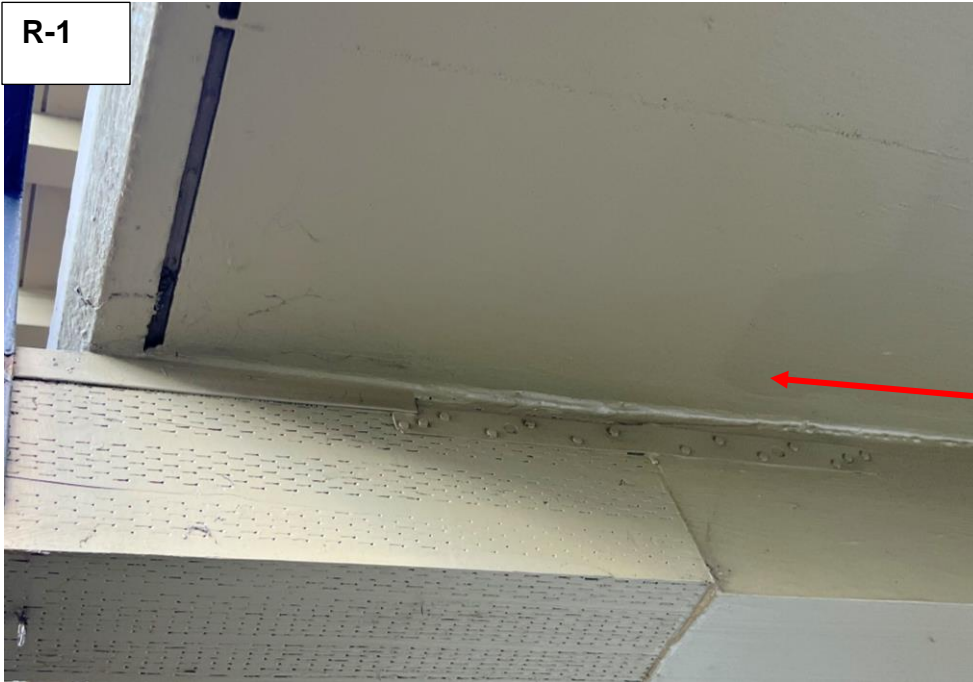
Repaired Beam:
Strap installed

- I. Install straps where they are missing from previous beam repairs.
 - See photos: R-1 & R-2
 - II. Install sheet metal beam caps at all exposed beam locations.

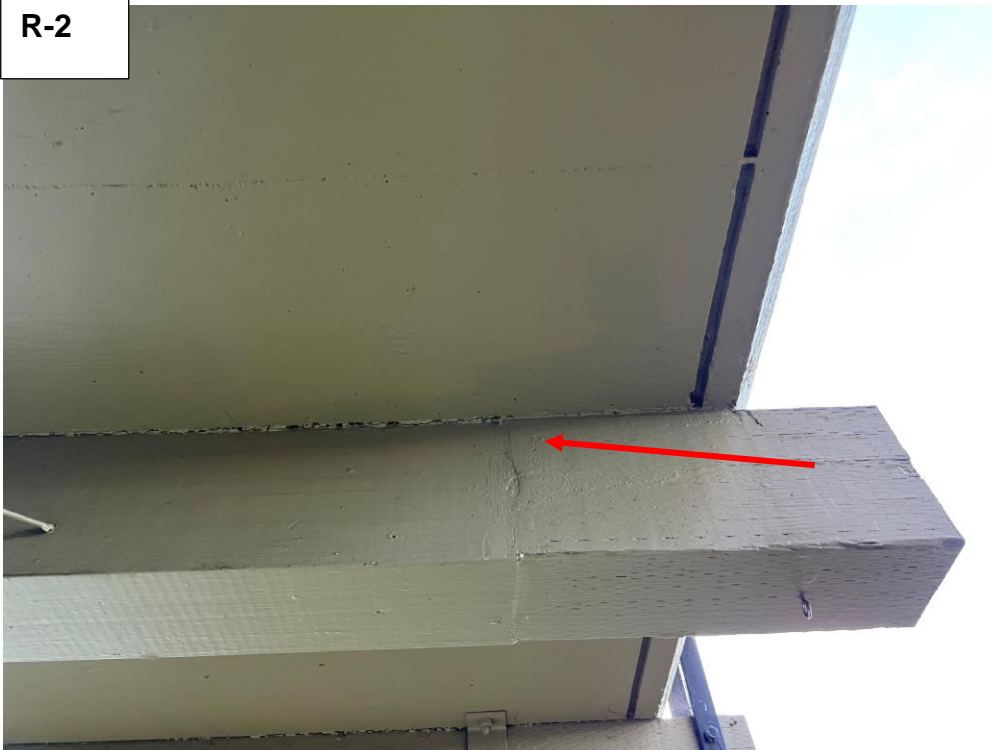
R-2

Repaired Beam:
No Strap installed

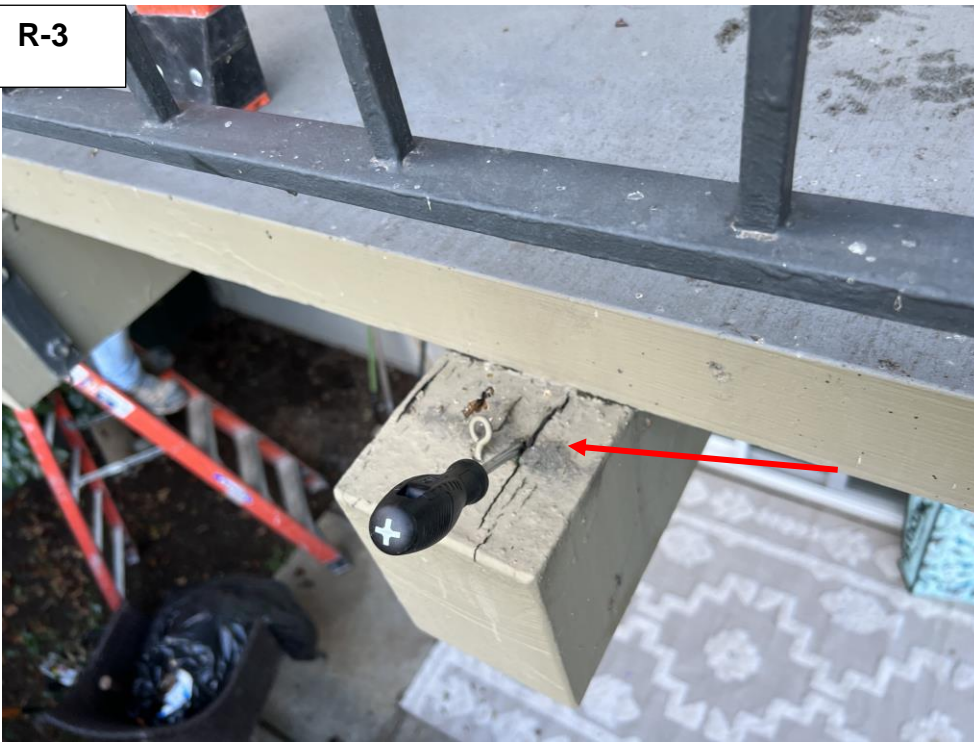
No sheet metal beam caps. Allows water to damage top of beam and damage beam

- See photos: R-3 & R-4
 - III. Repair damaged beams (require engineered plans)
 - See photos: R-5 & R-6
 - IV. Repair specific guard rail damaged wood components

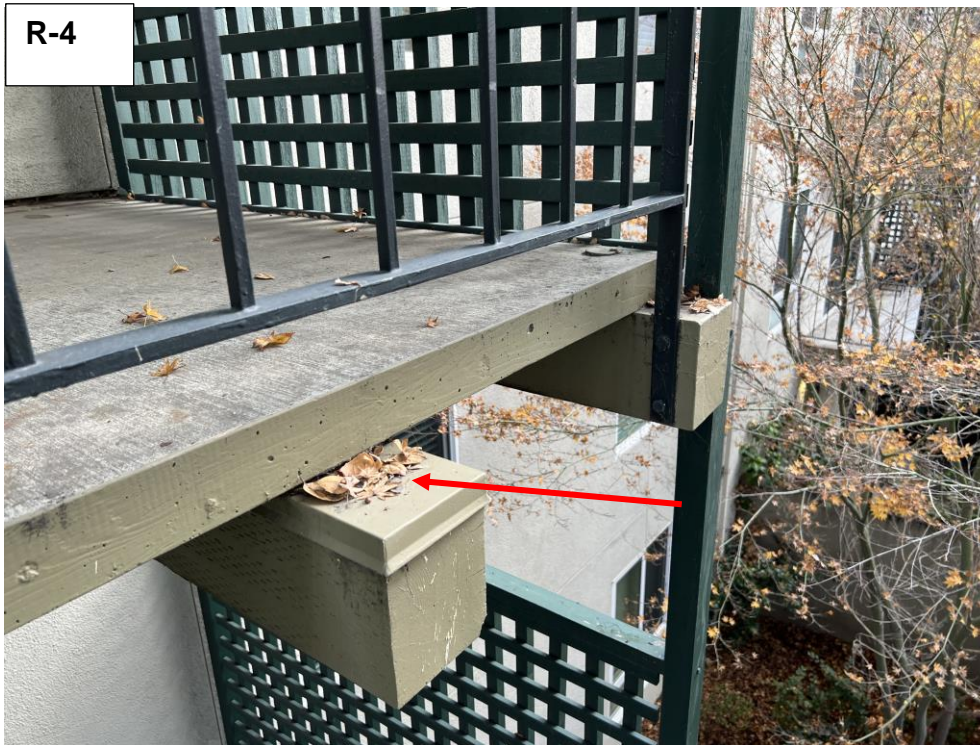
R-4

sheet metal beam cap installed.

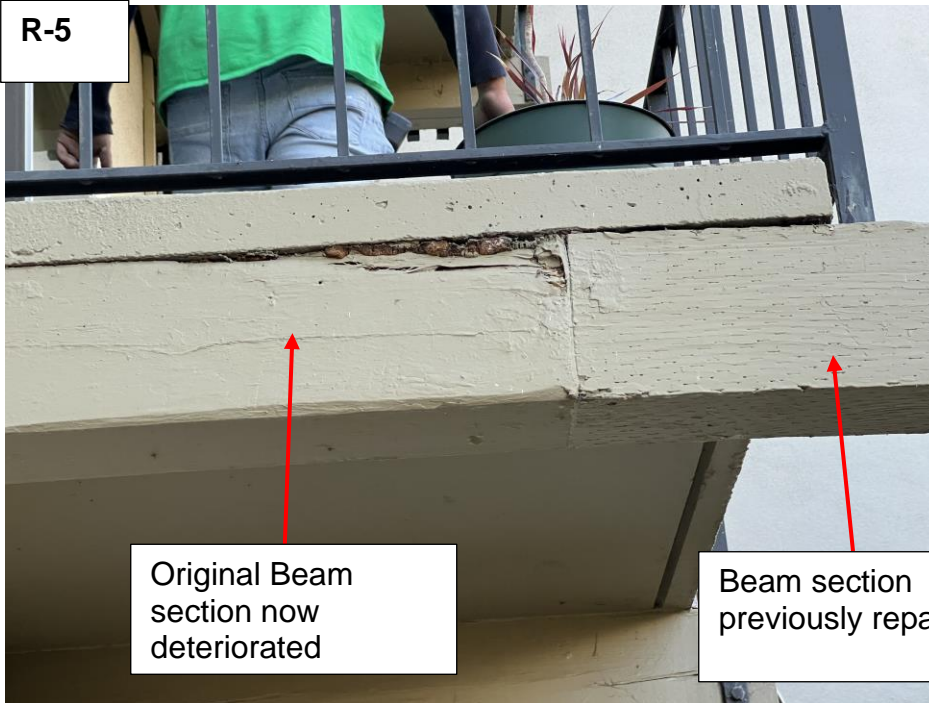
R-5

Beam damaged / rotted.

Original Beam section now deteriorated

Beam section previously repaired

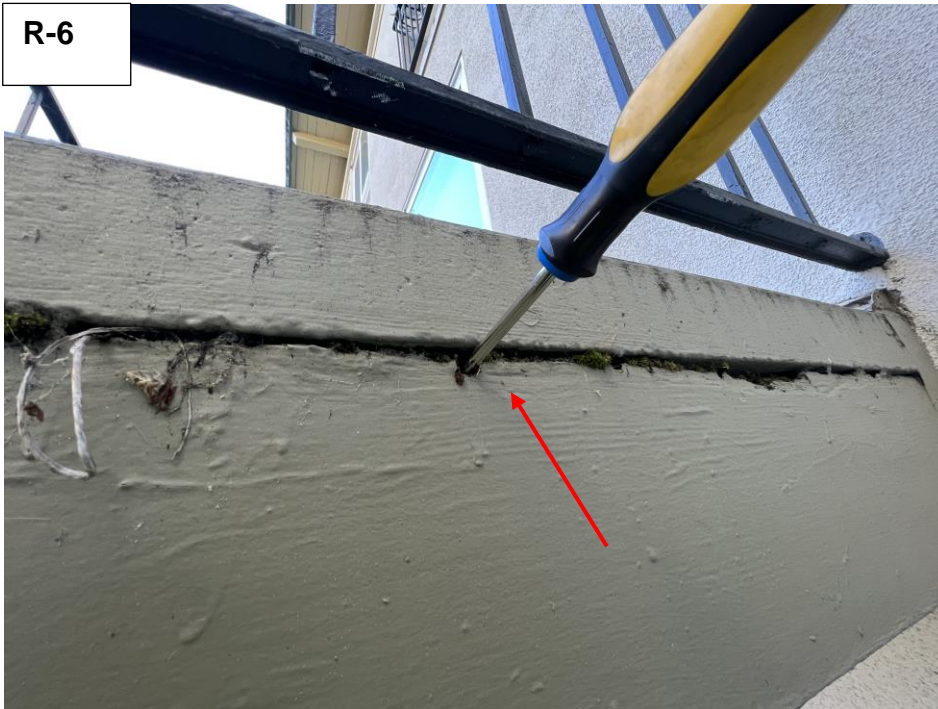
R-6

Beam damaged / rotted.

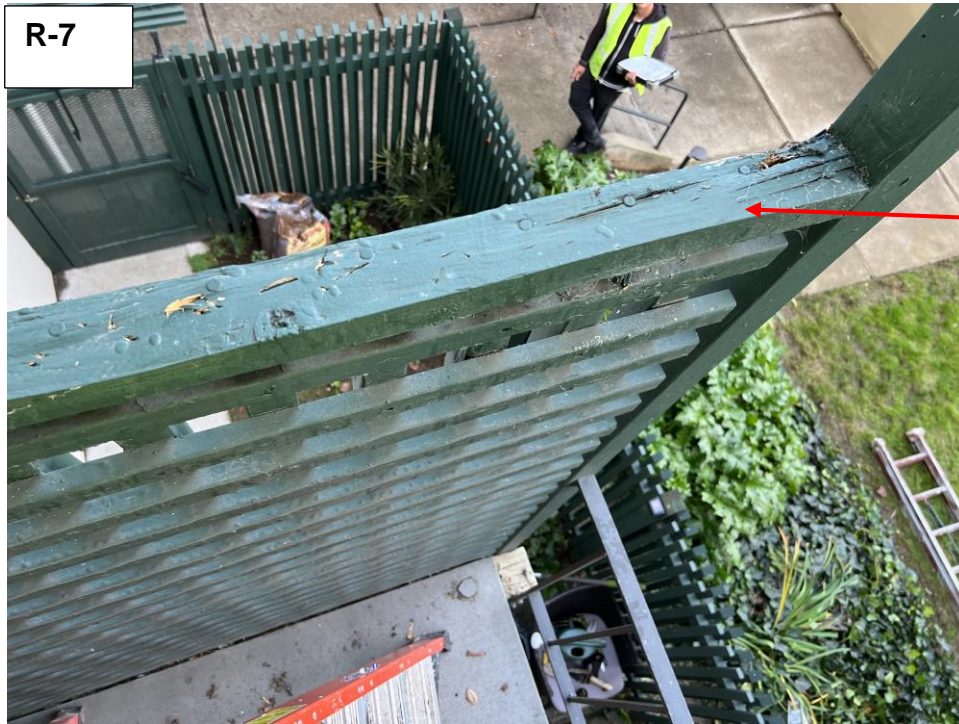
Wood lattice guardrail wall damaged / lattice support Cap rail rotted

- See photos: R-6 & R-7
 - V. Podium level concrete show signs of spalling. Repair spalling during site wide paint project and add sealer and corrosion inhibitor to rebar before repairing concrete. Waterproof membrane suggested site wide to limit rebar and podium level concrete damage.

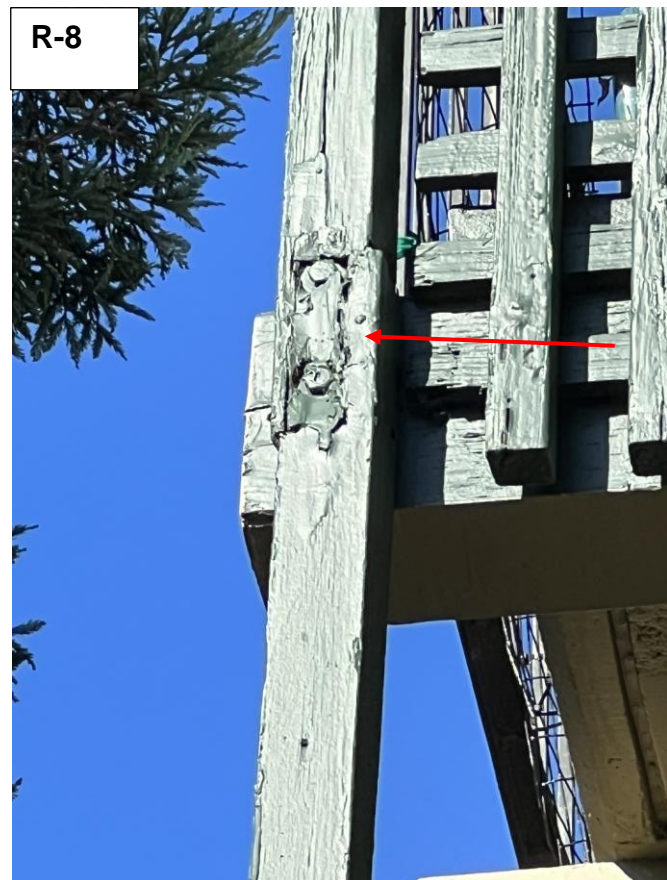
R-8

Wood lattice guardrail wall damaged

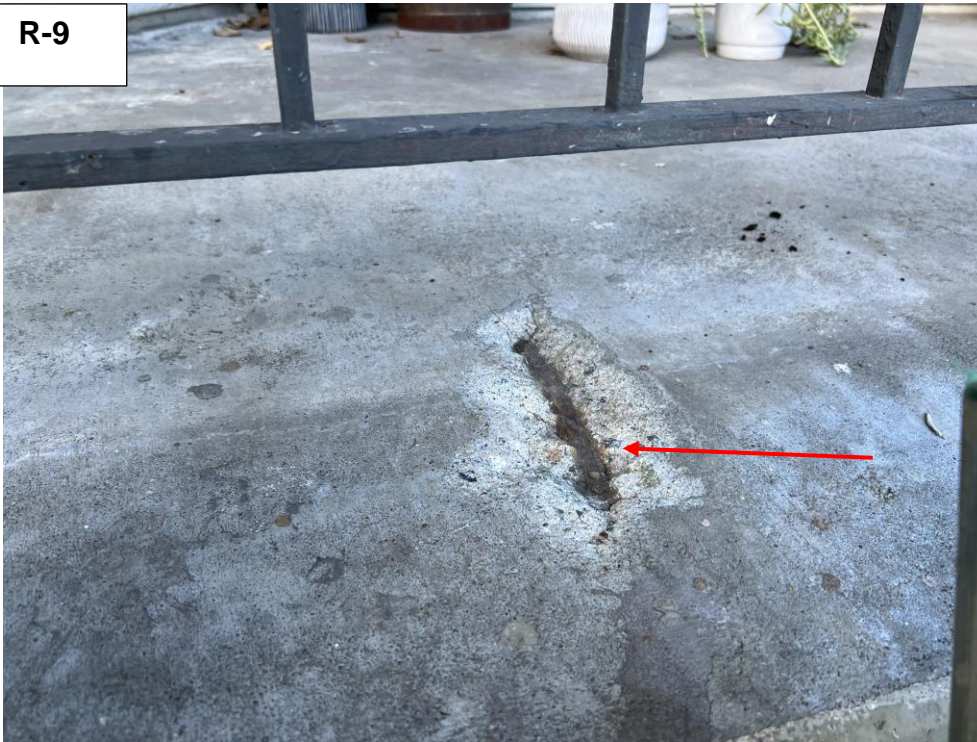
R-9

Concrete spalling at podium level – Exposed rebar

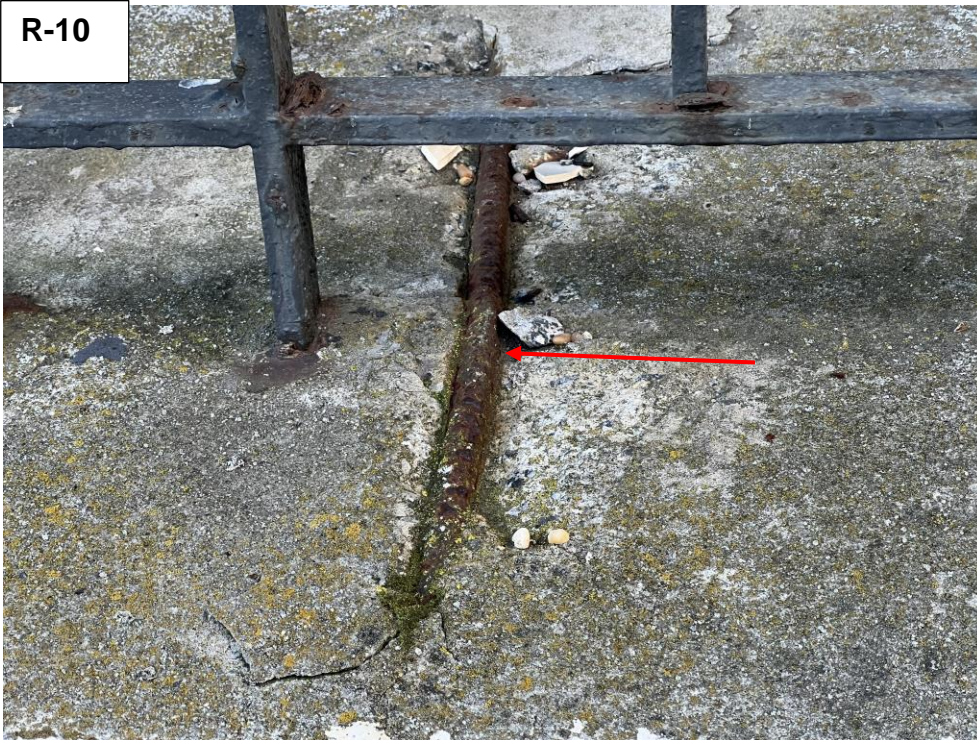
R-10

Concrete spalling at podium level – Exposed rebar

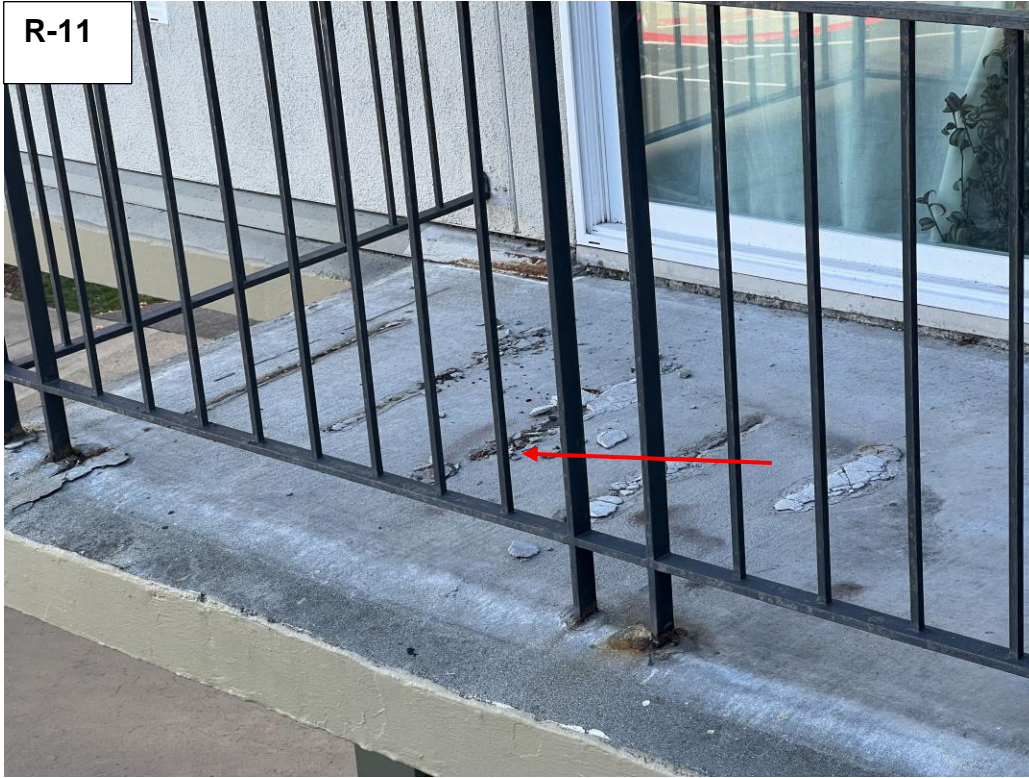
R-11

Concrete spalling at podium level – Exposed rebar

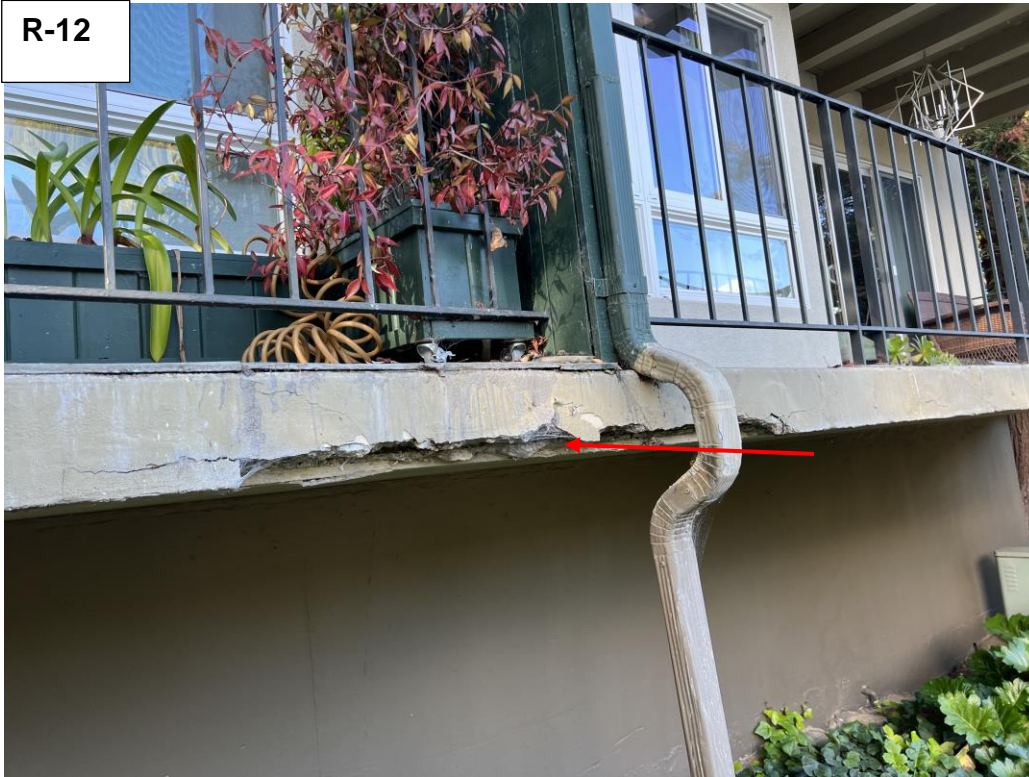
R-12

Concrete spalling at podium level – Exposed rebar

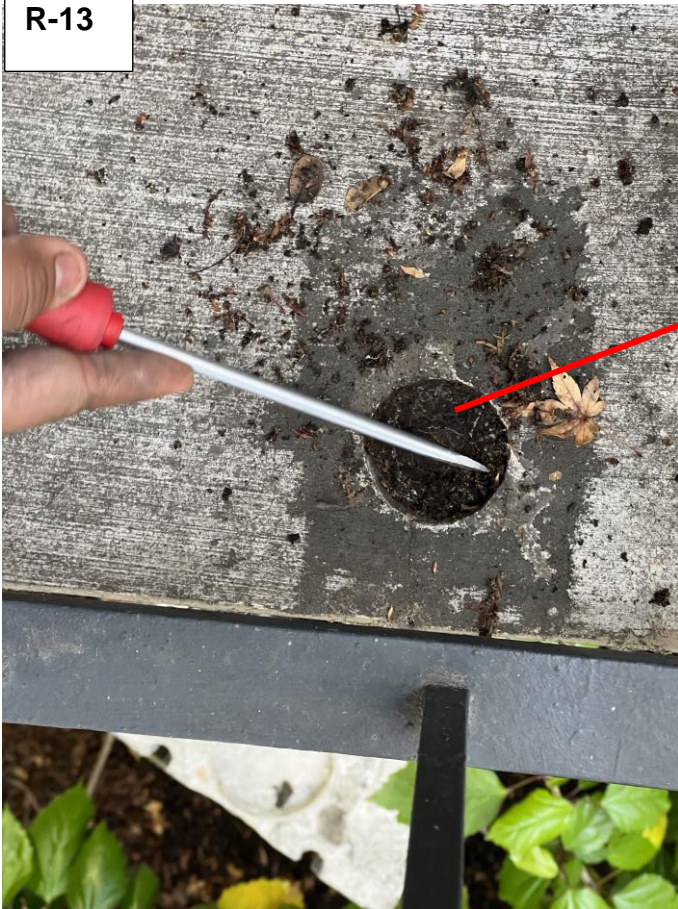
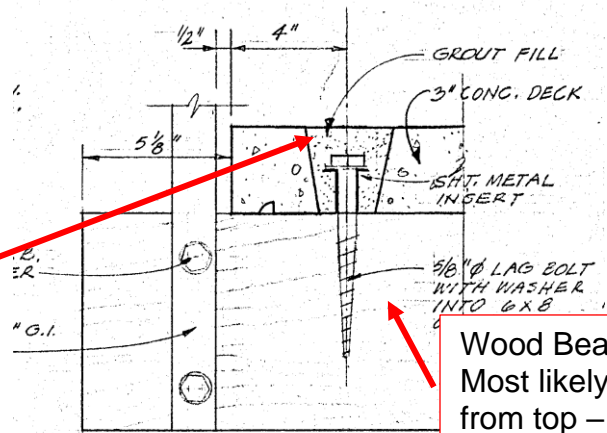
R-13

Wood Beam - Most likely rotted from top - not visible during visual inspection.

Concrete plug missing. Hole used to attach wood beam below to concrete slab.

- See photos: R-9 through R-12
 - VI. Balcony Concrete slab fastener plugs have grout that has come off. Once this round opening allows water to enter cavity, it allows top of beam to deteriorate. Top of beam can not be inspected, so beam may be damaged without sides showing damage. Where plugs are found to be loose and allow standing water, anticipate beam replacement, and repair fastener plug with non-shrink grout. Waterproof membrane suggested site wide to limit rebar and concrete damage.

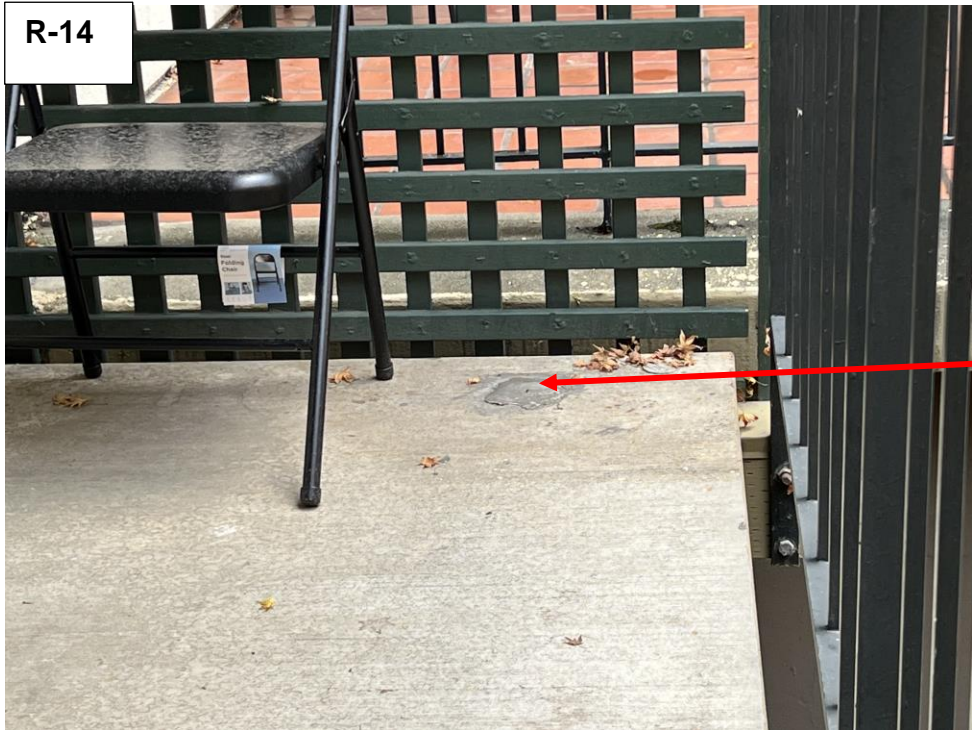
R-14

Concrete plug filled in.

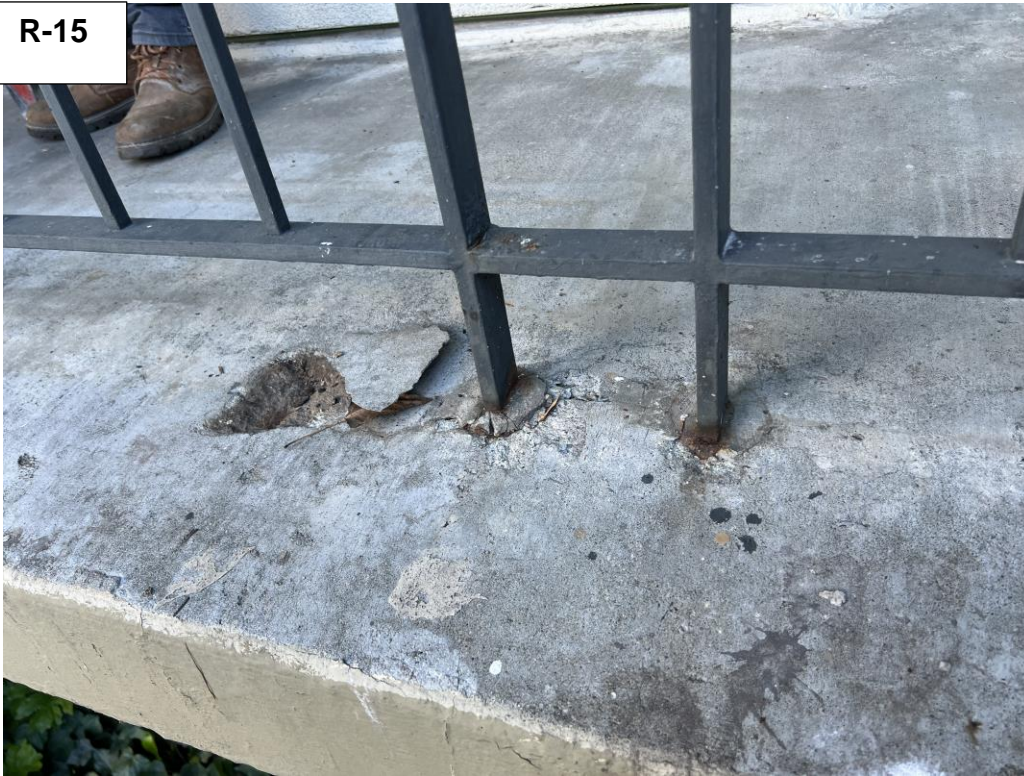
Rust at base of railing – causes concrete spalling

- See photos: R-13 & R-14
 - VII. Steel railings at podium level have rust. Remove rust and re-paint. Replace sections damaged beyond repairs.
 - See photos: R-15 & R-16

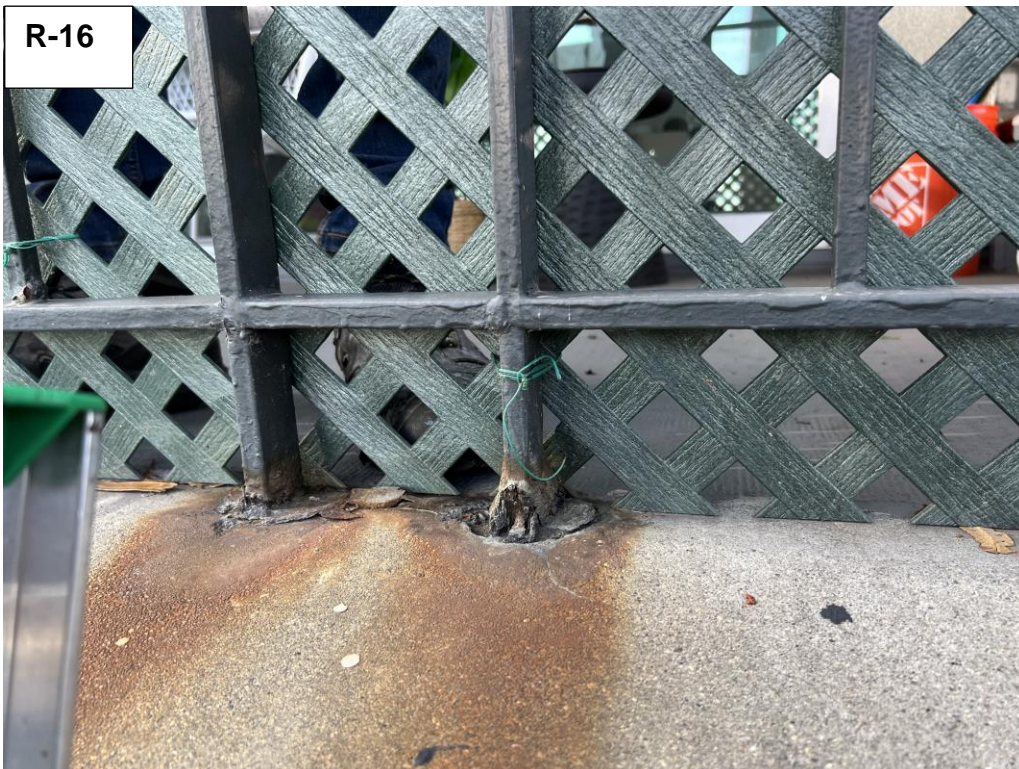
R-16

Rust at base of railing – causes concrete spalling

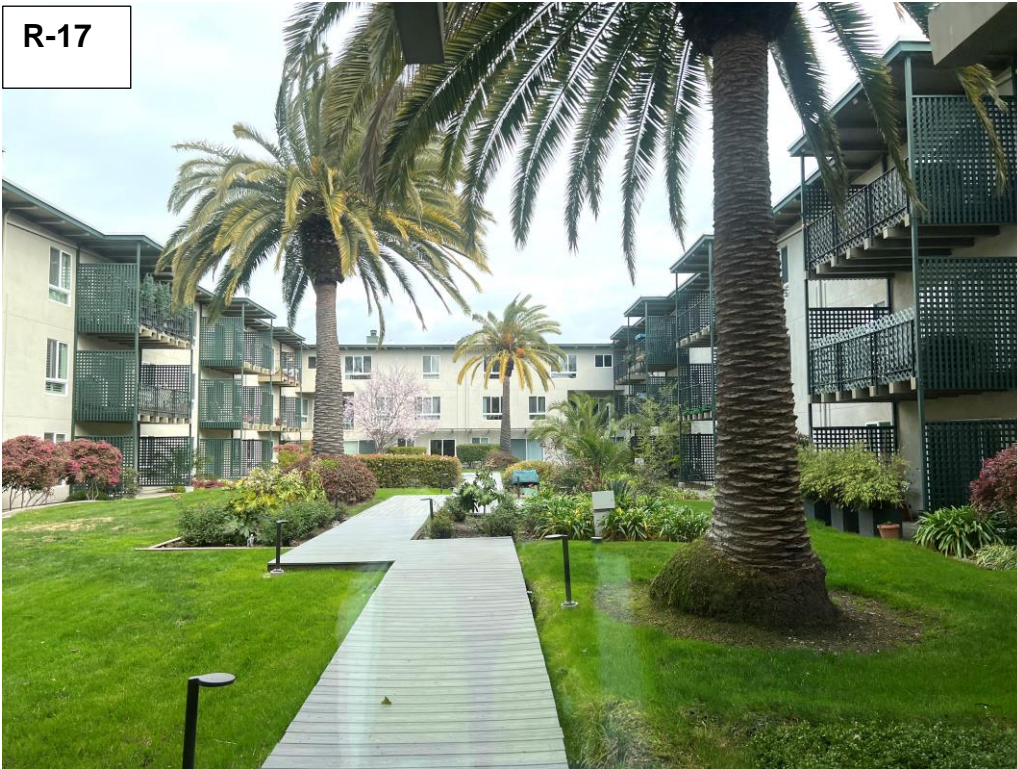
R-17

Courtyard Area.
Mature palm
trees supported
by concrete
podium slab

Signs of water infiltration through the courtyard buried waterproofing system under the courtyard planters were evident throughout the site. Association should start the process of reviewing options to permanently address this issue and limit deterioration of the structural slab.

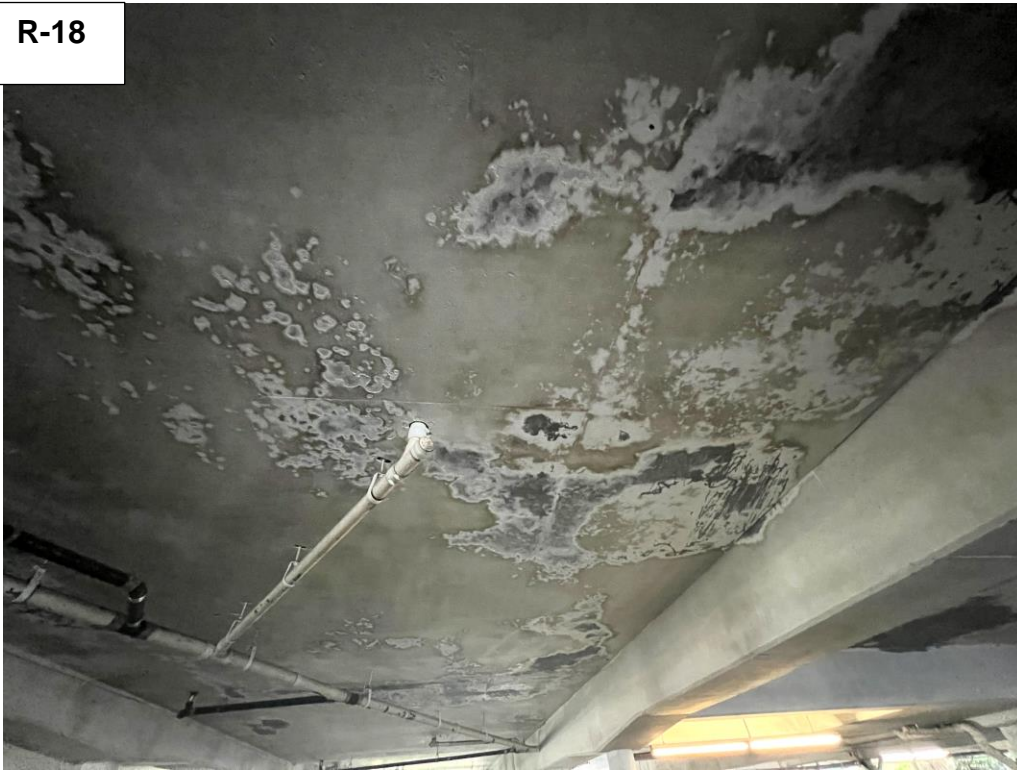
R-18

Courtyard podium
slab shows signs of
water infiltration
through podium
waterproof
membrane. Excess
moisture may result
in damage to rebar
and concrete

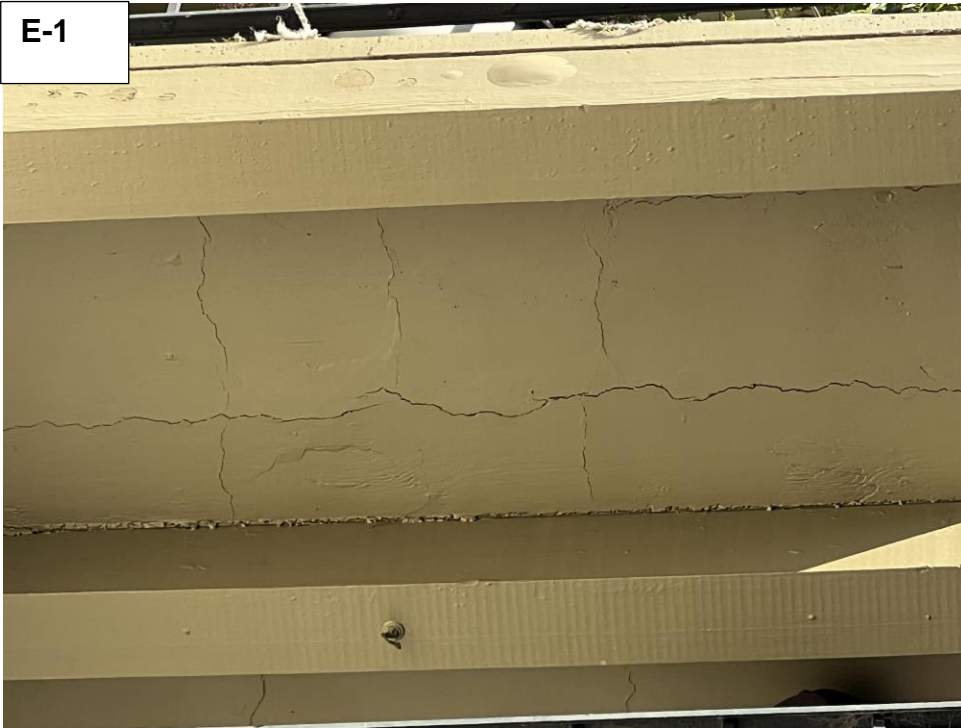
E-1

Concrete deck damaged – excessive cracking. Requires replacement. Typical

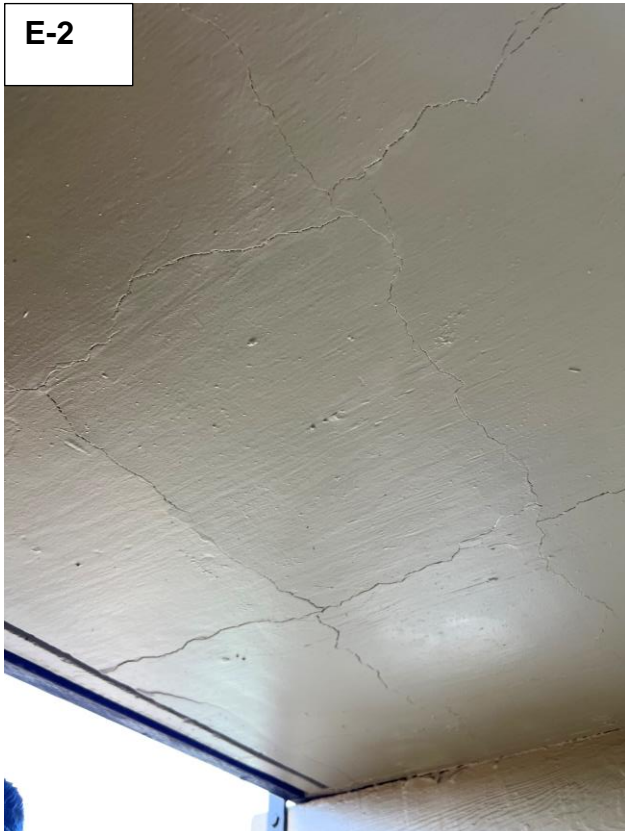
E-2

Concrete deck damaged – excessive cracking. Requires replacement. Typical

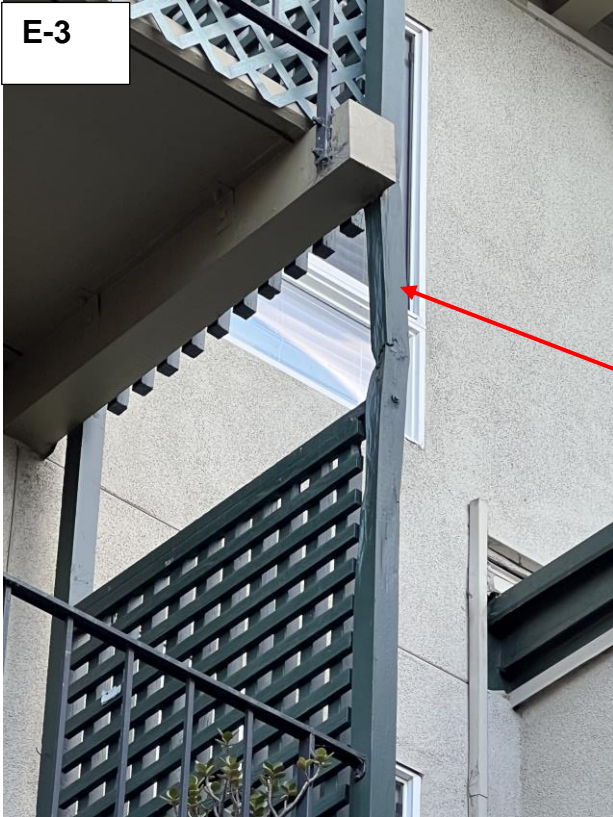
E-3

Replace Lattice Wall
– Column is structural Guardrail component.
Replacement shall meet current code requirements.

- C. Repairs should be performed within the next 6-12 months.
 - a. Lattice Wall Repairs - Residents access to balcony should be limited to one person, and residents should be informed not to lean against wood lattice guardrail wall.

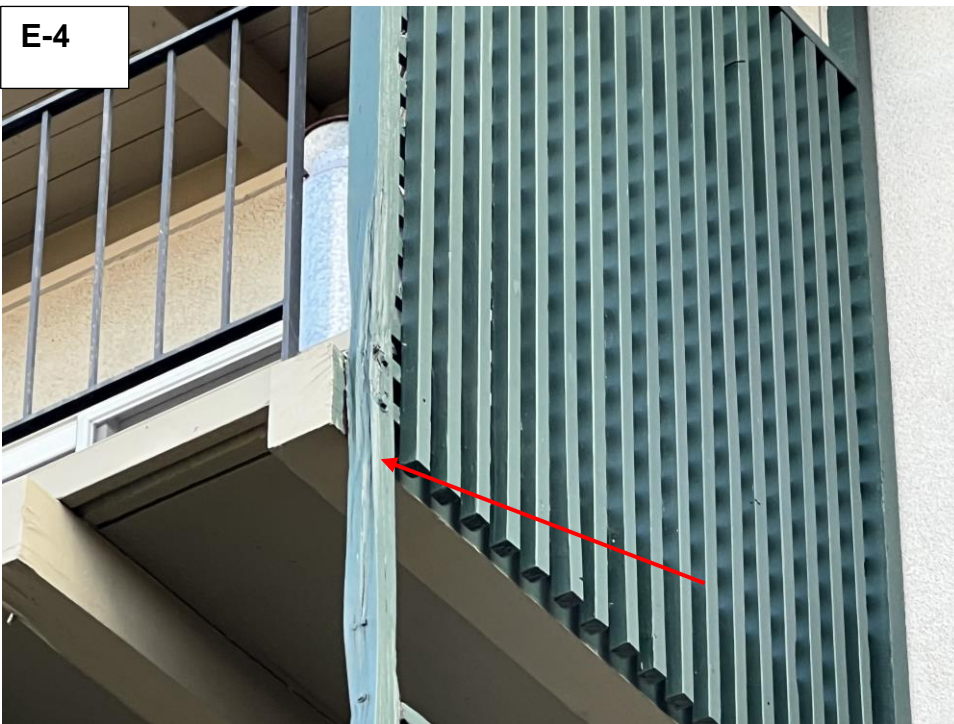
E-4

Replace Lattice Wall
– Column is structural Guardrail component.
Replacement shall meet current code requirements.

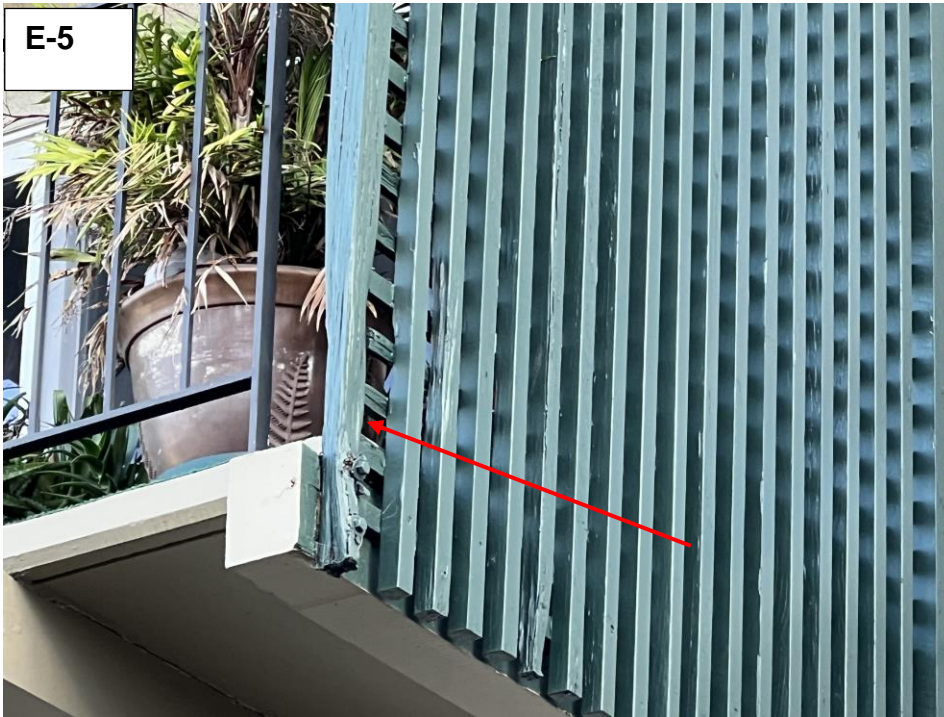
Replace Lattice Wall
– Column is structural Guardrail component. Replacement shall meet current code requirements.

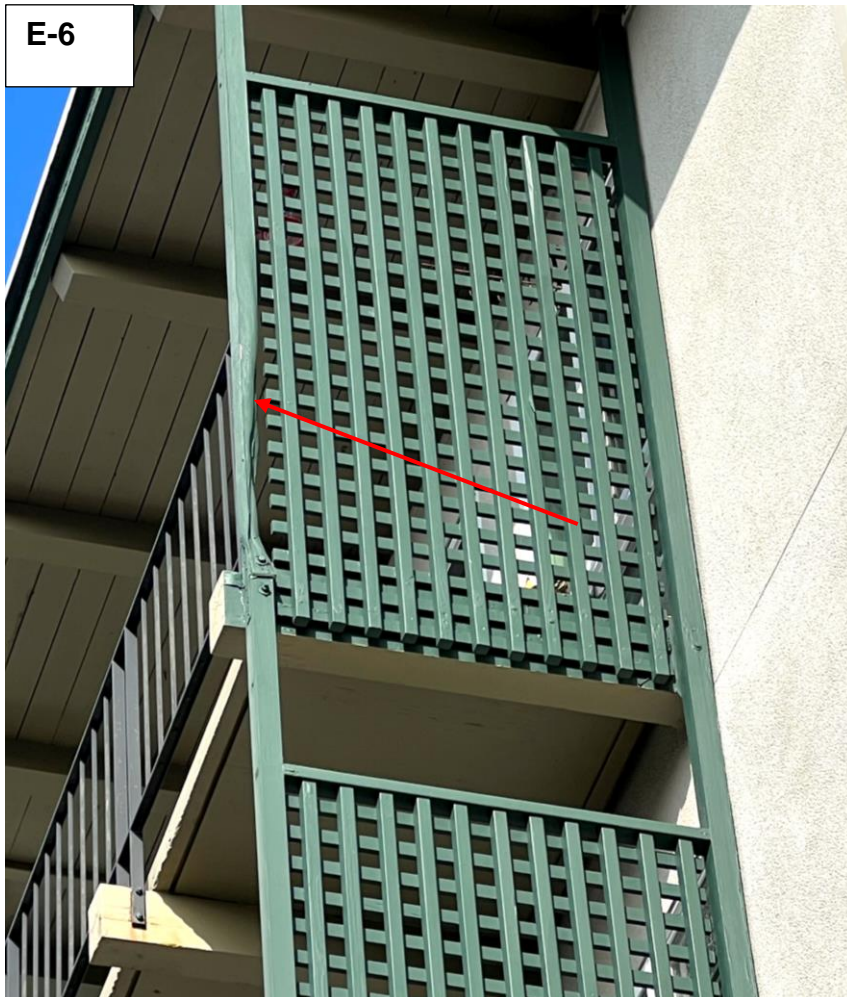
Replace Lattice Wall
– Column is structural Guardrail component. Replacement shall meet current code requirements.

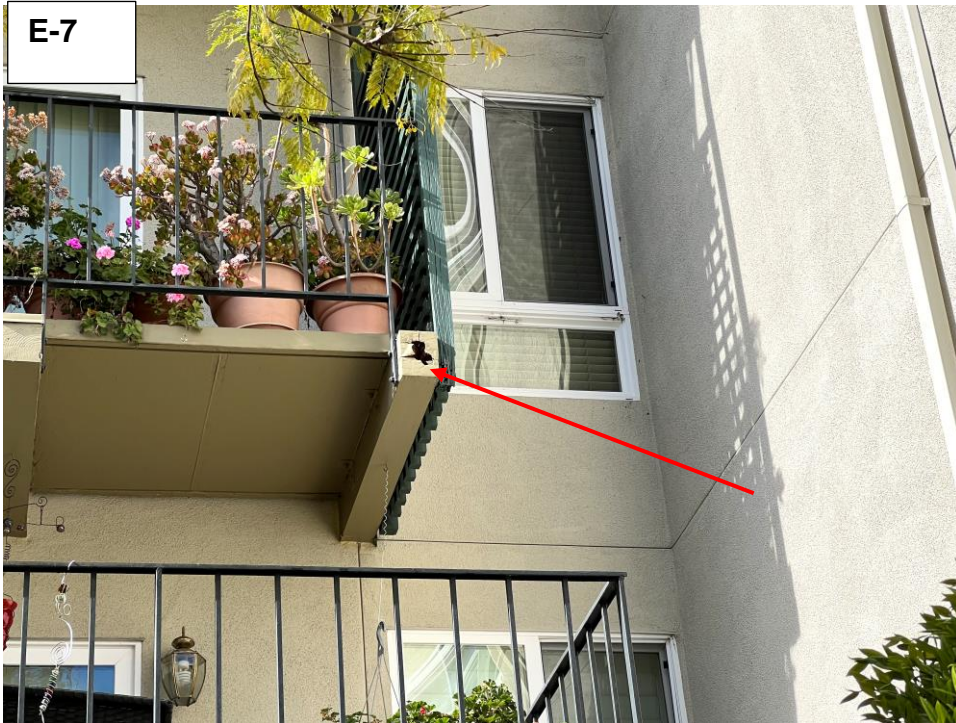
E-7

Beam at edge of balcony deteriorated. Requires replacement

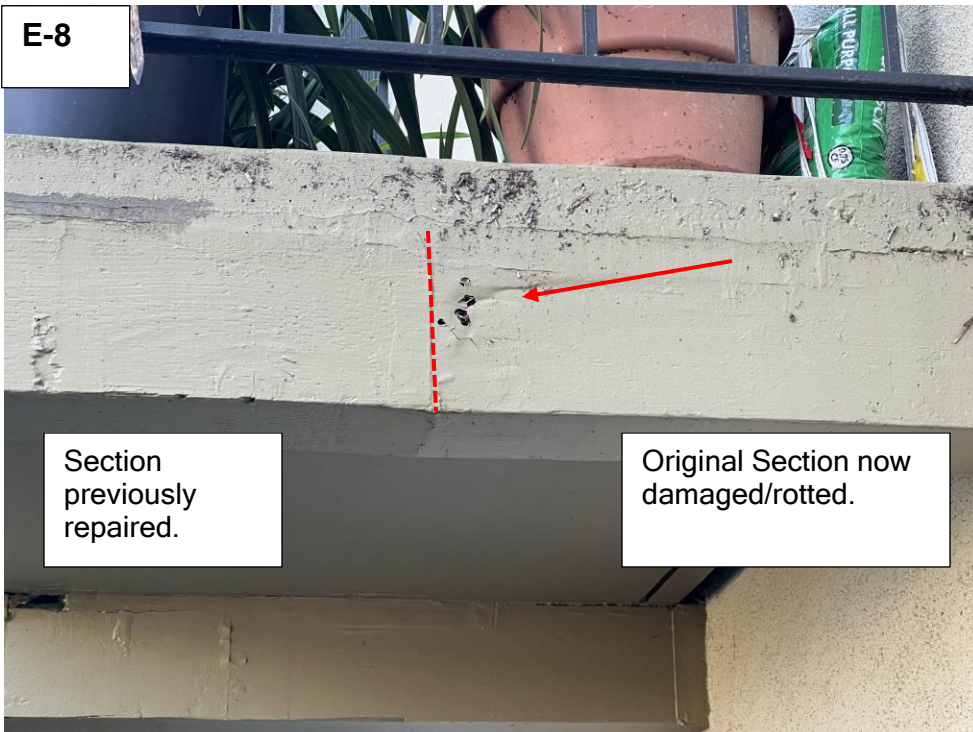
E-8

Beam at edge of balcony deteriorated. Requires replacement

Section previously repaired.

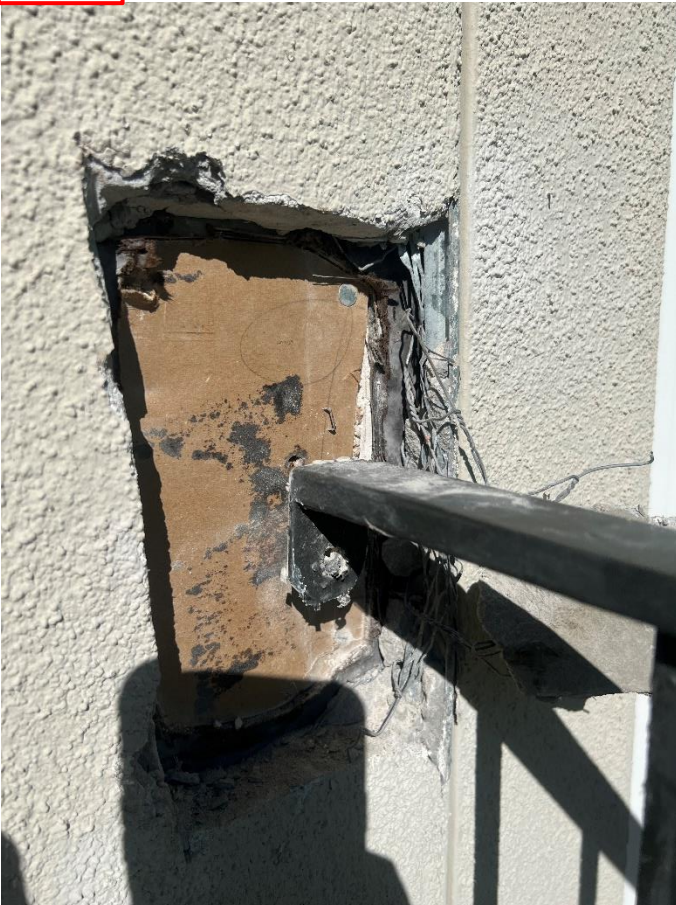
12

Location # 1 At Rail
- no water staining
observed

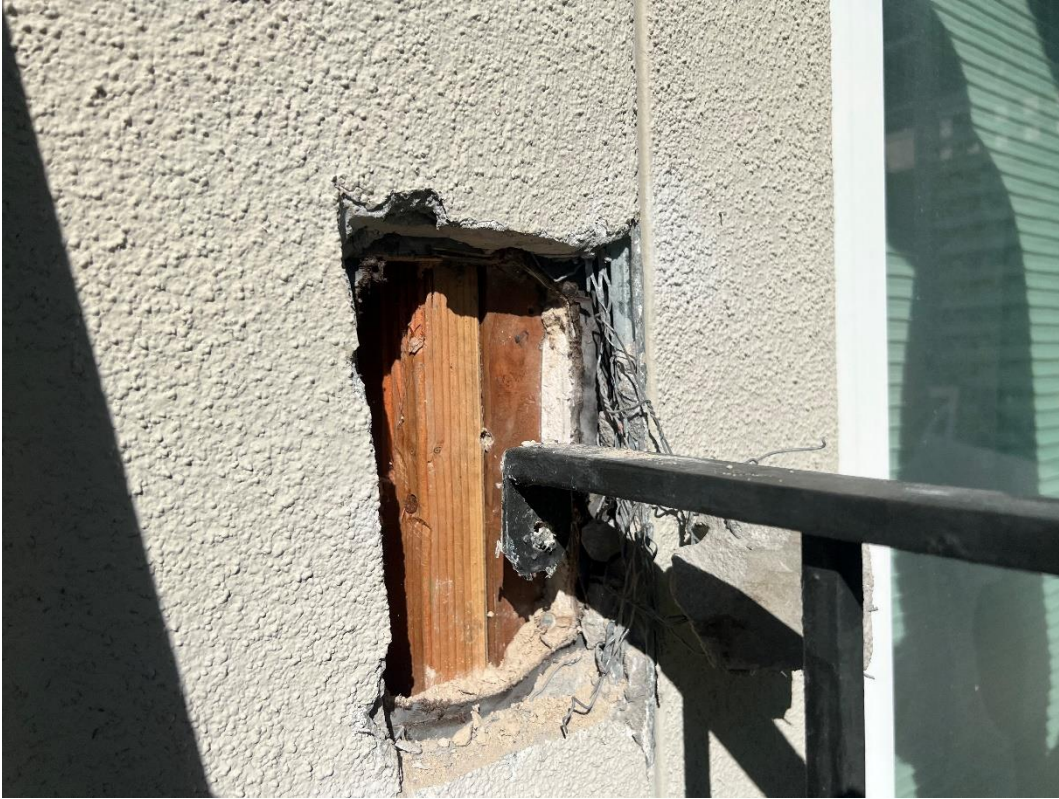
13

Location # 1 solid framing at wall confirmed

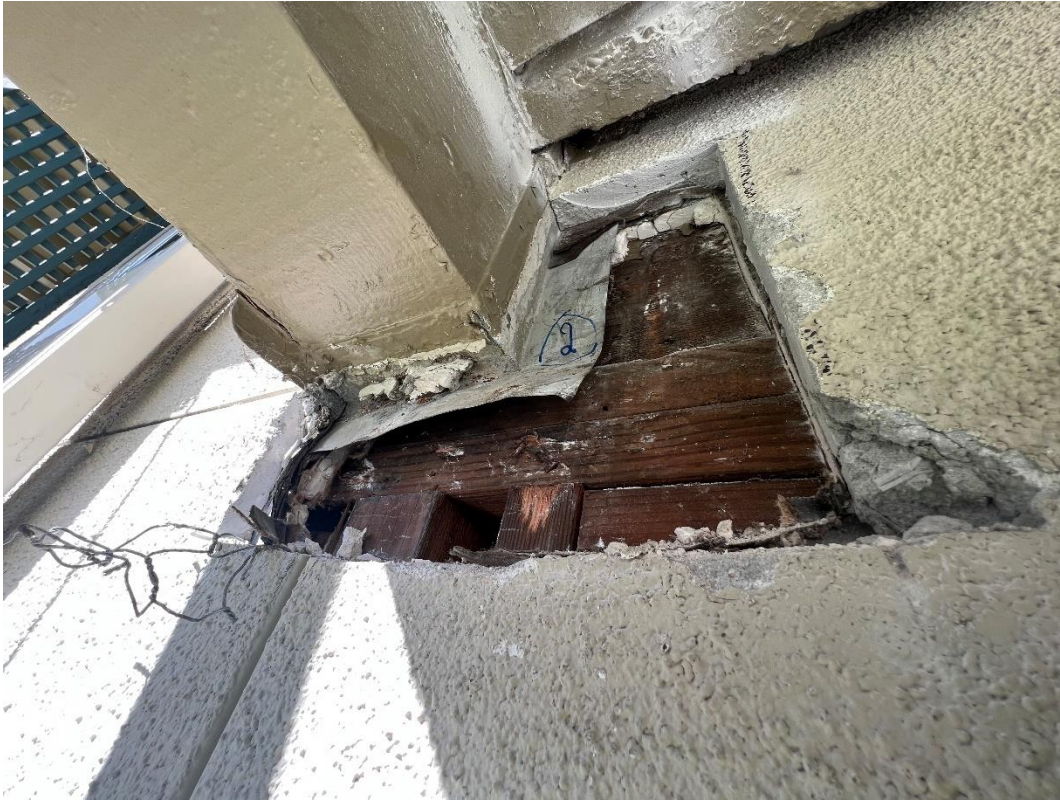
15

Location # 1 cantilever beam flashing is adequate.
No signs of water damage to framing observed.

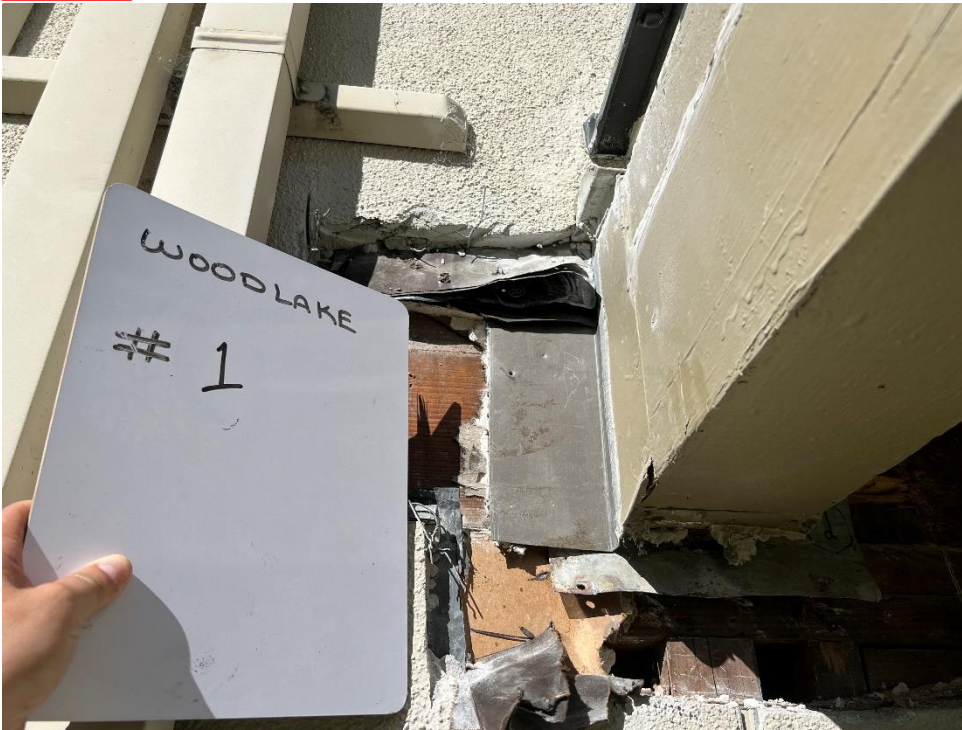
16

Location # 1 ; Note: Additional stucco removed along exterior side of joist/beam. cantilever joist/beam flashing is adequate. No signs of water damage to framing observed.

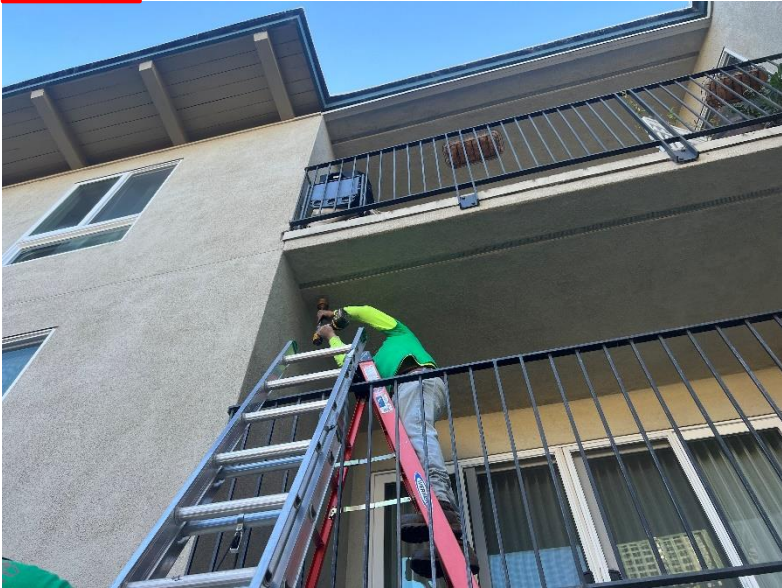
18

Location # 2
Two 3" holes bored through stucco soffit.
No signs of water infiltration observed.
