INSPECTION REPORT IN ACCORDANCE WITH CALIFORNIA CIVIL CODE SECTION 5551

For Woodlake Association
900 Peninsula Avenue,
San Mateo, CA 94401

Fifteen Buildings – 974 Units

April 19, 2023

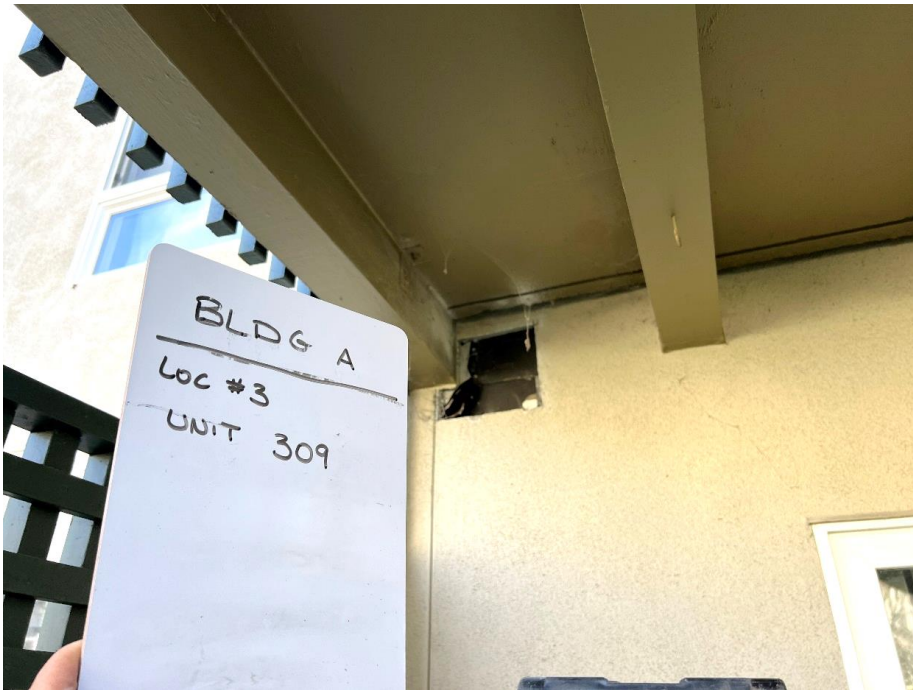
25

Location # 3 No signs of water damage/deterioration to building paper

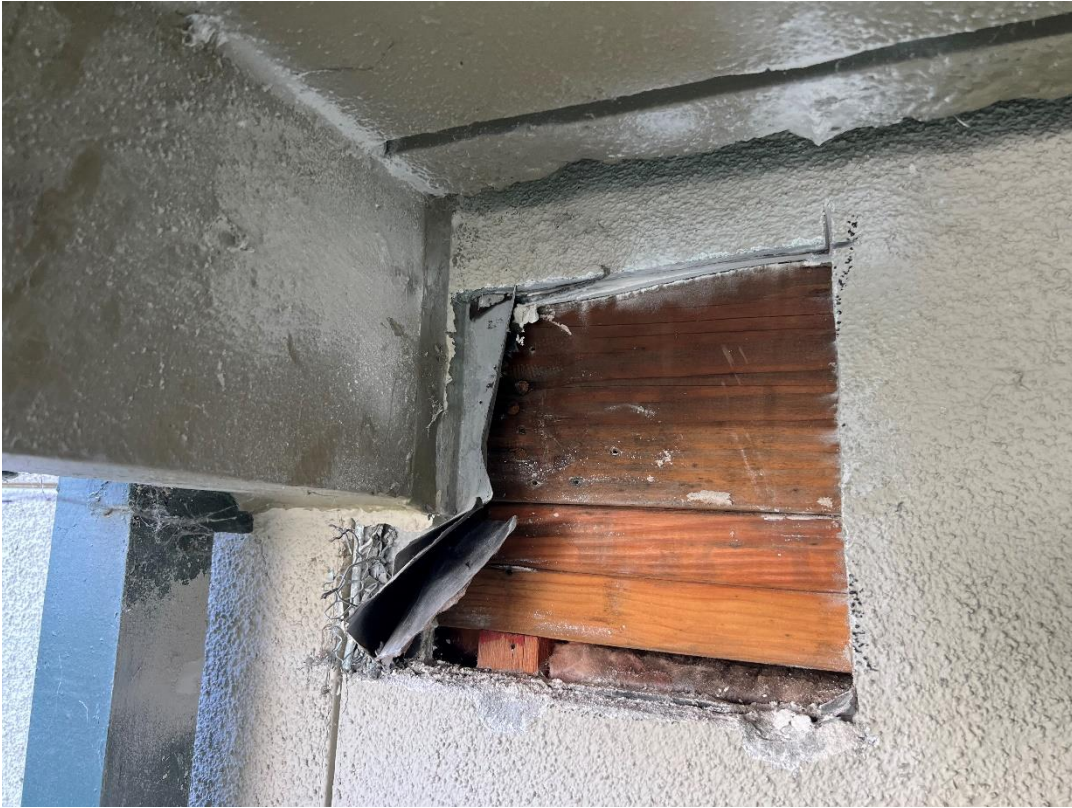
27

Location # 3 No signs of water damage to framing around cantilever joist

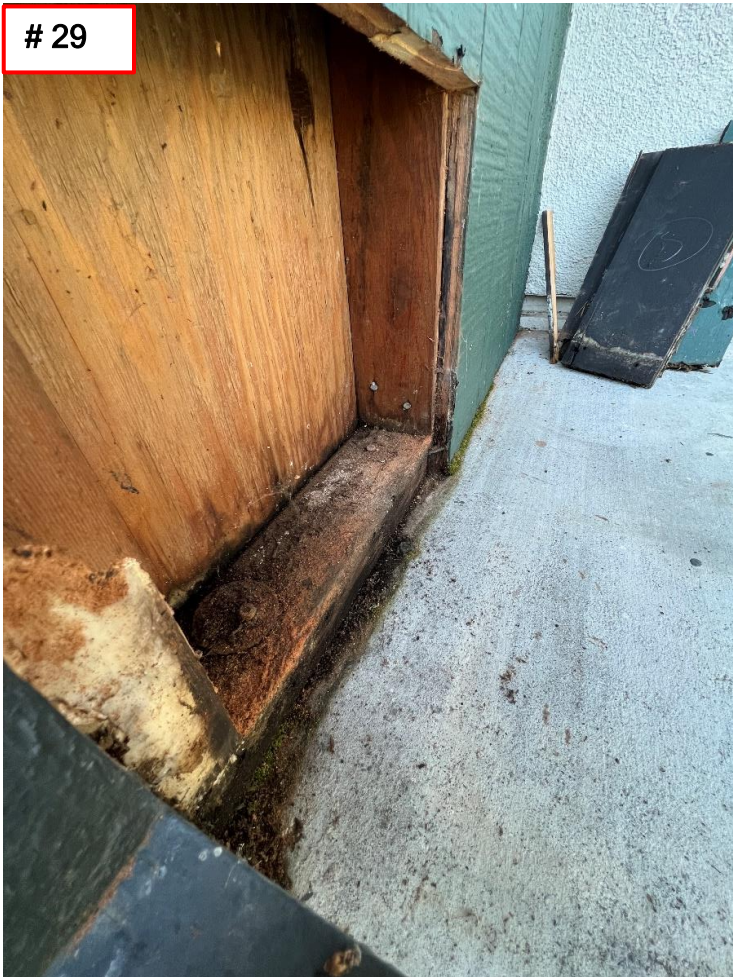
29

Location # 4. Damaged siding on both sides of wall. Mudsill is not pressure treated and shows signs of water damage.

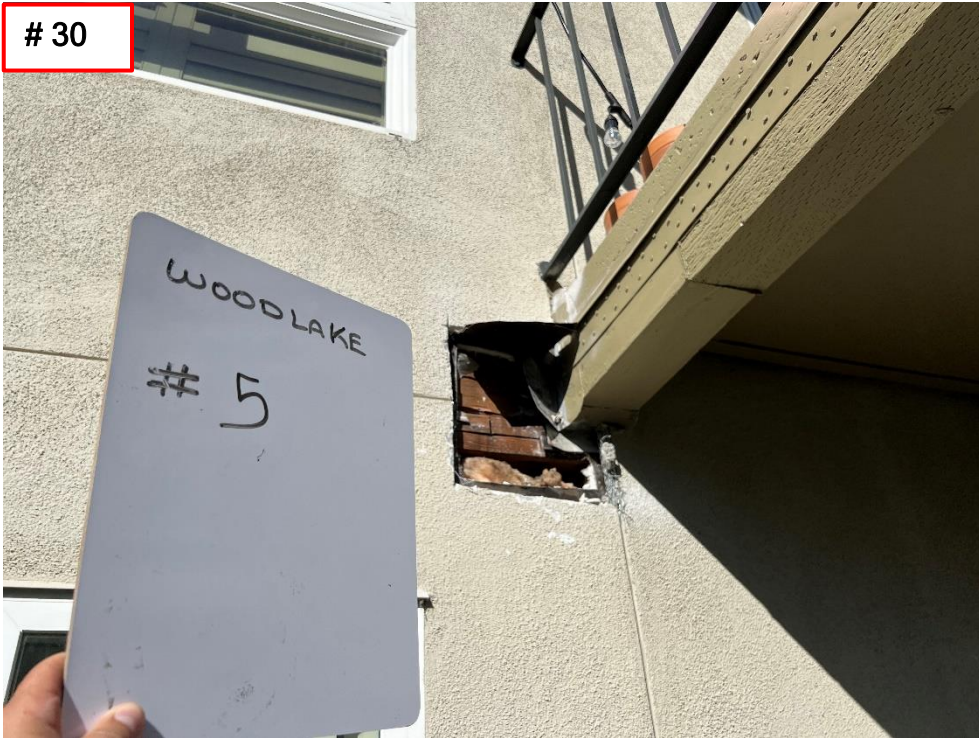
30

Location # 5 No signs of water damage to framing around cantilever joist/beam

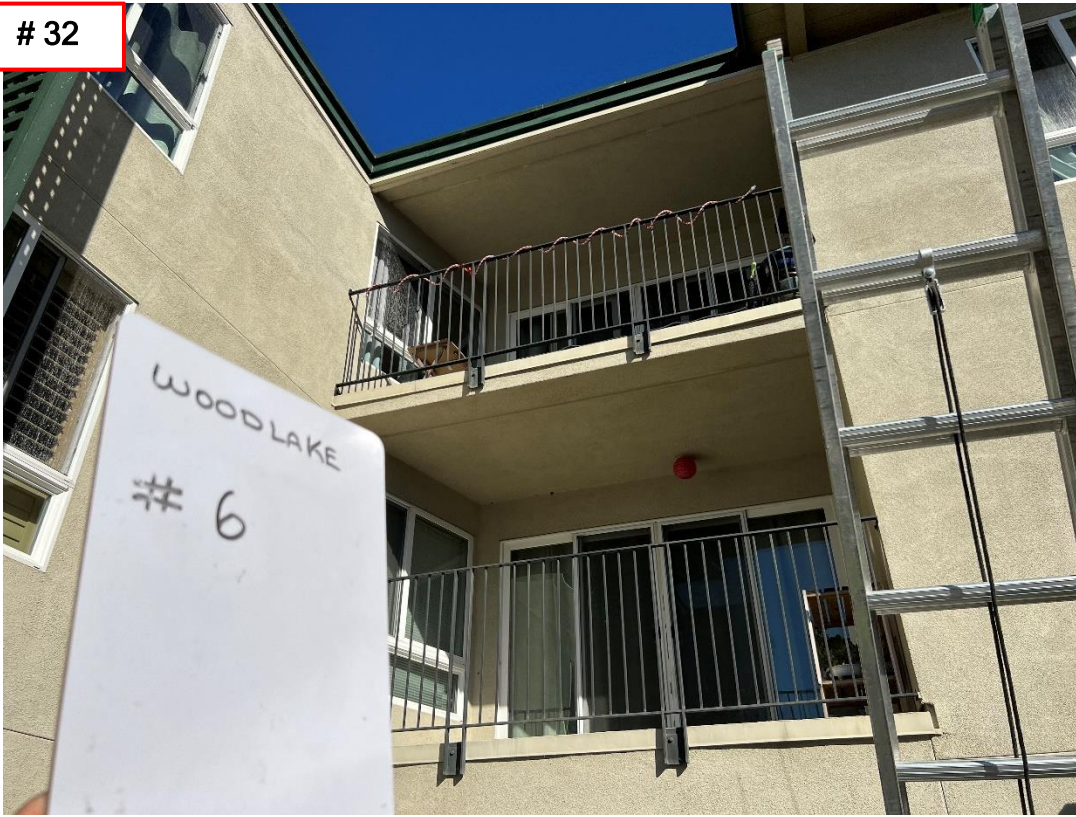
32

Location # 6
Two 3" holes bored through stucco soffit.
No signs of water infiltration observed.

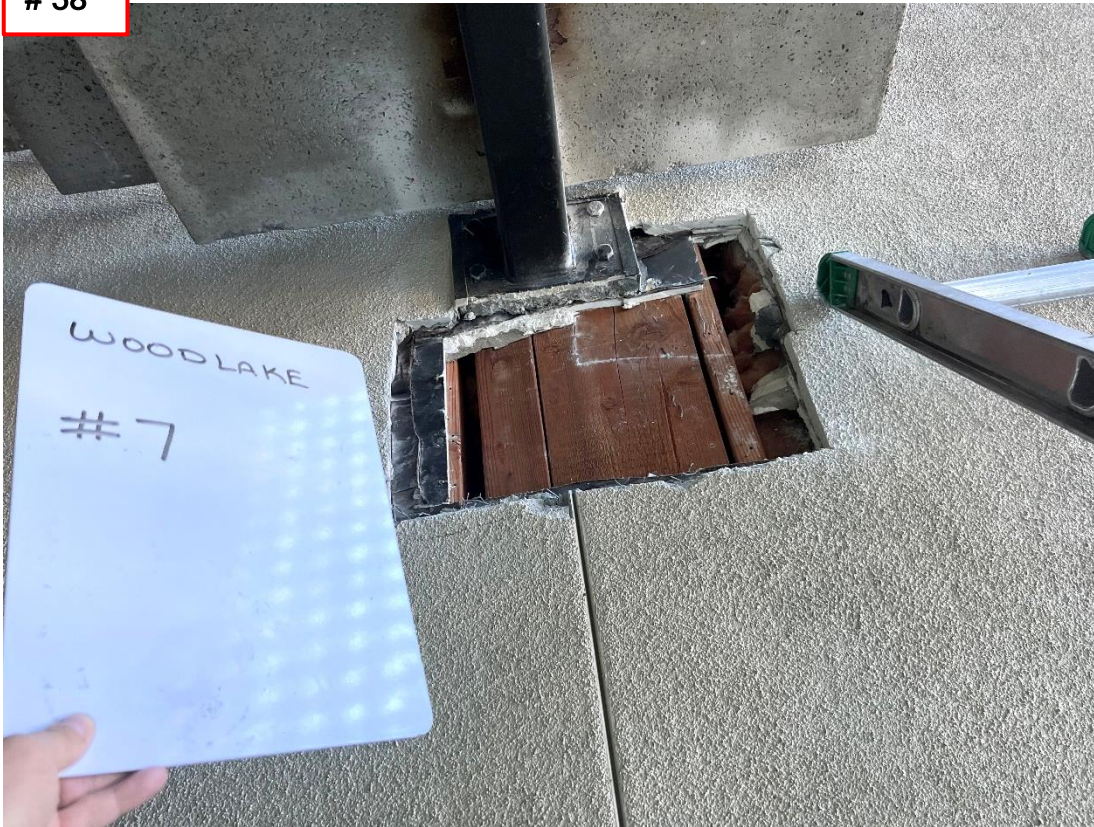
38

Location # 7
Staircase attachment
to wall

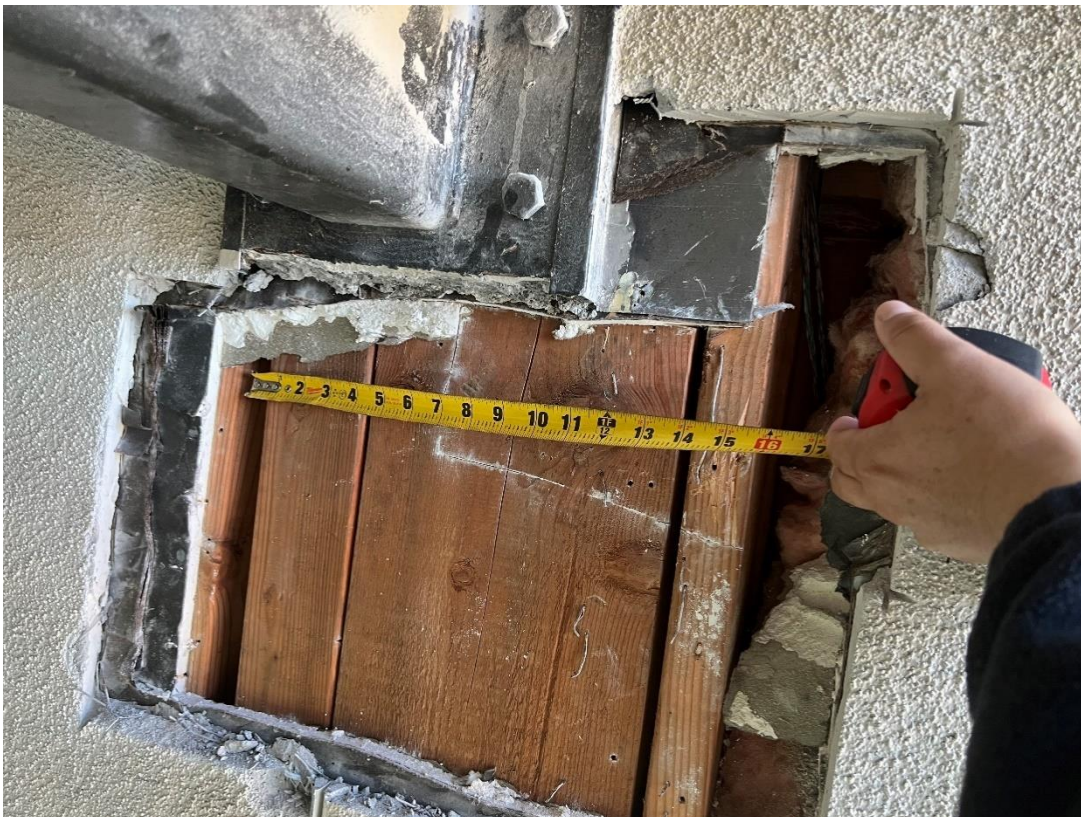
39

Location # 7
Staircase attachment
to wall - no damage
to framing

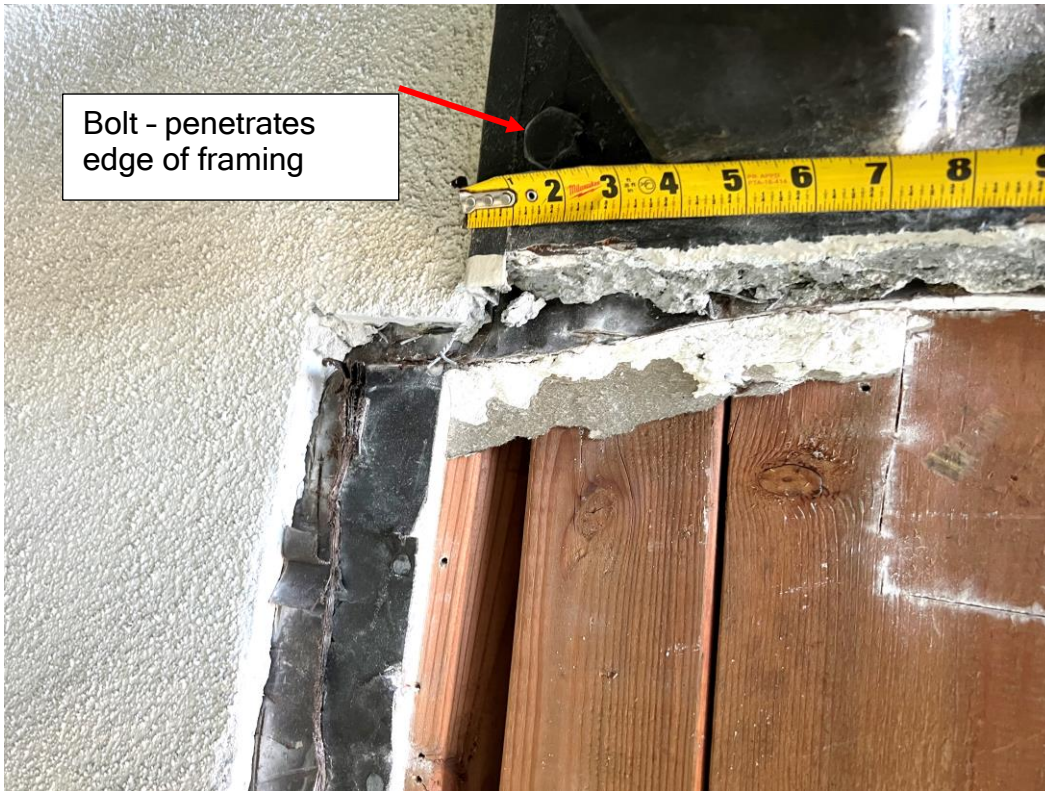
40

Bolt - penetrates
edge of framing

Location # 7
Staircase attachment
to wall - lag bolt for
steel plate attachment
to wall is 2 inches
from edge of steel
plate. Lag bolt is
aligned with edge of
2x4 stud framing.

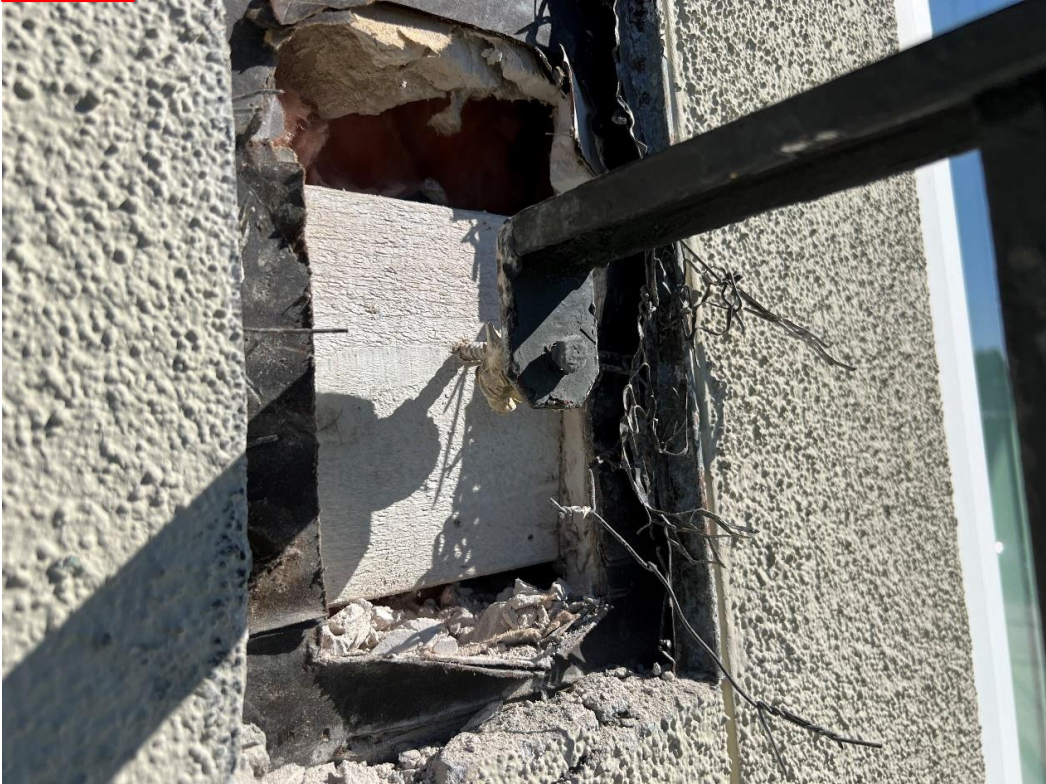
43

Location # 8 At Rail
- Rail lag bolt
attached directly to
blocking between
stud wall framing.
Blocking attached to
stud wall framing
with nails.

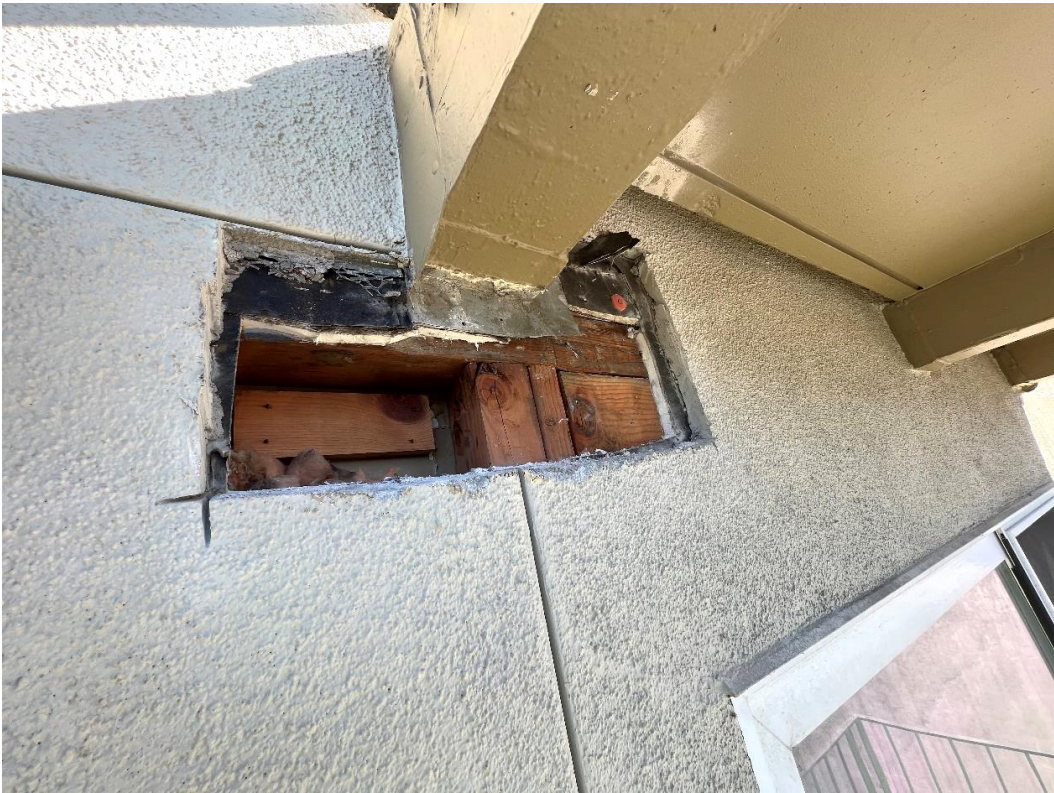
44

Location # 8
No water damage
observed to framing
around cantilever
joist/beam.

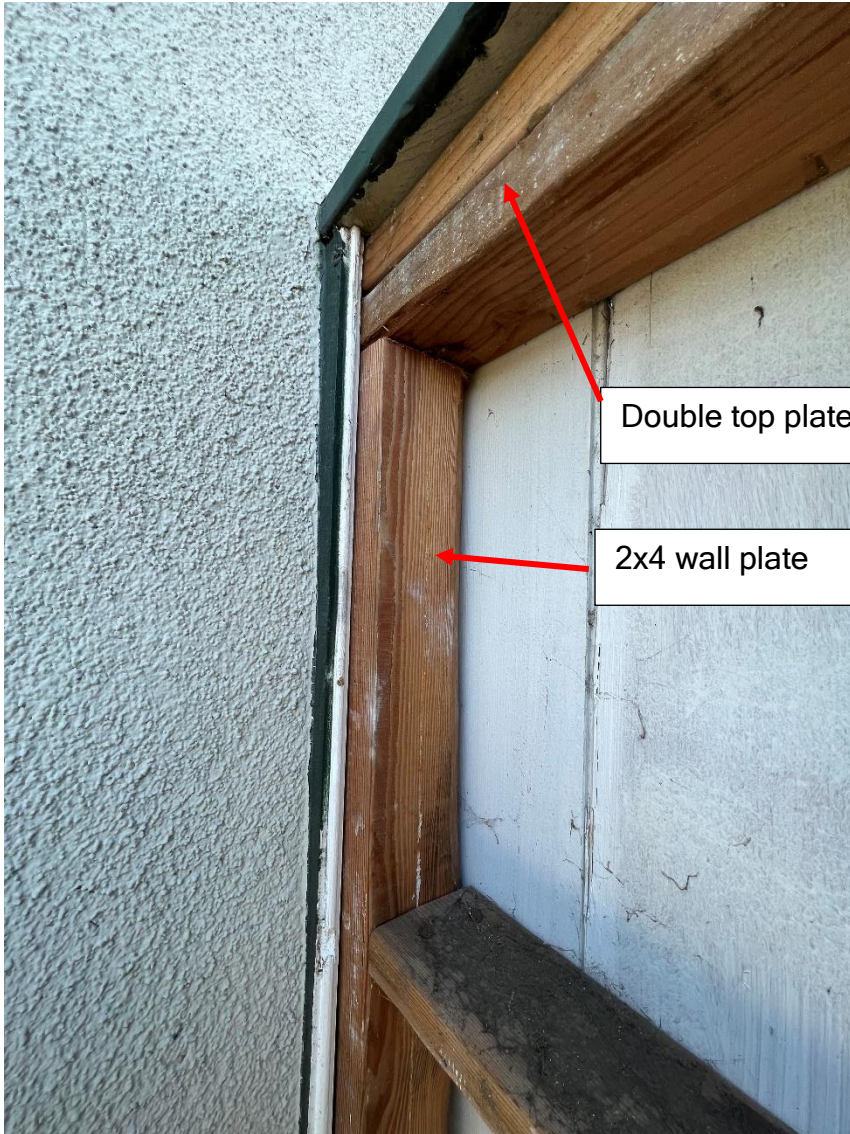
47

Location # 9
Guardrail wall
supported on 4x10
cantilevered beam.

Double top plate

2x4 wall plate

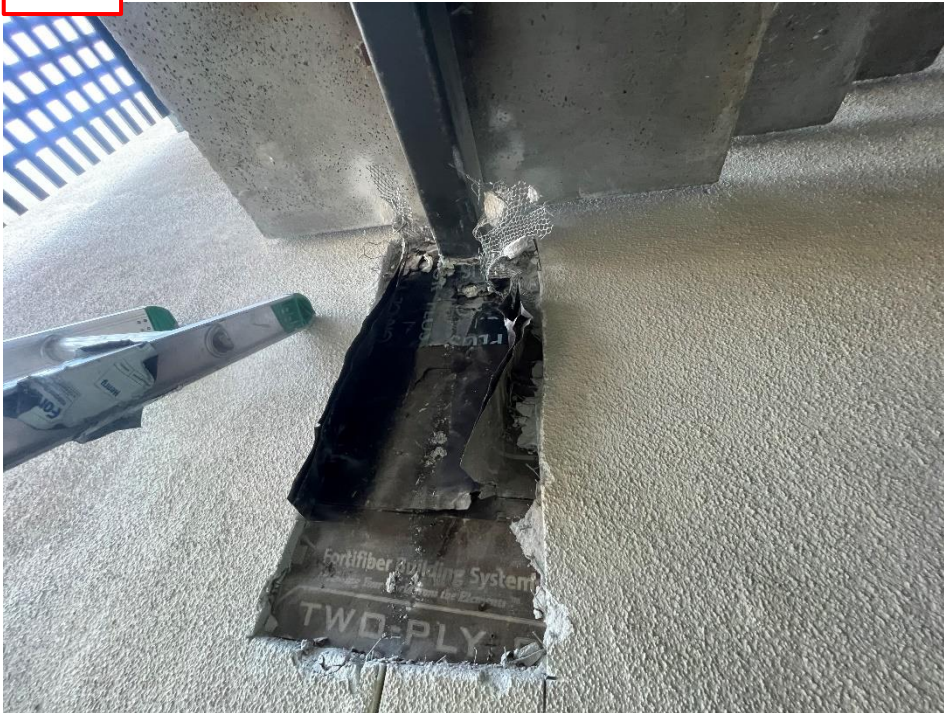
51

Location # 10
Staircase
No water infiltration
damage observed

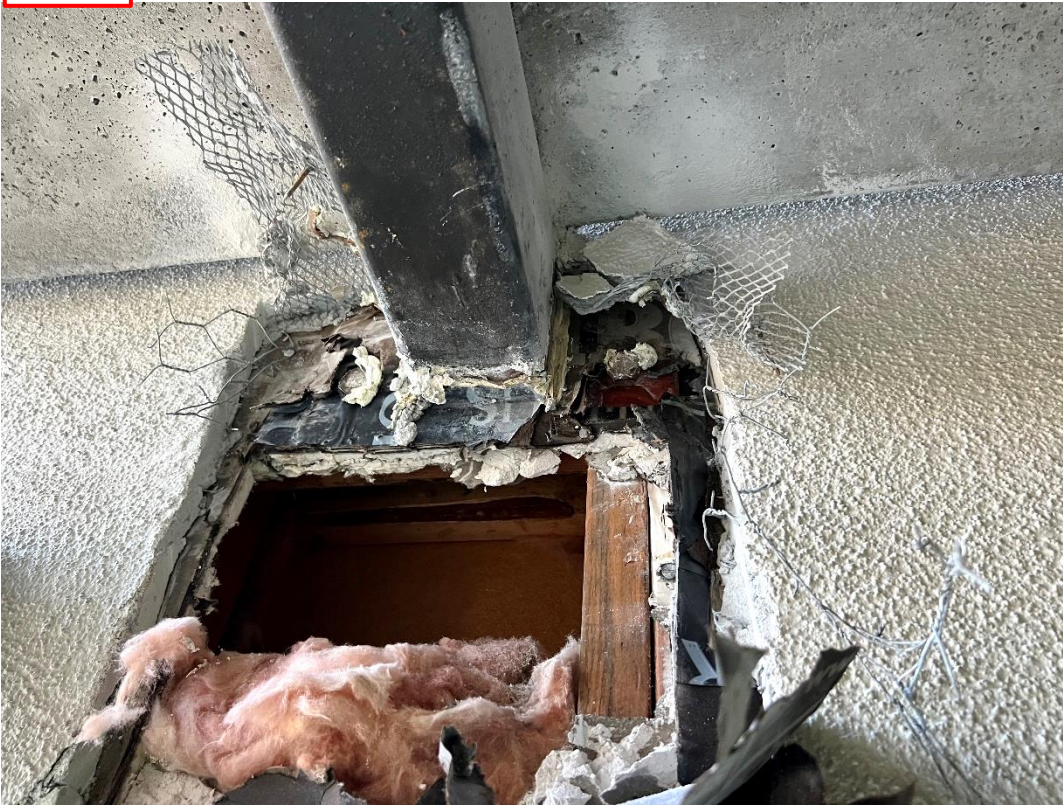
52

Location # 10
Staircase

No framing directly
below steel beam
attachment.

Emergency shoring
was placed at this
location.

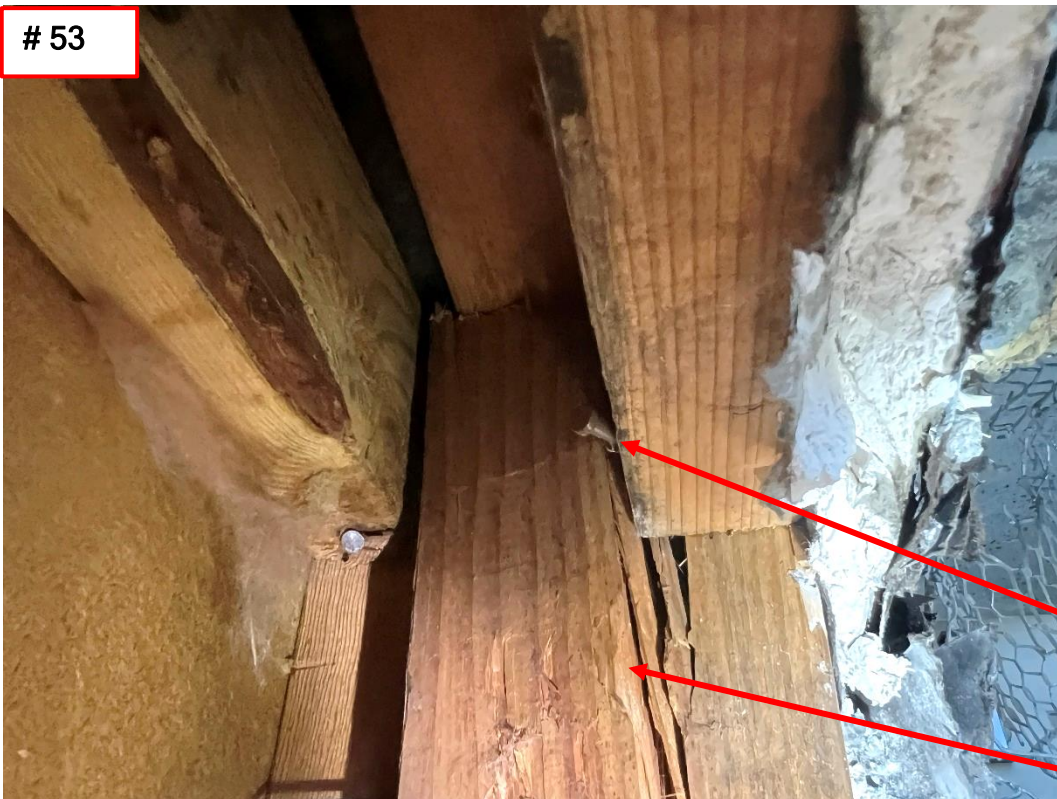
53

Location # 10
Staircase

2x6 blocking
attached to wall stud
with only nails.

Wall framing stud -
split

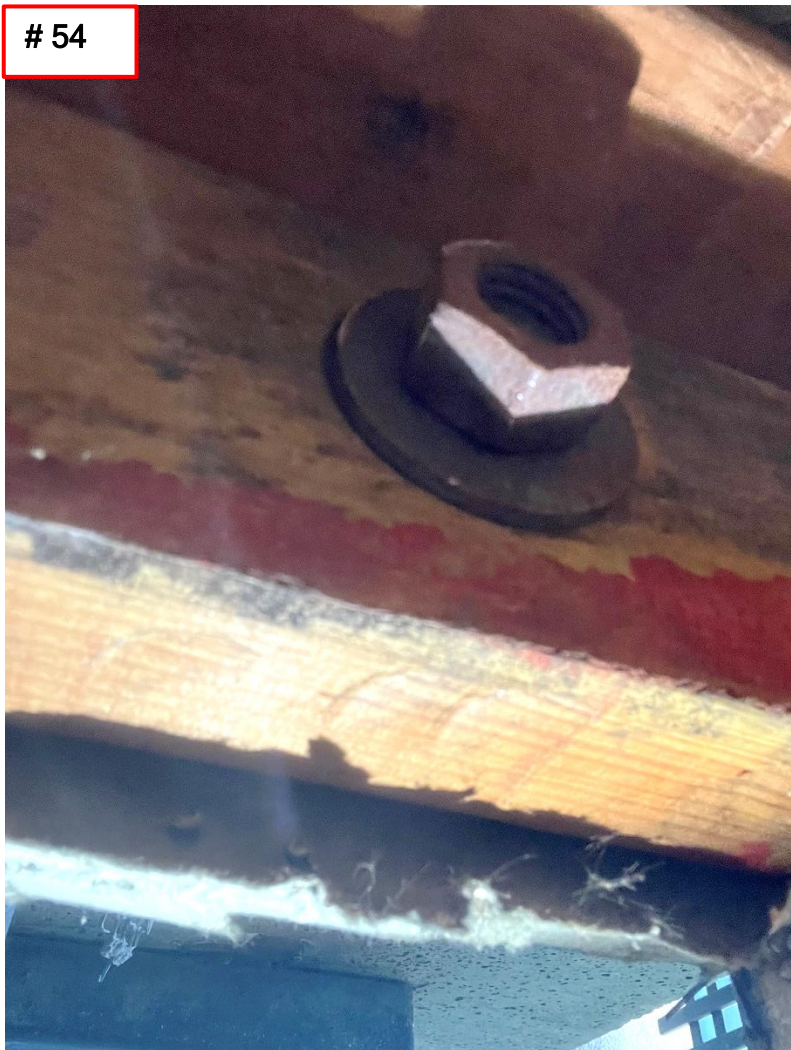
54

Through bolt not threaded pass bolt nut.

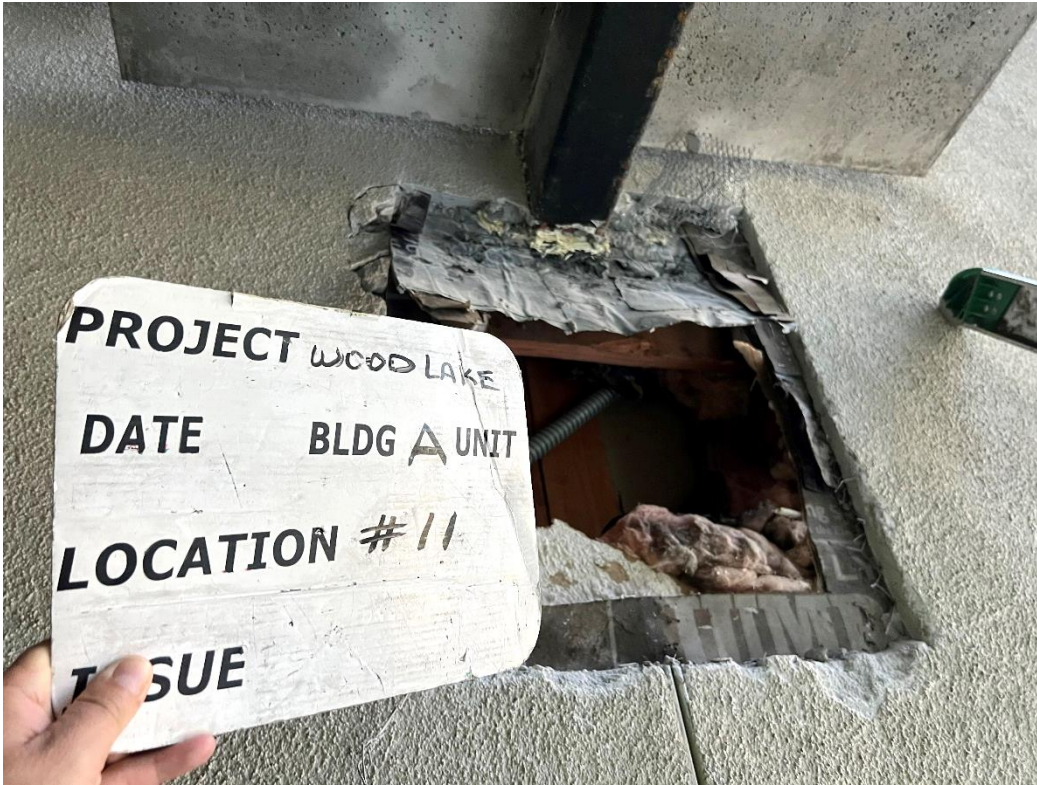
55

Location # 11
Staircase

No framing directly
below steel beam
attachment.

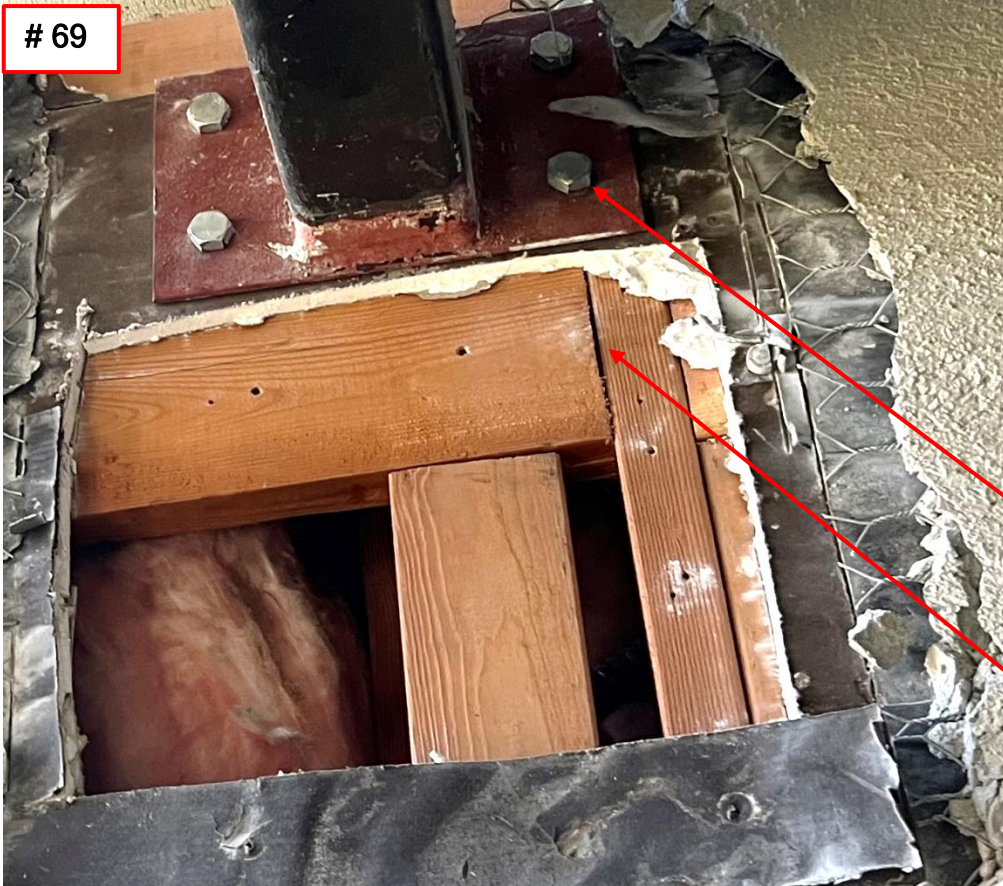
69

Location # 15
Staircase

Right bolt penetrates directly between blocking and edge of wall stud.

Wall stud and Blocking

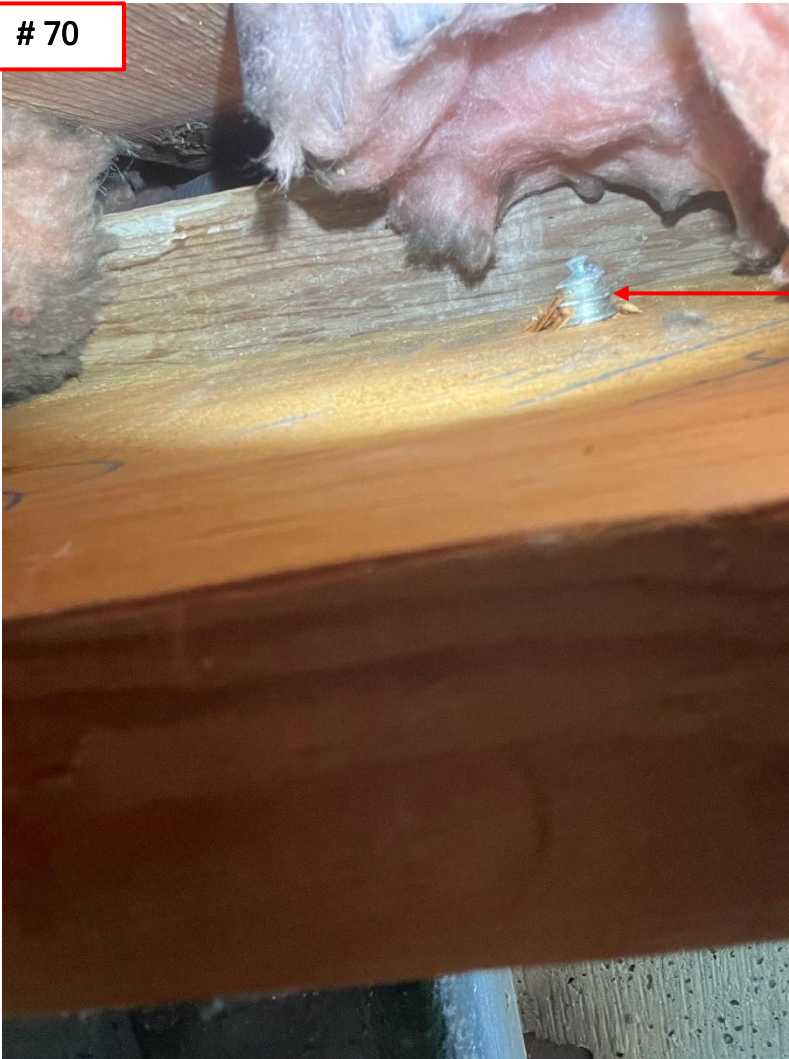
70

Location # 15
Staircase

Lag bolt installed in lieu of through bolt with nut.
