PROPERTY INSPECTION REPORT

2222 Raspberry Lane, Mountain View, CA 94043

April 30, 2026

File #: 20260430-24

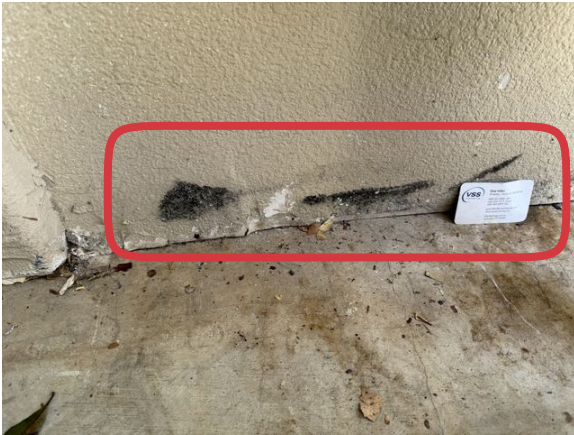
1. **Repair/Further Evaluation:** There was black staining and moisture damage observed to the sheetrock at the garage. It is beyond the scope of the inspection to identify this type of material. This material is present because of a moisture intrusion problem. Recommend a qualified moisture intrusion specialist, identify the source of the moisture and make repair recommendations. You may also wish to have an air quality test done by a state licensed industrial hygienist. See termite report.

Inspector's recommendation: the inspector suggested to cut out the sheetrock around the red outlined area and replacing it with the new sheetrock.

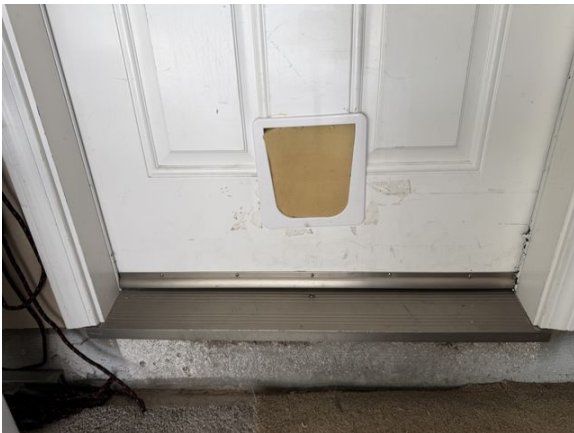
2. **Correct:** The pet door installed in this fire door violates the integrity of the door as a fire barrier. This is a safety concern.

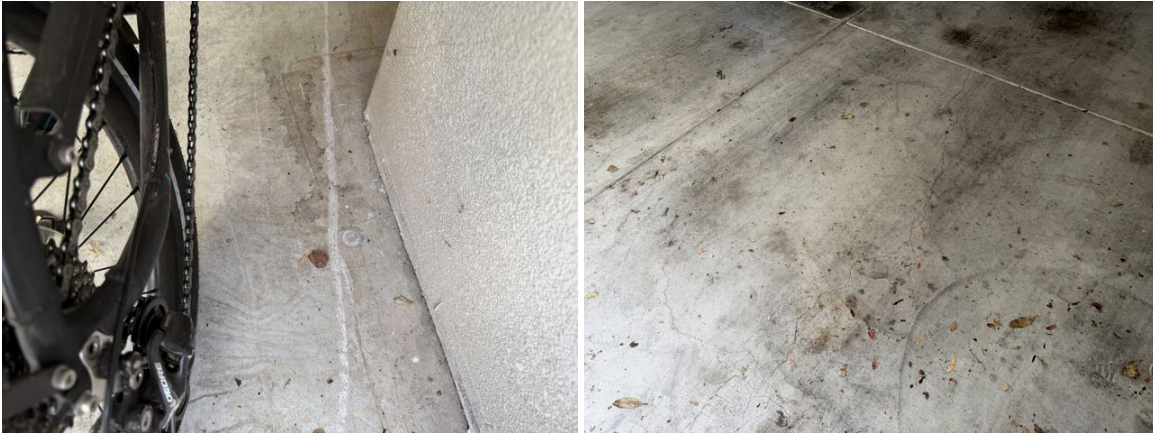
☑ Note: There were minor cracks observed in the concrete of the floor. There are no structural ramifications. It is a cosmetic concern. This condition does not appear to compromise the serviceability of the garage. If so desired, flexible urethane caulk can be used to fill the cracks of those that are at least 1/8" in width.

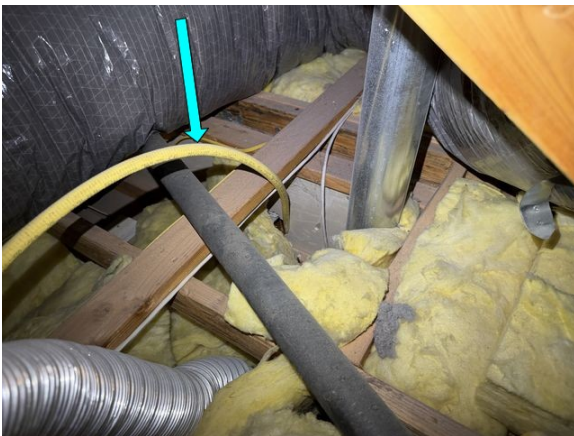
1. **Further Evaluation:** Portions of the gas piping system in this home is comprised of Corrugated Stainless Steel Tubing (CSST). Manufacturers of yellow corrugated stainless steel tubing believe that yellow corrugated stainless steel tubing is safer if properly bonded and grounded as required by the manufacturer's installation instructions. Proper bonding and grounding of this product can only be determined by a licensed electrical contractor.

CSST (corrugated stainless steel tubing), is being used as a gas supply line in this home. We recommend installation of Excess Flow Valves in the event of a gas line breach that would shut down the gas flow.

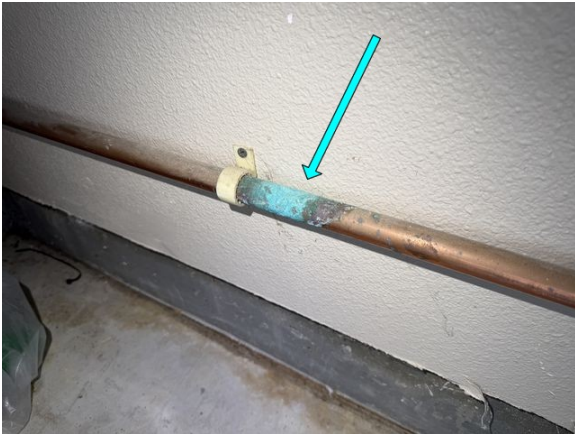
1. **Repair:** Corrosion noted at the overflow leg.

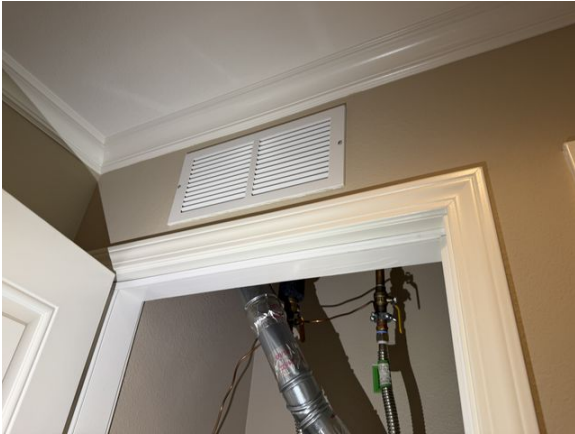
2. **Further Evaluation/Safety:** The combustion is being drawn from the indoors. We recommend it be drawn from the outdoors for added safety of occupant(s) and operation of the unit.

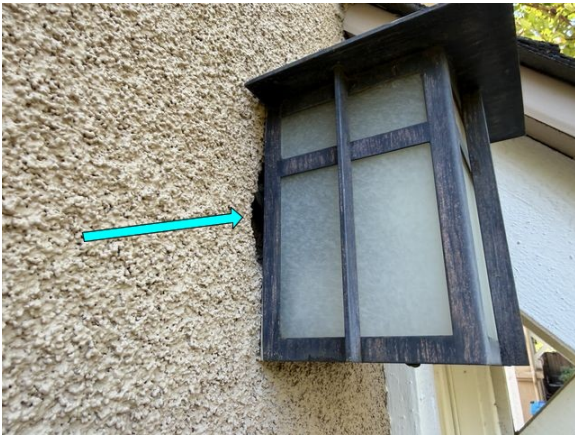
1. **Repair:** The exterior light fixture at the front wall should be sealed/caulked at the wall to prevent moisture penetration.

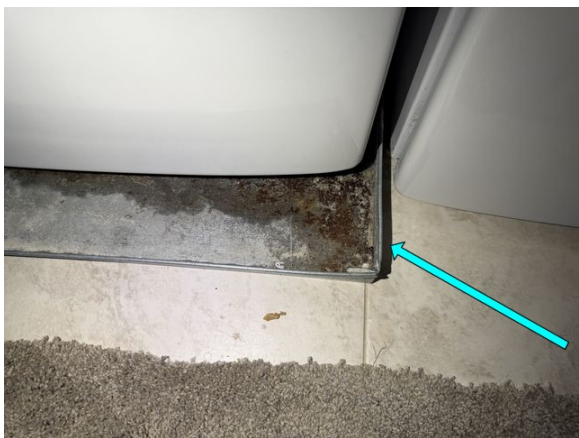
1. **Service:** There was rust noted to the drain pan. This could indicate leakage from the appliance.

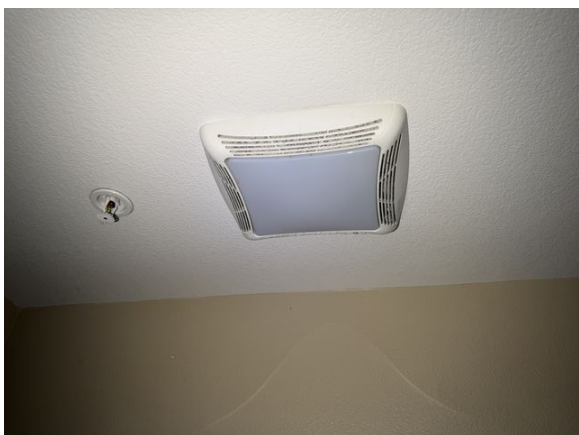
- Note: The ceiling exhaust fan was in need of servicing.

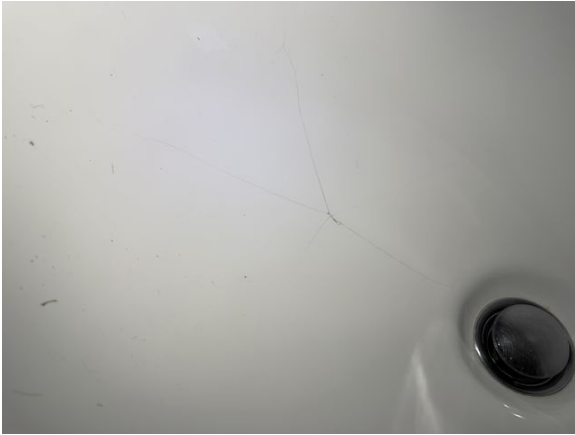
1. **Repair:** Loose or missing grout noted to tiles in the guest bathroom. See termite report.
2. **Repair:** Cracks noted to the sink basin in the guest bathroom. See termite report.

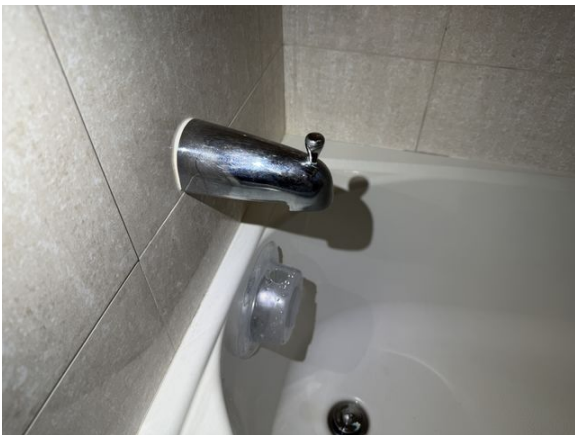
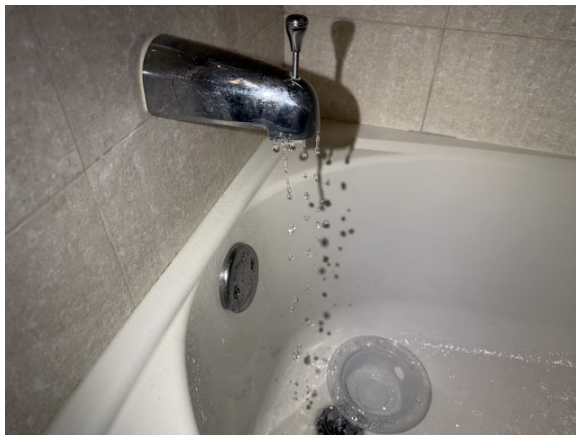
3. **Repair:** Loose spout noted in the guest bathroom. A diverter leak was also noted. See termite report.

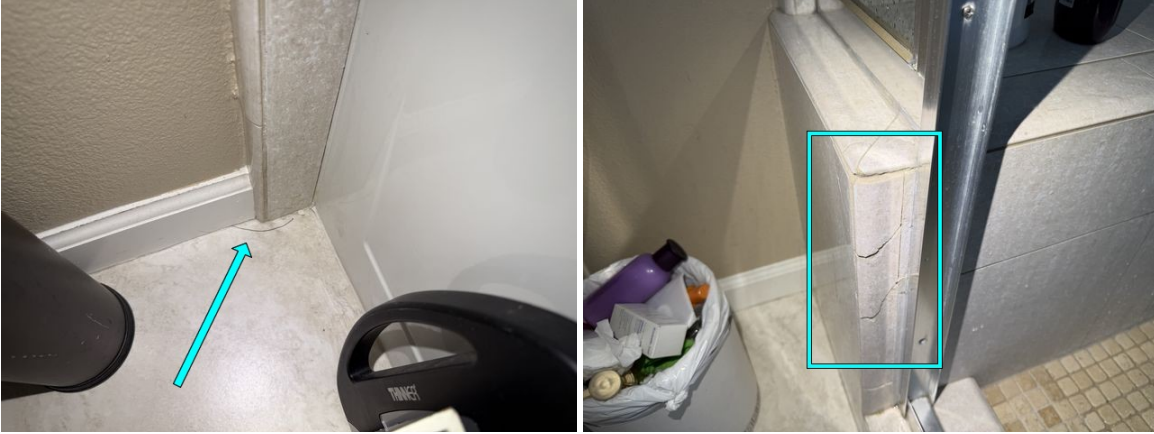
4. **Repair:** Cracked floor and wall tile(s) noted in the guest and third floor hall bathroom. Water leakage was noted through the bench (possible the waterproof membrane is compromised). See termite report.

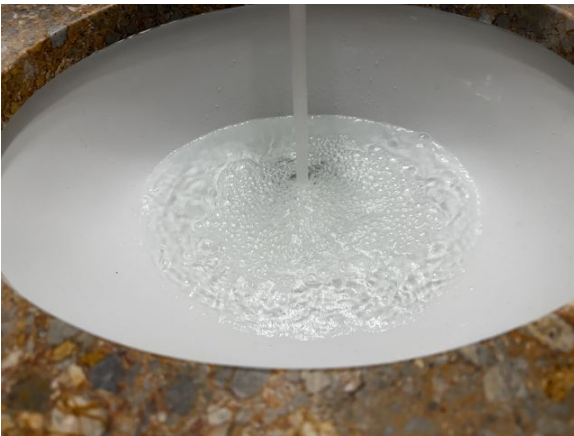
5. **Repair:** There was slow drainage observed at the sink in the half bathroom.

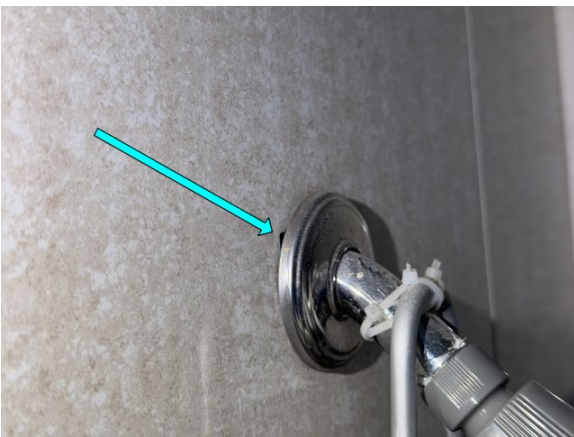
6. **Repair:** There was a gap noted between the showerhead pipe and wall in the third floor hall bathroom. See termite report.

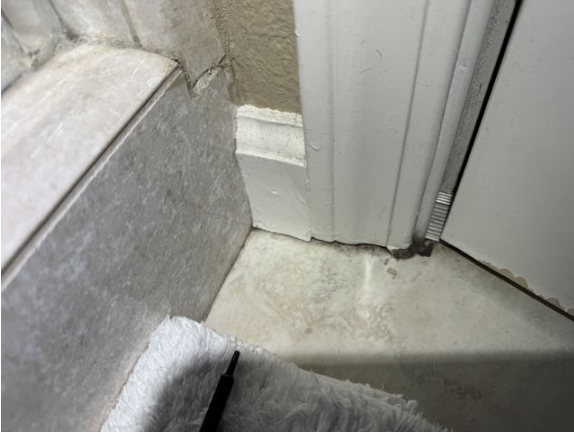
7. **Repair:** The baseboard in the third floor hall bathroom was delaminated or swollen from excessive moisture. See termite report.

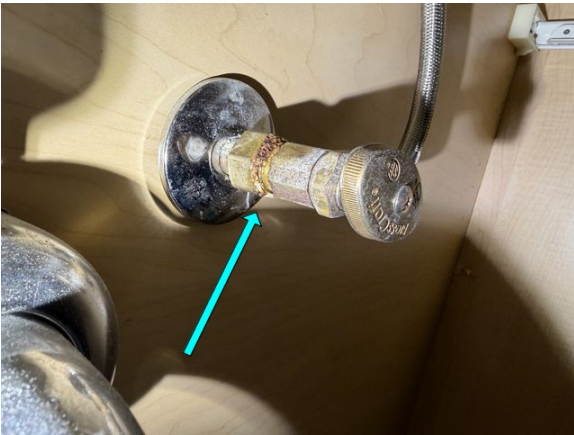
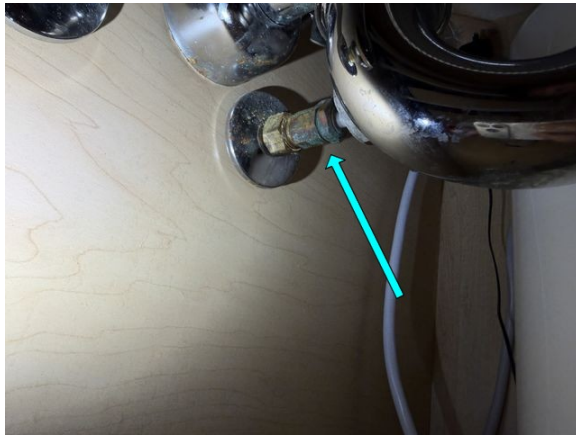
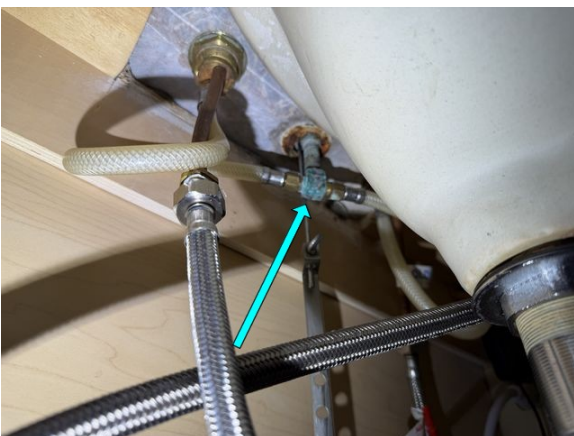
10. **Repair:** There were minor signs of corrosion observed at the plumbing in the guest and third floor hall bathroom. See termite report.

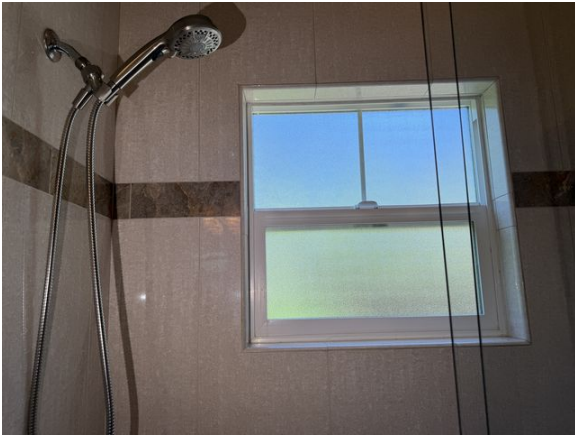
☑ Note/Monitor: The window in the guest bathroom tub/shower was installed below the shower head. This may allow moisture intrusion behind the tiles when the caulking deteriorates or becomes loose. We recommend that you ensure that all joints and tiles are properly caulked and sealed. This will require maintenance on a periodic basis. See also termite report.

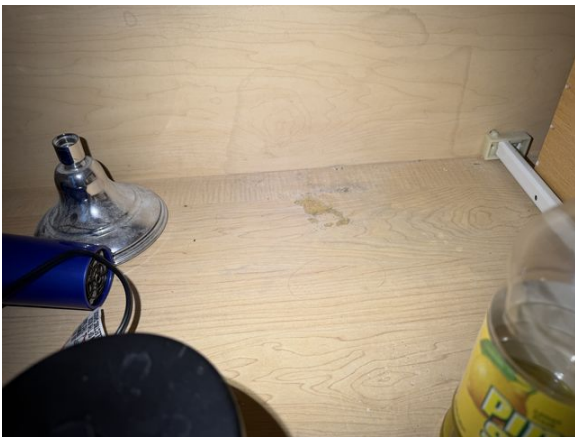
☑ Note: There was minor delamination/swelling noted to the false bottom in the third floor hall bathroom (from moisture or liquids). See termite report.

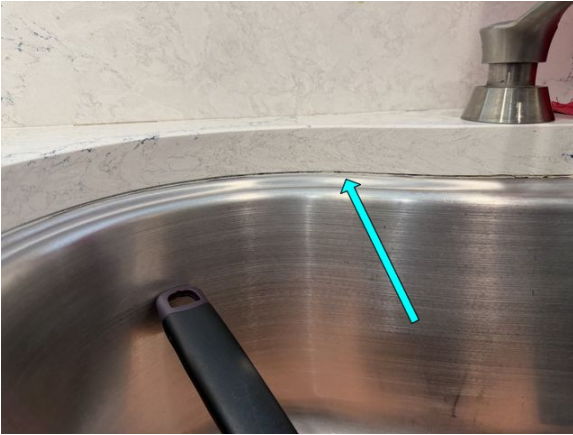
1. **Repair:** Some of the caulking and/or grout was loose or insufficient at the sink. See termite report.

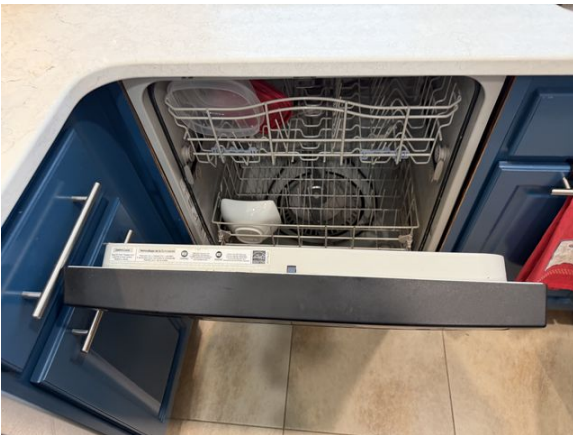
2. **Correct:** The dishwasher was not properly anchored into the cabinet.

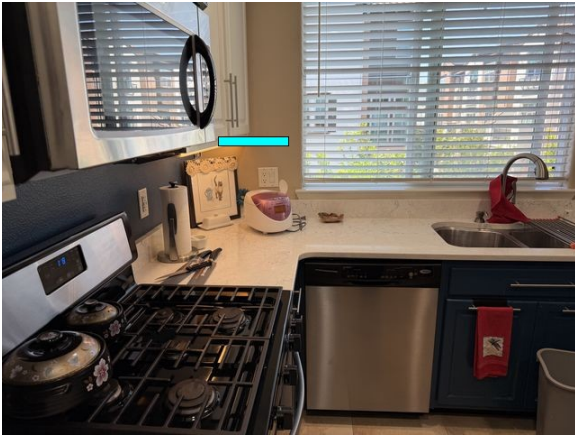
Improve: The range hood does not overhang the range hood properly. This can decrease efficiency of the hood.

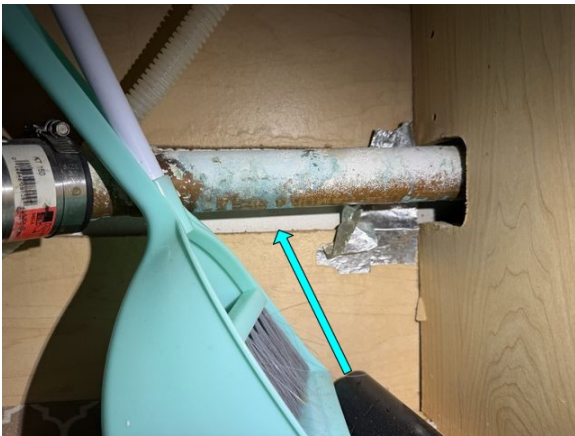
Monitor: There was corrosion observed to the plumbing in the sink cabinet. To prevent future problems this should be repaired. See also termite report.

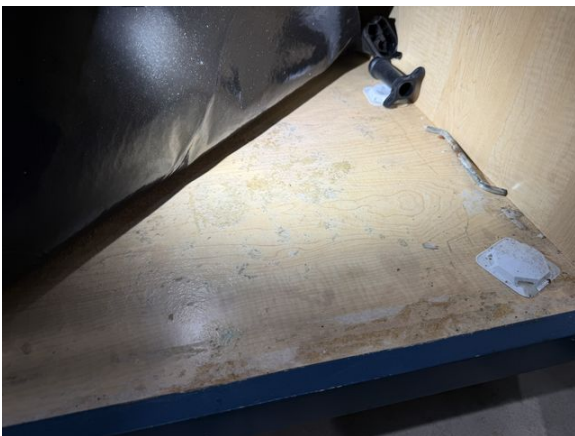
Note: The false bottom in the kitchen was delaminated or swollen from excessive moisture or liquids. See termite report.

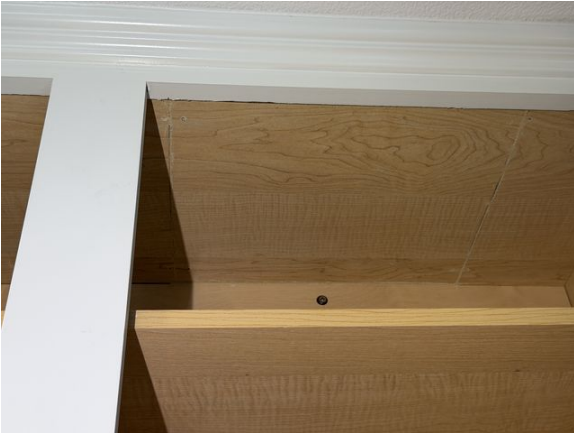
Note: Evidence of repairs were noted to portions of the cabinetry. Advise consulting with property owner or the appropriate persons to provide information regarding the cause and what corrective actions were taken in meditating this potential defect.

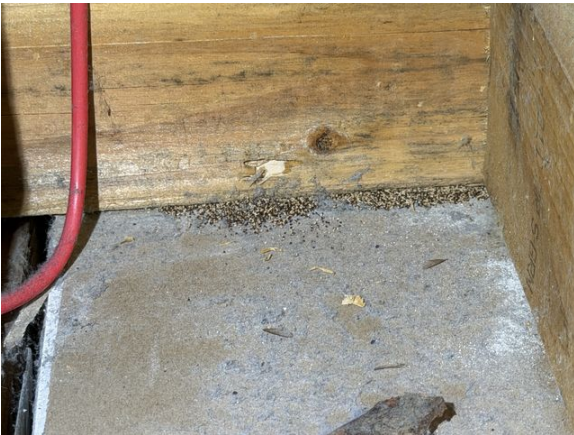
1. **Repair:** There was evidence of wood-destroying organisms observed in the attic. See termite report.

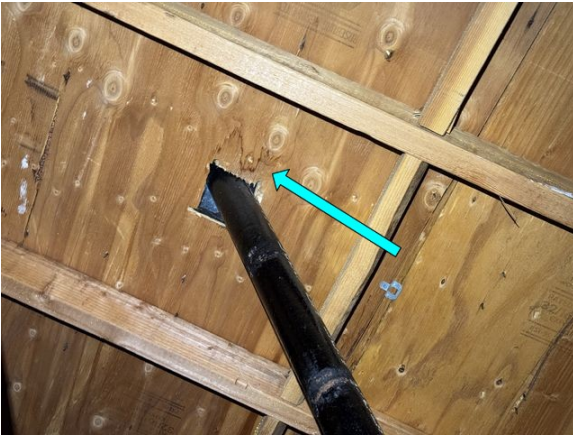
2. **Repair:** There were past or present moisture stains observed to the roof sheathing. See also termite report.

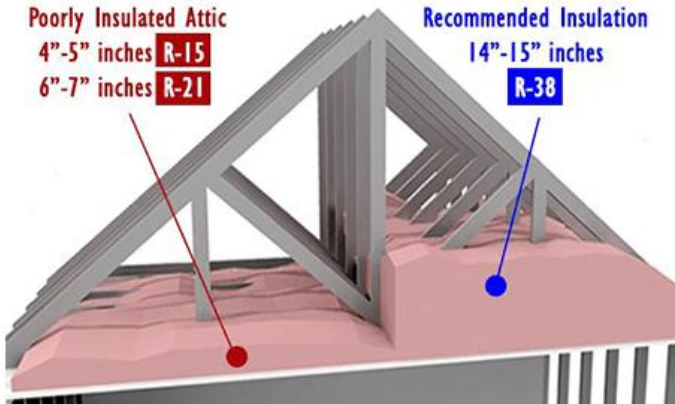
Improve: There was insufficient insulation observed in the attic space. Recommend to install insulation with a rating of R-30-50.

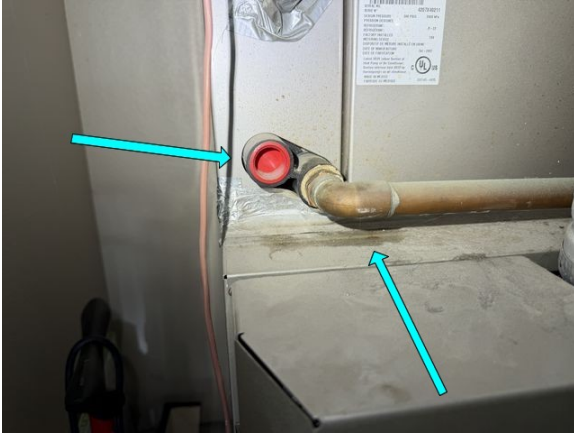
1. **Repair:** There was no secondary condensate drain line or float/kill-switch installed on the furnace (opening provided). This is needed or recommended in the event of stoppage in the primary condensate drain piping. There was also moisture leakage noted to the condensate vent in the furnace. This is causing corrosion to the furnace and can lead to water damage.

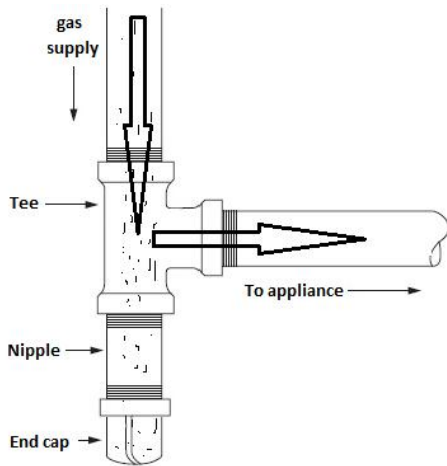
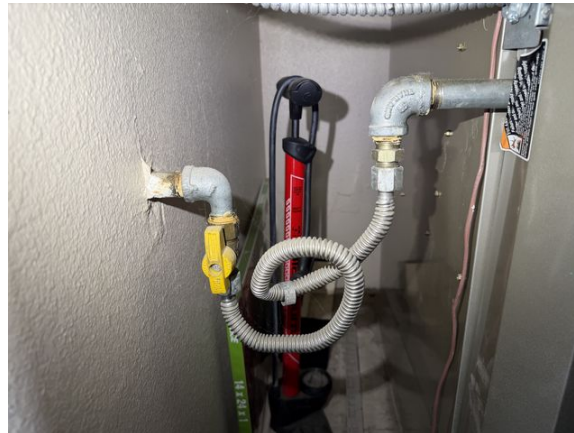
2. **Repair:** There was no sediment trap observed to the gas pipe serving the heater. Any debris that contaminates the control can cause the system to operate unsafely. A sediment trap should be installed the gas line downstream of the appliance shut-off valve and as close to inlet of the equipment as practical for added safety.

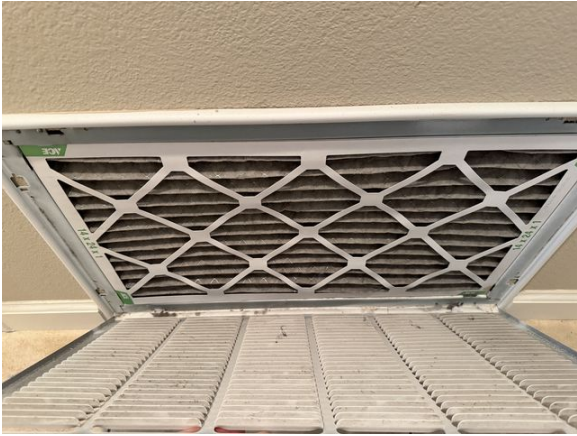
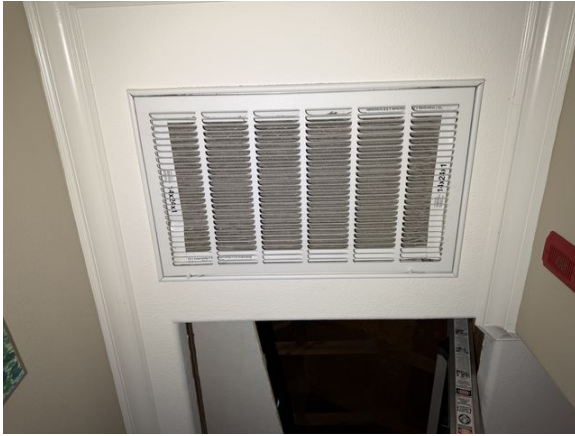
3. **Repair:** The filter was dirty and in need of replacement/cleaning. Dirty filters restrict airflow and if the filter gets too clogged, the heat exchanger will overheat and shut off too quickly.

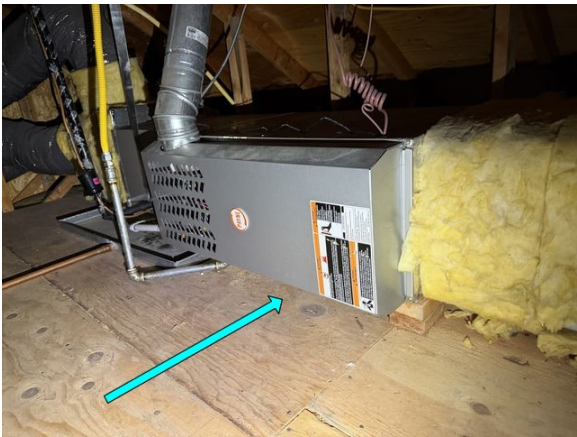
4. **Repair:** There was a missing non-combustible galvanized metal pan/floor observed below the furnace, which is typically required for attic installations.

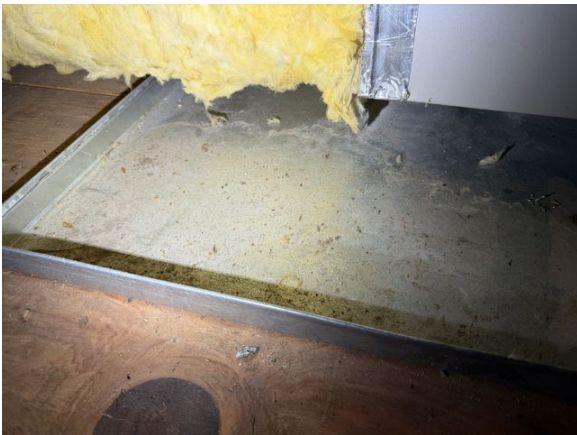
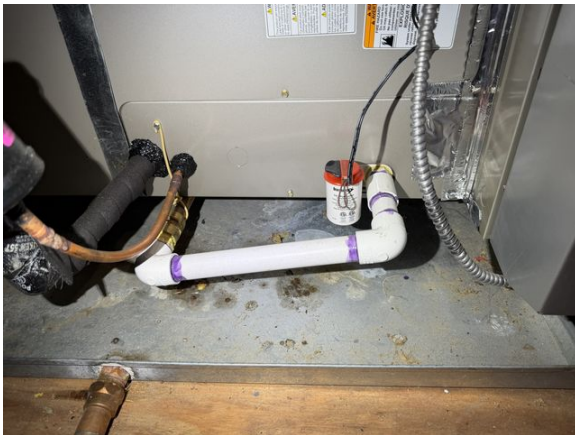
5. **Service:** The auxiliary/secondary drain pan under the coil housing had standing water and rust build-up. This would indicate that the cooling equipment may be in need of repair. Auxiliary/secondary drain pans that hold water, are discolored, rusted or damaged may result in water damage or other defects.

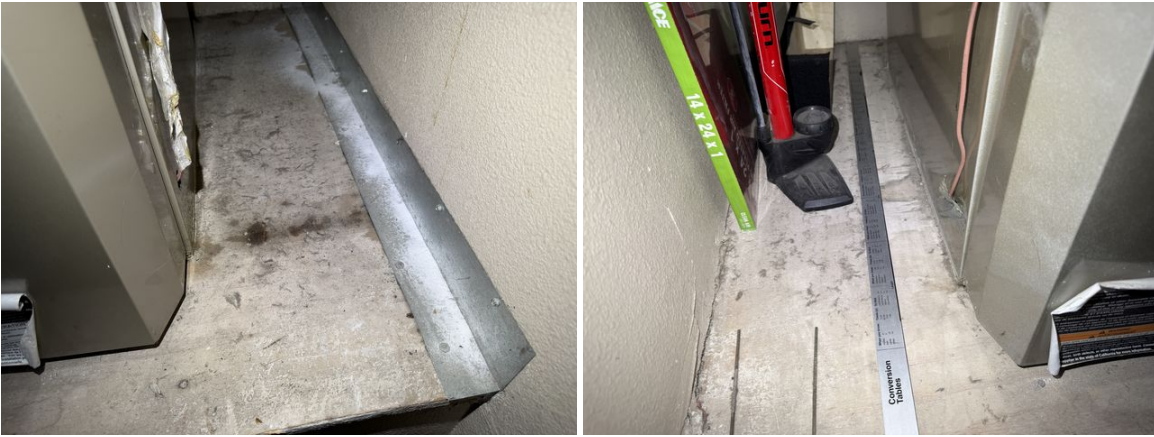
Monitor: Past or present moisture stains noted on the platform below the furnace.

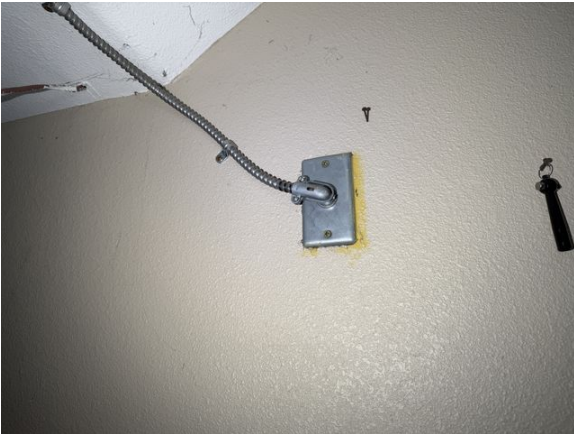
Note: There was a kill switch noted for the furnace, however there was no safety fuse observed (the unit may be internally protected or may not be required by manufacturer). The purpose of a fuse is to help shut off the furnace if it is operating improperly. Check with the manufacturer or the appropriate technician.

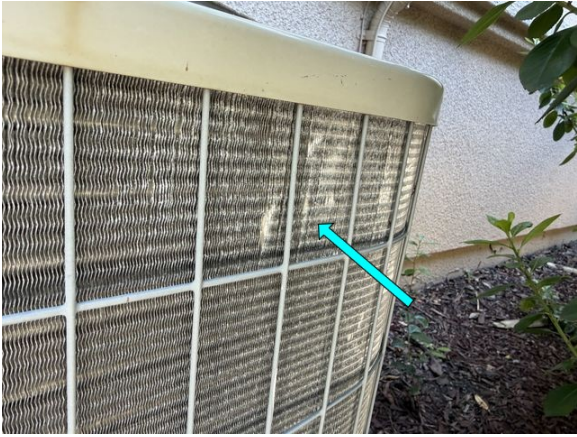
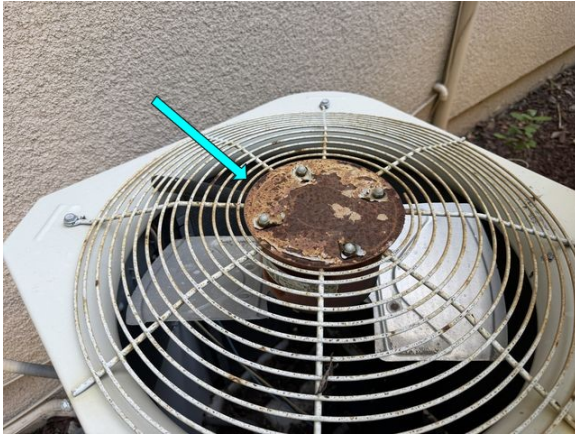
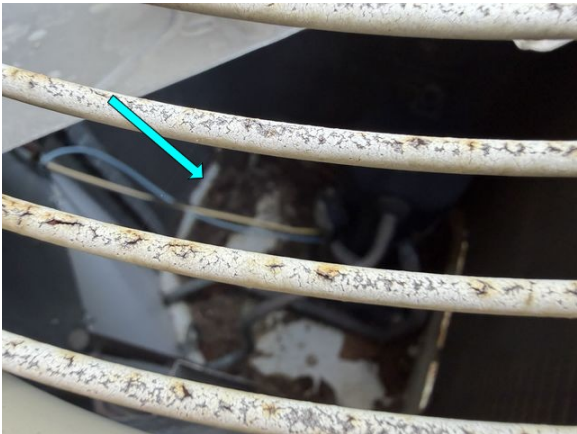
1. **Repair:** There was rust observed to the air conditioner. Rust is a sign that the unit has aged and approaching its useful life expectancy. Many units are still operable despite being rusted, but should always be evaluated by a qualified HVAC personnel - prior to use - to see if the unit is still safe and efficient to operate, whether any internal components (such as the coils or cabinet) are compromised, and if repair or replacement is recommended.

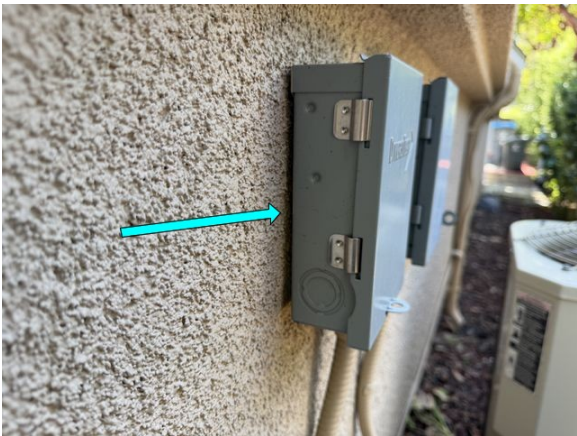
2. **Repair:** There was loose/missing caulking observed at the back wall of the breaker panel.
