HOME INSPECTION REPORT

1177 Redrock Court, Sunnyvale

672540

March 27, 2026

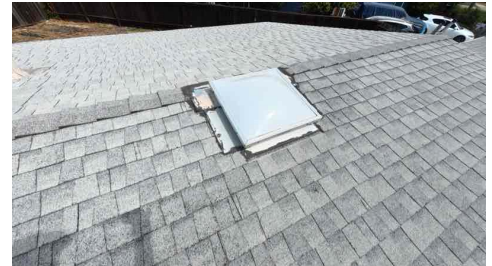
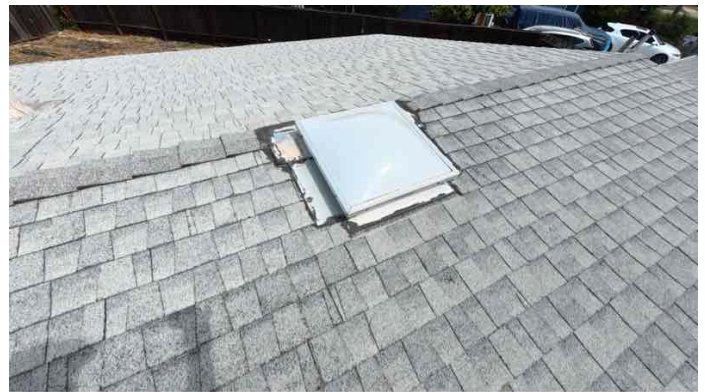
Photo 04

1. The roof mounted skylight cover has been improperly flashed and integrated into the roof covering. It should be repaired or replaced. (See Photo 4)

- ! 1. The roof mounted skylight cover has been improperly flashed and integrated into the roof covering. It should be repaired or replaced. (See Photo 4)

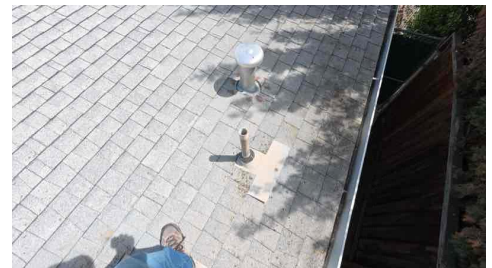
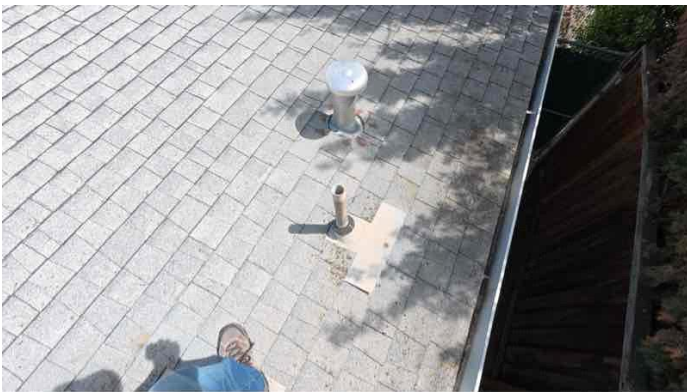
Photo 03

2. Repairs to the roof covering are recommended. Damaged, loose, or improper shingles and/or flashing should be repaired or replaced. All roof penetrations should be examined and sealed as necessary. For further evaluation of the condition of the roof we recommend you consult a licensed roofing contractor. (See Photo 3)

- ! 2. Repairs to the roof covering are recommended. Damaged, loose, or improper shingles and/or flashing should be repaired or replaced. All roof penetrations should be examined and sealed as necessary. For further evaluation of the condition of the roof we recommend you consult a licensed roofing contractor. (See Photo 3)

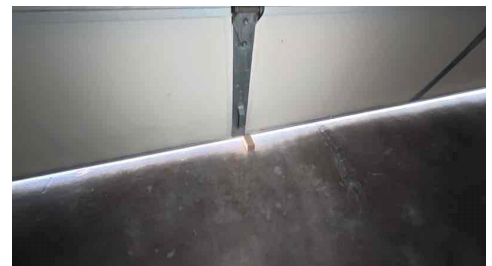
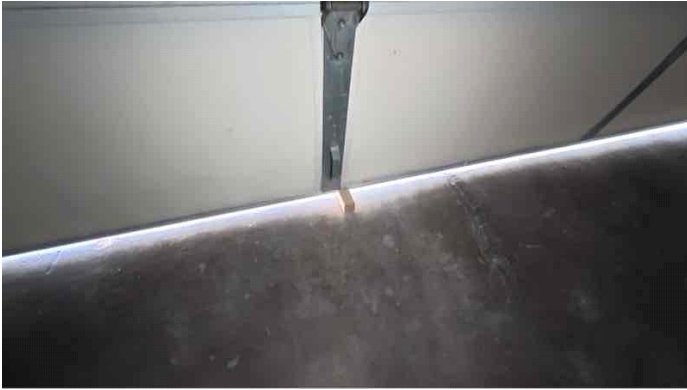
Photo 23

3. The automatic reverse safety feature of the garage door opener did not activate when the door made contact with a 2x2-inch block placed under the center of the door during testing. This feature is an important safety requirement designed to prevent injury or damage if an obstruction is present. The photo-eye sensors were tested separately and found to be operational. We recommend that the garage door opener be adjusted, repaired, or replaced as necessary to restore proper function of the automatic reverse mechanism. A qualified garage door service technician should evaluate and correct this condition for improved safety. (See Illustration 3V) (See Photo 23)

- ! 1. The automatic reverse safety feature of the garage door opener did not activate when the door made contact with a 2x2-inch block placed under the center of the door during testing. This feature is an important safety requirement designed to prevent injury or damage if an obstruction is present. The photo-eye sensors were tested separately and found to be operational. We recommend that the garage door opener be adjusted, repaired, or replaced as necessary to restore proper function of the automatic reverse mechanism. A qualified garage door service technician should evaluate and correct this condition for improved safety. (See Illustration 3V) (See Photo 23)

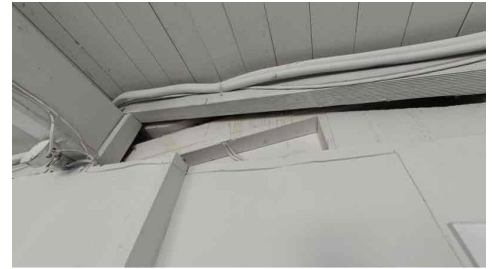
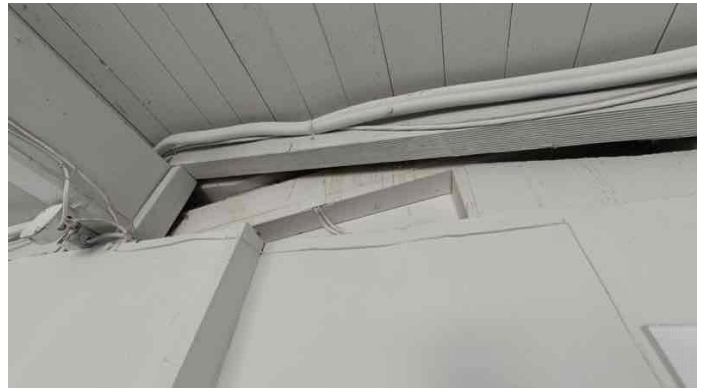
Photo 20

4. Damaged, open or missing wall and/or ceiling finishes of attached garages should be repaired and sealed where they abut the interior of a house. This reduces the potential of toxic automobile gases entering the house and serves as a fire break. Current standards require all walls/ceilings common to the finished living spaces be covered with 5/8" fire resistant sheetrock double taped at all seams. (See Illustration 3A) (See Photo 20)

- ! 2. Damaged, open or missing wall and/or ceiling finishes of attached garages should be repaired and sealed where they abut the interior of a house. This reduces the potential of toxic automobile gases entering the house and serves as a fire break. Current standards require all walls/ceilings common to the finished living spaces be covered with 5/8" fire resistant sheetrock double taped at all seams. (See Illustration 3A) (See Photo 20)

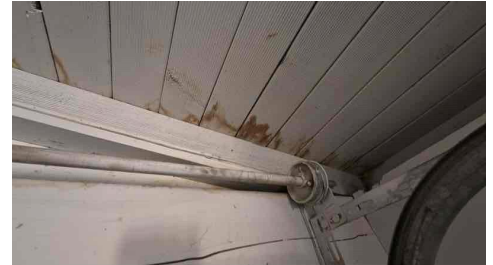
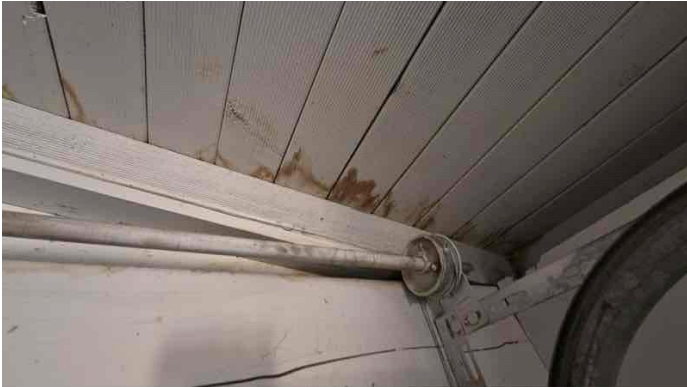
Photo 17

5. Water stains were noted on the ceiling of the garage. This is usually an indication of past plumbing or roof leaks. This area should be further evaluated by the appropriate trades. (See Photo 17)

- ! 3. Water stains were noted on the ceiling of the garage. This is usually an indication of past plumbing or roof leaks. This area should be further evaluated by the appropriate trades. (See Photo 17)

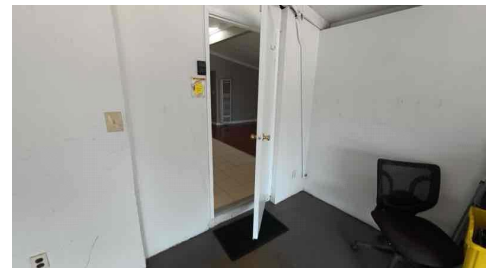
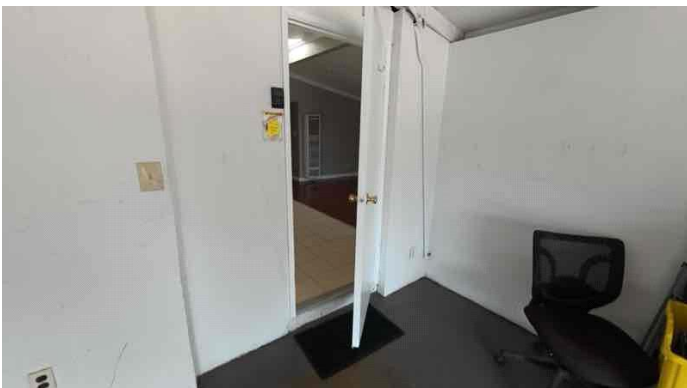
Photo 21

6. The door between the garage and the house did not have an automatic closing mechanism. The door between the garage and the interior of the house should be fitted with an automatic closing mechanism. This will reduce the potential of toxic automobile gases entering the house and serves as a fire break. (See Illustration 3G) (See Photo 21)

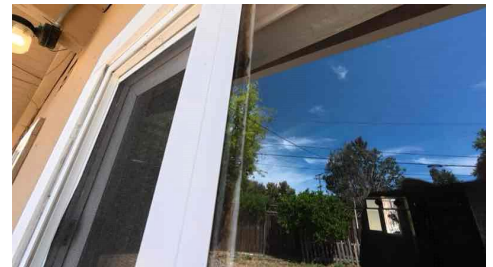
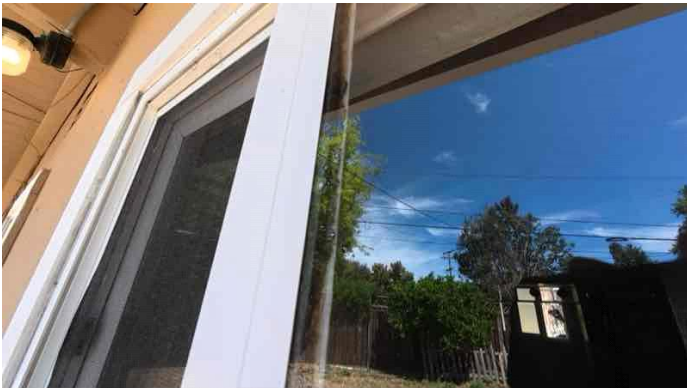
Photo 11

7. Cracked or broken exterior window glass at the primary bathroom should be replaced. (See Photo 11)

! 23. Cracked or broken exterior window glass at the primary bathroom should be replaced. (See Photo 11)

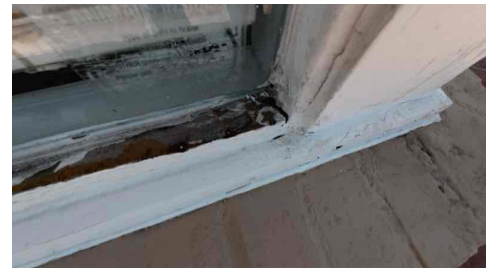
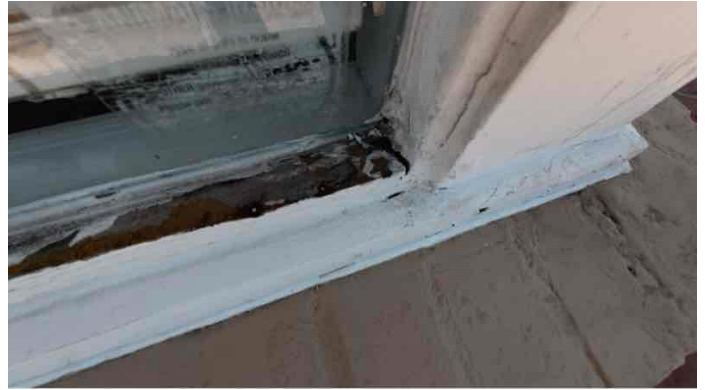
Photo 16

8. The window at the front right wall shows evidence of water damage to the sill/jamb. We recommend the advice and services of a general contractor and/or structural pest control company regarding repairs. (See Photo 16)

- ! 5. The window at the front right wall shows evidence of water damage to the sill/jamb. We recommend the advice and services of a general contractor and/or structural pest control company regarding repairs. (See Photo 16)

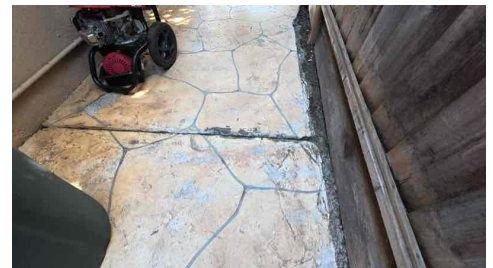
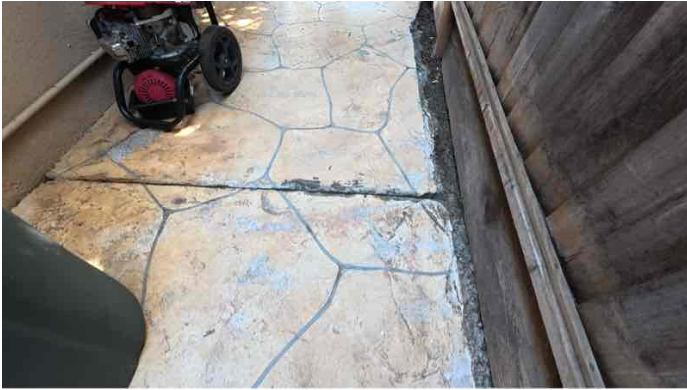
Photo 15

9. The cracked, heaved, or uneven walkway sections at the left side pose a potential trip hazard. We recommend corrective action to improve safety and reduce the risk of injury. A qualified contractor should assess the affected areas and perform necessary repairs to ensure a level walking surface. (See Photo 15)

- ! 6. The cracked, heaved, or uneven walkway sections at the left side pose a potential trip hazard. We recommend corrective action to improve safety and reduce the risk of injury. A qualified contractor should assess the affected areas and perform necessary repairs to ensure a level walking surface. (See Photo 15)

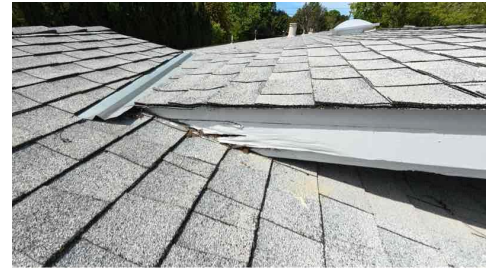
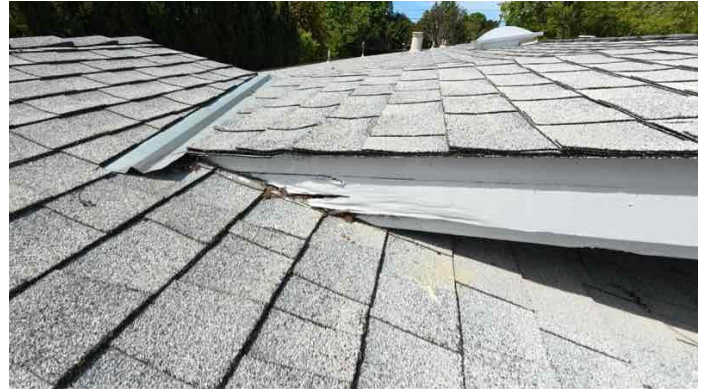
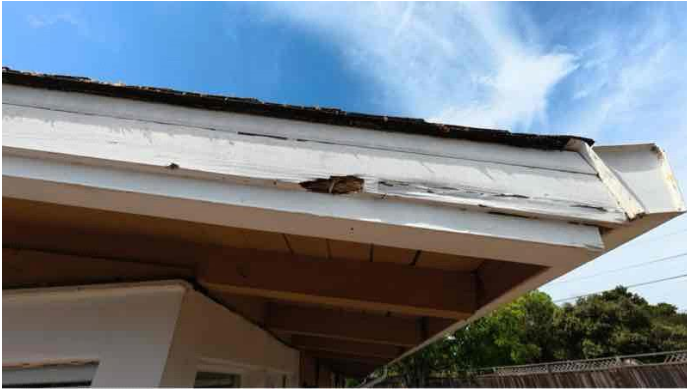
Photo 02

Exterior

- ! 7. Water damage was observed to the rafters at the front and various areas. We recommend the services of a licensed general contractor and/or structural pest control company. (See Photo 2) (See Photo 7)

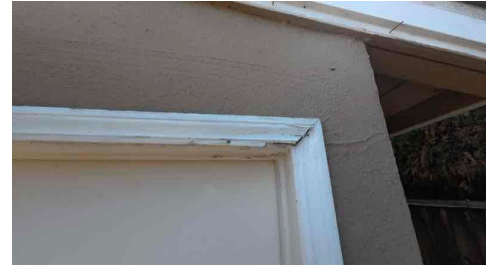
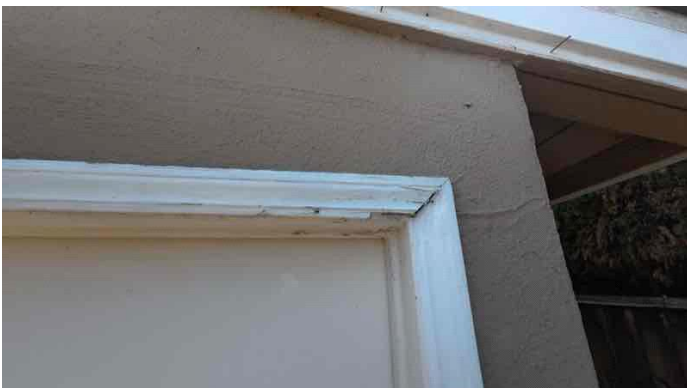
Photo 13

11. Water damage was observed to the exterior trim at the rear garage door. We recommend the services of a licensed general contractor and/or structural pest control company. (See Photo 13)

- ! 8. Water damage was observed to the exterior trim at the rear garage door. We recommend the services of a licensed general contractor and/or structural pest control company. (See Photo 13)

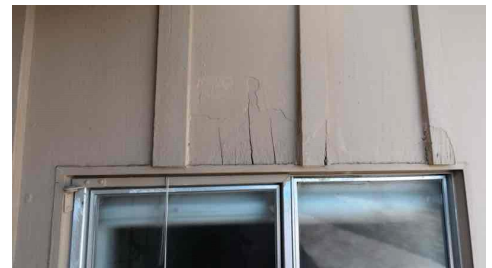
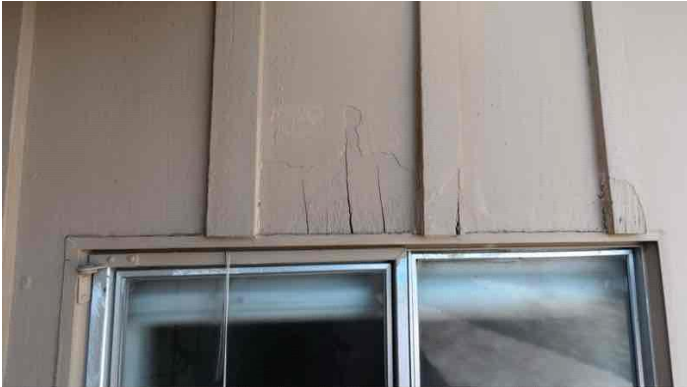
Photo 09

12. Damaged or cracked siding was noted at the front right side exterior wall. We recommend the services of a licensed general contractor. (See Photo 9)

- ! 9. Damaged or cracked siding was noted at the front right side exterior wall. We recommend the services of a licensed general contractor. (See Photo 9)

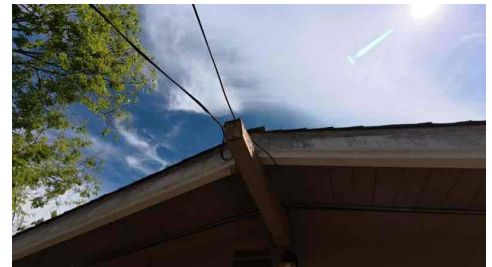
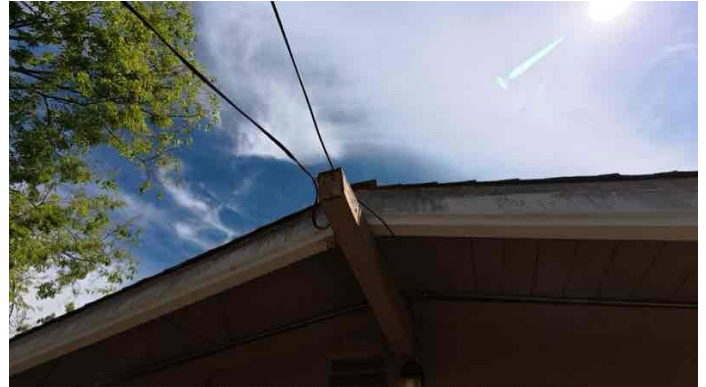
Photo 10

13. Water damage was observed to the beam ends at the rear. We recommend the services of a licensed general contractor and/or structural pest control company. (See Photo 10)

- ! 10. Water damage was observed to the beam ends at the rear. We recommend the services of a licensed general contractor and/or structural pest control company. (See Photo 10)

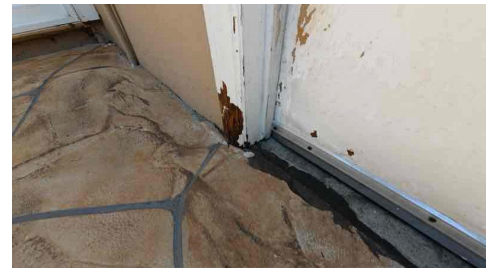
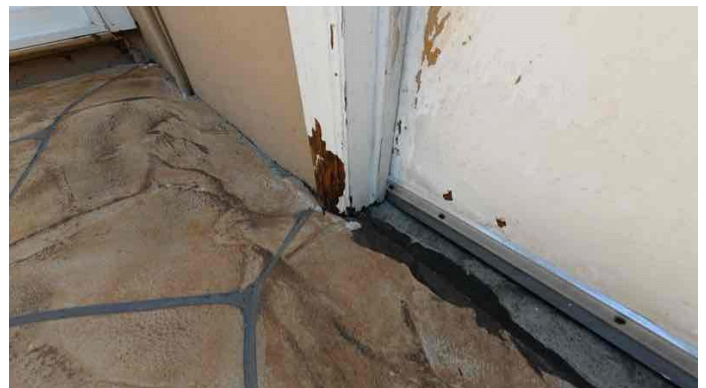
Photo 14

14. Water damage was noted at the rear garage door jamb. We recommend the services of a licensed general contractor and/or structural pest control company. (See Photo 14)

- ! 11. Water damage was noted at the rear garage door jamb. We recommend the services of a licensed general contractor and/or structural pest control company. (See Photo 14)

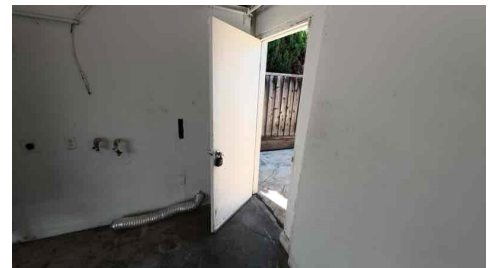
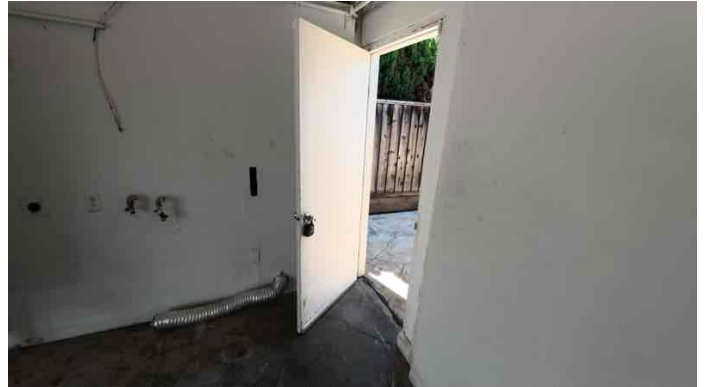
Photo 18

15. The exterior door at the rear of the garage is not a solid core exterior grade. Although the door may be functional, we recommend replacing the door for security reasons. Hollow core or interior grade doors do not meet this requirement. (See Illustration 3W) (See Photo 18)

- ! 12. The exterior door at the rear of the garage is not a solid core exterior grade. Although the door may be functional, we recommend replacing the door for security reasons. Hollow core or interior grade doors do not meet this requirement. (See Illustration 3W) (See Photo 18)

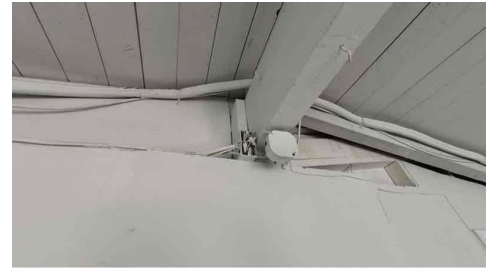
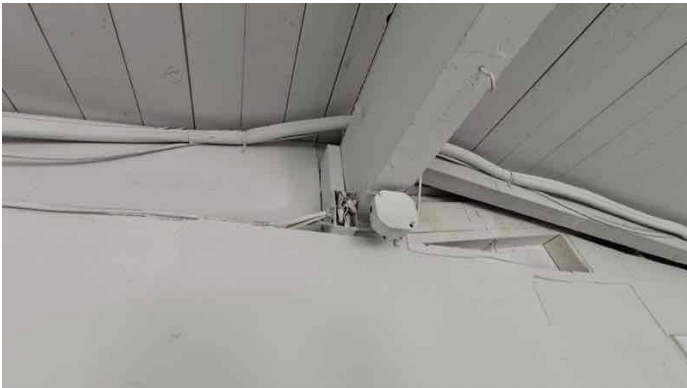
Photo 19

16. Exposed electric connections or open junction boxes at the garage should be corrected. All electric connections should be made inside approved junction boxes fitted with proper cover plates. (See Photo 19)

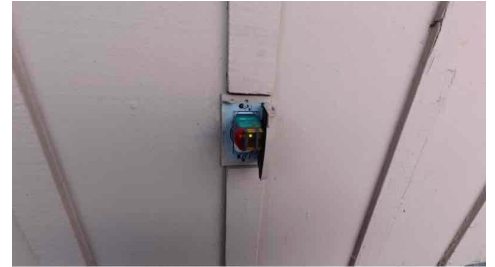
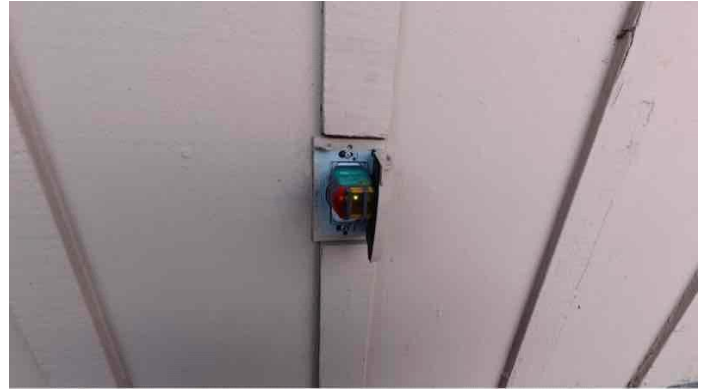
Photo 08

17. Ungrounded "3-prong" outlets should be improved. A grounded cable or ground wire could be installed at these outlets, the outlet labeled as ungrounded or the original "2-prong" receptacle could be replaced. Based upon our inspection of a representative number of outlets, we recommend testing of every outlet. Repairs or rewiring are recommended at all deficient locations. For additional information we recommend a licensed electrician be consulted. (See Illustration 4O) (See Photo 8)

- ! 2. Ungrounded "3-prong" outlets should be improved. A grounded cable or ground wire could be installed at these outlets, the outlet labeled as ungrounded or the original "2-prong" receptacle could be reinstalled. Based upon our inspection of a representative number of outlets, we recommend testing of every outlet. Repairs or rewiring are recommended at all deficient locations. For additional information we recommend a licensed electrician be consulted. (See Illustration 4O) (See Photo 8)

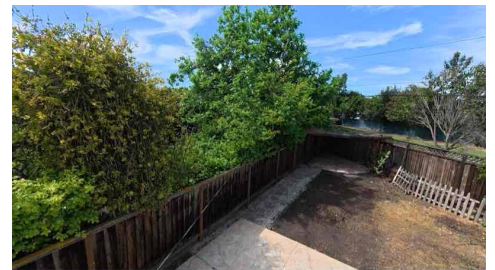
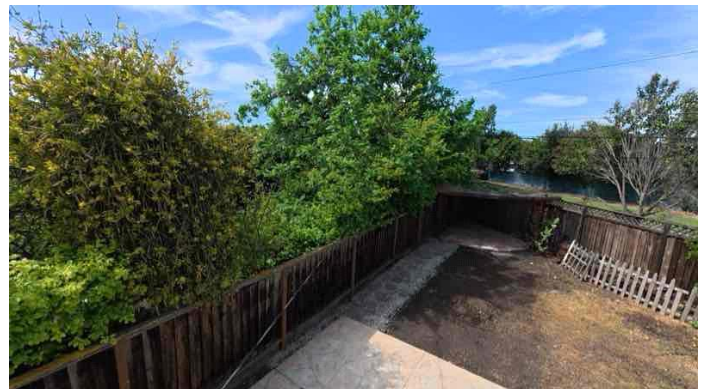
Photo 06

18. Tree limbs should be cut back from the electrical service entrance wires. This work should be done by or coordinated with the utility provider. (See Photo 6)

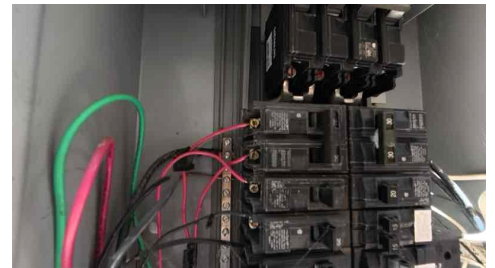
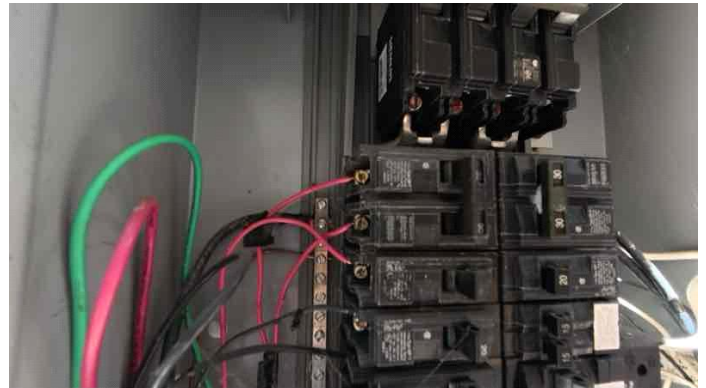
Photo 12

20. Improper wiring and/or circuitry for the main panel at the 30 amp breaker was noted. The wiring does not match the amperage rating of the panel circuitry. We recommend the wiring and circuitry be further evaluated and corrected as necessary. (See Photo 12)

- ! 5. Improper wiring and/or circuitry for the main panel at the 30 amp breaker was noted. The wiring does not match the amperage rating of the panel circuitry. We recommend the wiring and circuitry be further evaluated and corrected as necessary. (See Photo 12)

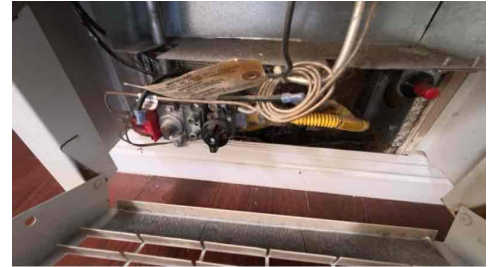
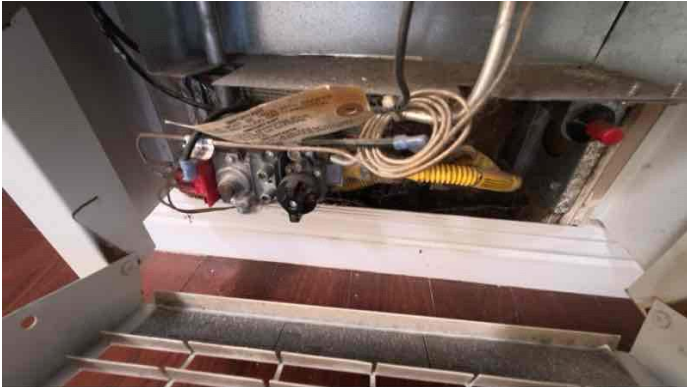
Photo 25

22. The wall heaters energy source was shut off and the system was not operational at the time of our inspection. We cannot offer opinions about system performance or general state or repair. We recommend inspection by a licensed HVAC contractor when service has been restored. (See Photo 25)

The wall heaters energy source was shut off and the system was not operational at the time of our inspection. We cannot offer opinions about system performance or general state or repair. We recommend inspection by a licensed HVAC contractor when service has been restored. (See Photo 25)

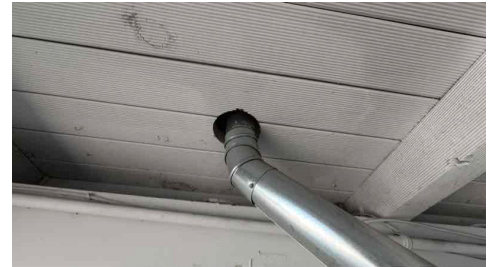
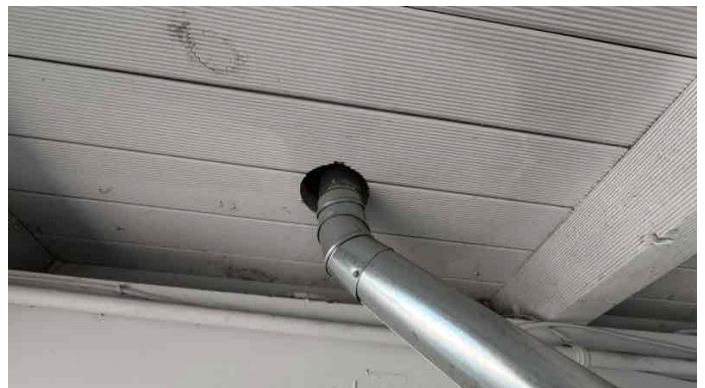
Photo 22

23. There is insufficient clearance between the water heater exhaust flue and combustible materials. This condition should be corrected. (See Illustration 8C) (See Photo 22)

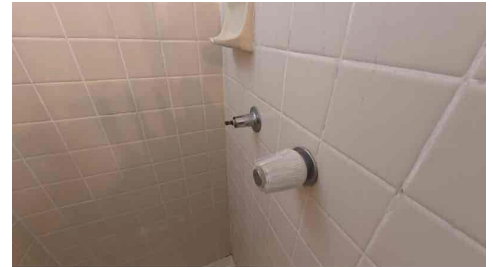
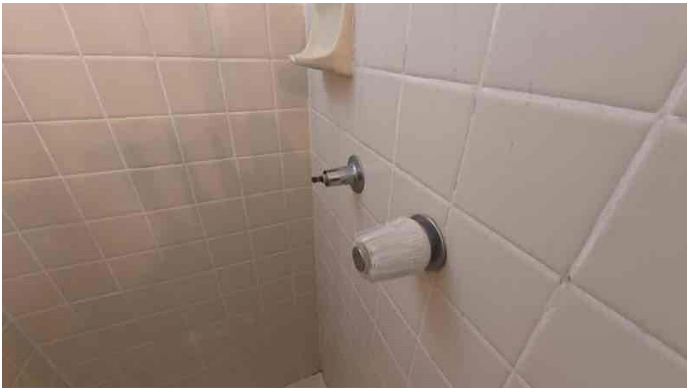
Photo 27

24. The faucet handles at the primary bathroom stall shower are damaged or missing. We recommend the handles be repaired or replaced for full use of the faucet. (See Photo 27)

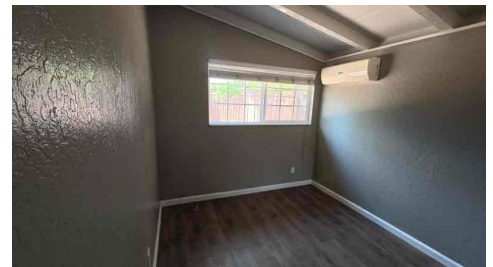
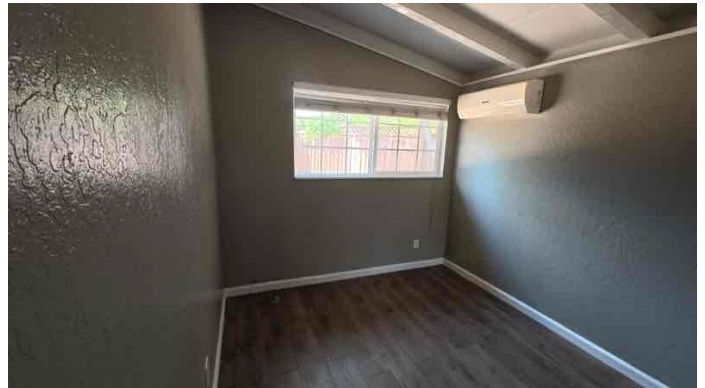
Photo 28

25. The height or size of the window in the rear right bedroom does not conform to proper standards for egress. We recommend contacting the local building department to confirm if this installation conforms to specifications for escape openings in bedrooms. (See Photo 28)

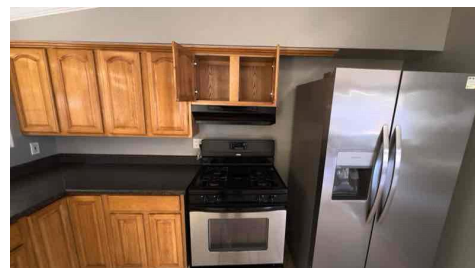
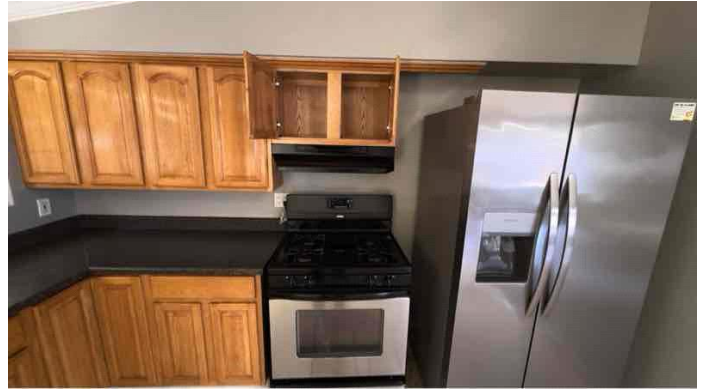
Photo 24

26. There is no "exterior vented" exhaust fan for the gas appliances installed in the kitchen. It is recommended that all gas appliances be vented to the exterior.
(See Photo 24)

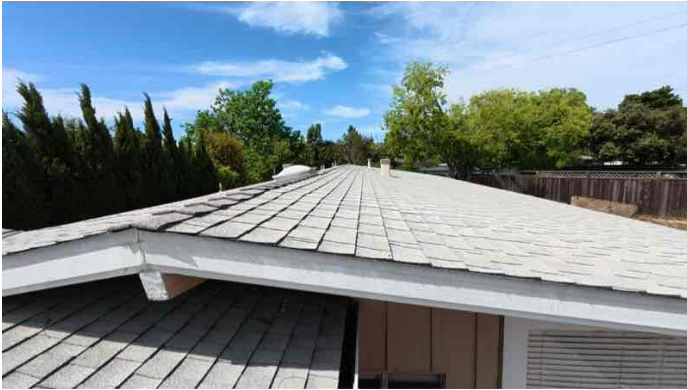
Photo 01

3. The visible roof sheathing is sagging in some areas. We recommend this condition be further evaluated by a licensed general contractor. (See Photo 1)
