HOME INSPECTION REPORT

2767 Winchester Drive, Hayward

671100

February 13, 2026

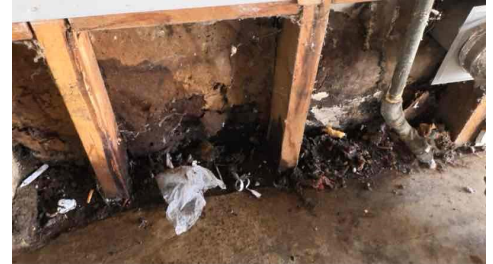
Photo 18

1. The wall framing and sheathing of the garage shows evidence of water damage. We recommend the advice and services of a licensed structural pest control operator. (See Photo 18)

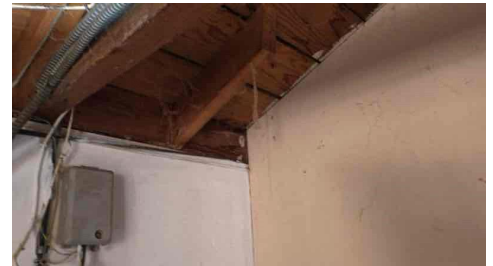
Photo 26

2. Water stains were evident in the garage and attic. This could indicate leakage through the roof covering. We recommend the services of a licensed roofing contractor to further evaluate this condition. (See Photo 26)

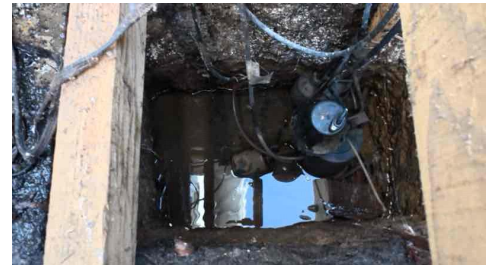
Photo 07

3. Both water sump pumps installed at the right exterior and basement to remove occasional water was inoperable or would not function properly at the time of our inspection. We recommend the pump be repaired or replaced. (See Photo 7) (See Photo 35)

Sellers had a general contractor tested the sump pumps, and they turned on and are working in late Feb. 2026.

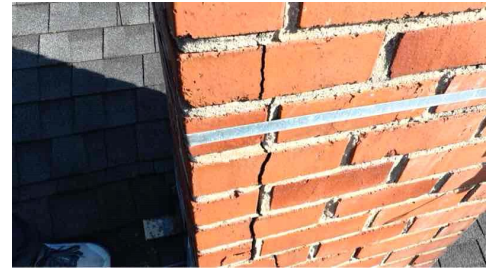
Photo 04

4. There is a large crack at the back of the chimney. This condition may indicate movement of the chimney. It is impossible to determine the rate of movement during a one time visit to the property. We recommend the advice of a licensed masonry contractor. (See Photo 4)

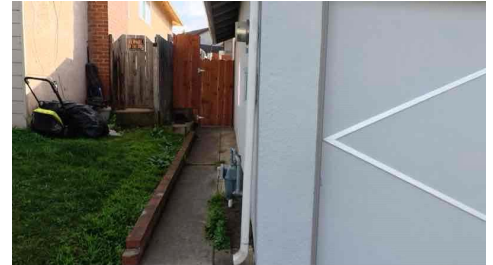
Photo 14

5. Loose downspouts at the front left corner should be repaired or replaced. (See Photo 14)

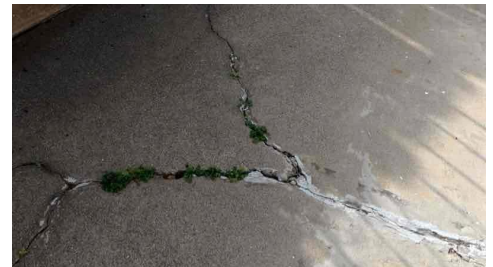
Photo 11

6. The rear patio surface has cracked, heaved, or uneven sections that create a potential trip hazard. We recommend addressing these conditions to improve safety and prevent potential injuries. (See Photo 11)

Sellers sealed the cracks and applied cement paint in last week of Feb. 2026.

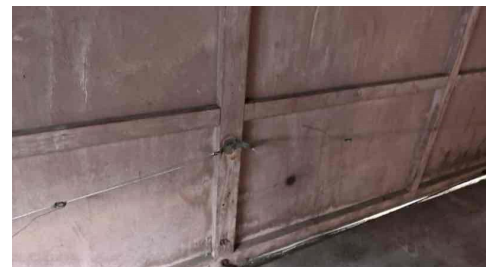
Photo 23

7. Damaged, loose and/or non-functional garage door hardware should be corrected. (See Photo 23)

Sellers had the general contractor adjusted the door and changed the lock.

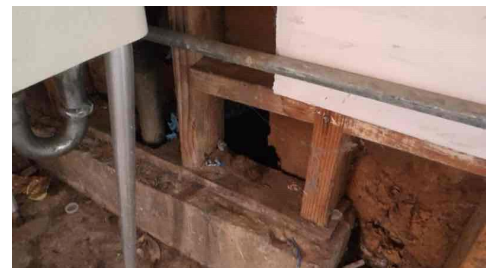
Photo 24

8. Damaged, open or missing wall and/or ceiling finishes of attached garages should be repaired and sealed where they abut the interior of a house. This reduces the potential of toxic automobile gases entering the house and serves as a fire break. Current standards require all walls/ceilings common to the finished living spaces be covered with 5/8" fire resistant sheetrock double taped at all seams. (See Illustration 3A) (See Photo 24)

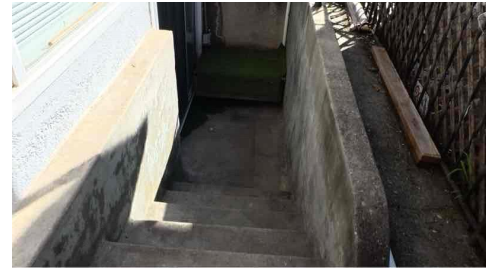
Photo 06

9. For safety purposes, railing(s) should be provided at the rear stairway, right side stairway and walkway. (See Illustration 3J) (See Photo 6)

Seller had a handyman installed the handrail.

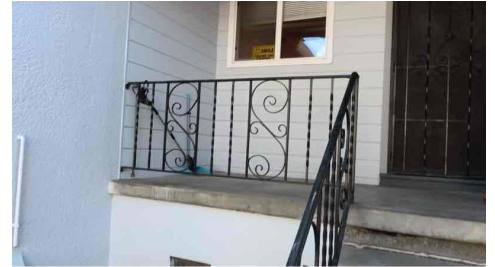
Photo 03

10. The openings in the front stair railings are larger than 4" inches. It is recommended that this be corrected for improved safety. (See Illustration 3N) (See Photo 3)

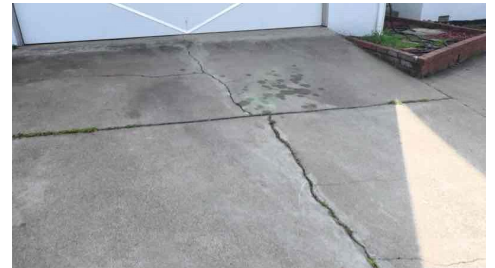
Photo 13

11. The driveway has cracked, heaved, or uneven sections, creating a potential trip hazard. We recommend repairing or resurfacing the affected areas to improve safety and prevent further deterioration. (See Photo 13)

Sellers sealed the cracks and applied cement paint in last week of Feb. 2026.

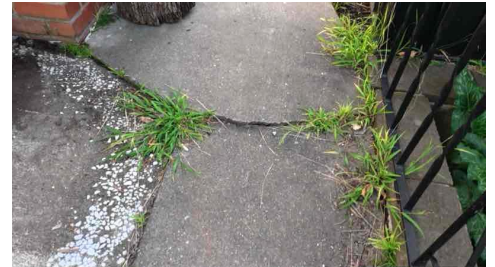
Photo 05

12. The cracked, heaved, or uneven walkway sections at the right side pose a potential trip hazard. We recommend corrective action to improve safety and reduce the risk of injury. A qualified contractor should assess the affected areas and perform necessary repairs to ensure a level walking surface. (See Photo 5)

Sellers sealed the cracks and applied cement paint in last week of Feb. 2026.

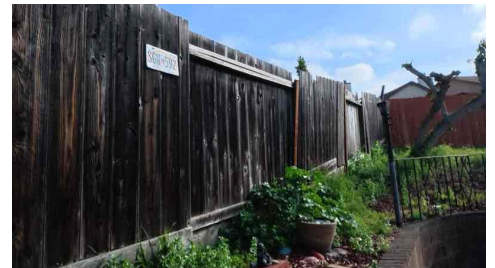
Photo 09

13. The wood fencing at the rear of the property is in need of repairs. (See Photo 9)

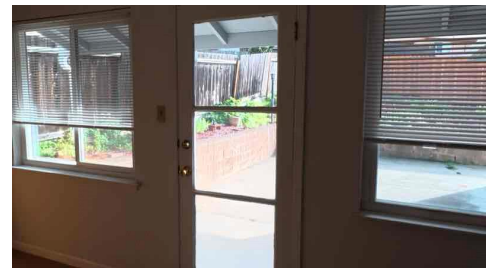
Photo 28

14. The rear patio door was locked at the time of our inspection. Therefore, the door is considered inaccessible and was not inspected. With access and a opportunity for complete inspection, conditions in need of attention may be discovered. (See Photo 28)

The lock was repaired by the general contractor.

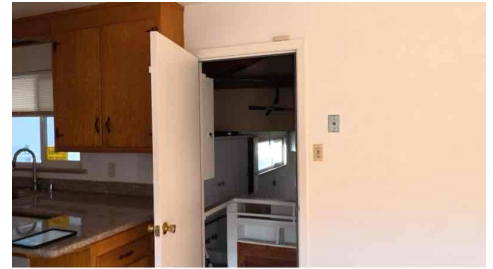
Photo 27

15. The door between the garage and the interior of the house should be a fire rated door as per local codes. Hollow core, windowed or interior grade doors do not meet this requirement. We recommend this door be replaced with a approved door for this location. (See illustration 3K) (See Photo 27)

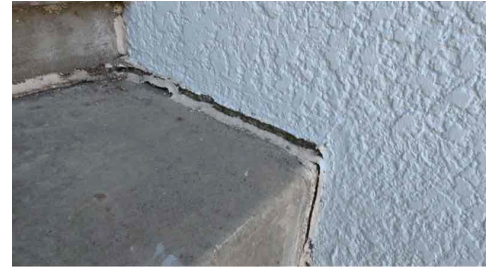
Photo 02

16. The front stairway has settled relative to the house proper. While still functional they should be monitored for further settlement. Exterior caulking at the edge of the porch/patio will help to limit moisture intrusion to the area where it abuts the building. For additional information we recommend a licensed soils and drainage contractor or engineer be consulted. (See Photo 2)

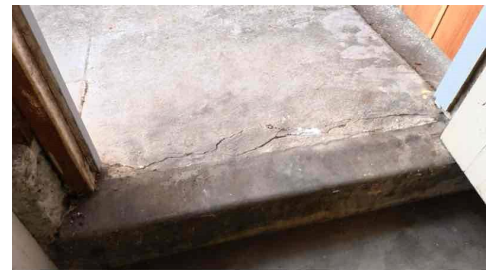
Photo 20

17. A missing threshold was noted at the garage side door. We recommend the installation of a threshold that conforms to present building standards. This will also help to avoid possible trip hazards and limit moisture intrusion. (See Photo 20)

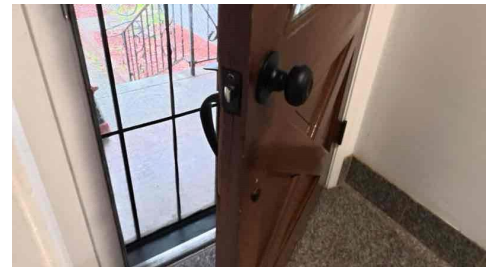
Photo 34

18. The front door is cracked or split. We recommend it be repaired or replaced. (See Photo 34)

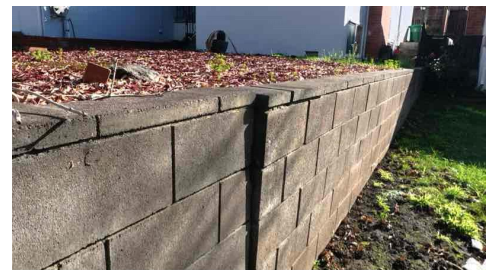
Photo 01

19. The retaining wall at the front right and rear shows evidence of movement. It is impossible to determine the rate of movement during a one time visit to the property. We recommend further evaluation by the appropriate trades for any recommendation deemed necessary to prevent further movement. (See Photo 1) (See Photo 10)

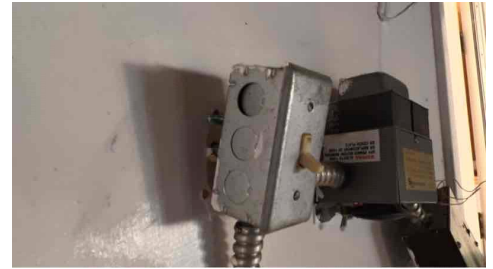
Photo 25

20. The switch housing at the garage is loose. Based upon our inspection of a representative number of outlets we recommend testing of every outlet. All loose outlets and receptacles should be repaired as necessary. (See Photo 25)

The general contractor fixed the loose switch.

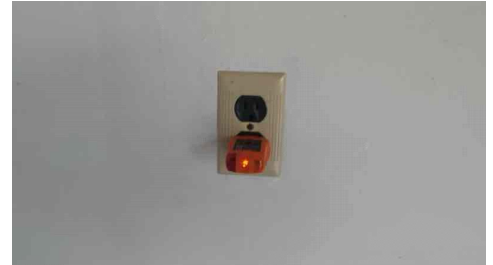
Photo 17

21. Ungrounded "3-prong" outlets at multiple locations should be improved. A grounded cable or ground wire could be installed at these outlets, the outlet labeled as ungrounded or the original "2-prong" receptacle could be reinstalled. Based upon our inspection of a representative number of outlets, we recommend testing of every outlet. Repairs or rewiring are recommended at all deficient locations. For additional information we recommend a licensed electrician be consulted. (See Illustration 4O) (See Photo 17)

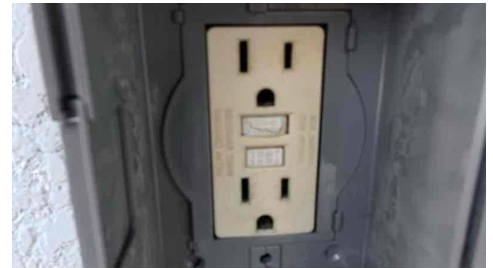
Photo 08

22. A receptacle at the rear patio is damaged. We recommend it be replaced. (See Photo 8)

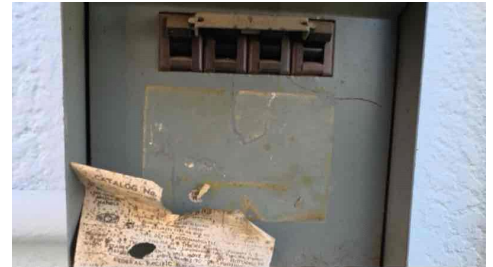
Photo 12

23. The "Federal Pacific" electrical panels (Main & 2 sub) on the property was not fully inspected due to inherent defects that are a potential safety hazard. A visual inspection of the front of the panel and breakers was performed, no covers were removed or internal components inspected. We recommend a licensed electrician be retained for further inspection and recommendations. An electrician is likely to recommend full replacement of this brand of panel. (See Photo 12) (See Photo 15) (See Photo 16)

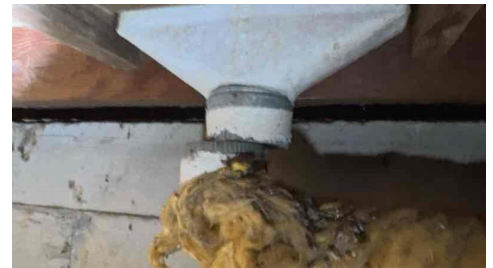
Photo 37

24. One or more sections of HVAC ductwork were observed disconnected at the left side of the crawlspace. Disconnections allow conditioned air to escape and can draw unfiltered air into the system, reducing efficiency and comfort. We recommend a qualified HVAC technician fully evaluate all ductwork, reconnect and properly seal joints, replace damaged sections as needed, and restore secure support and continuous, airtight duct runs throughout. (See Photo 37)

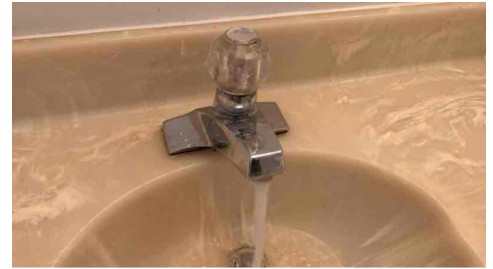
Photo 33

25. The sink faucet is leaking at the hall bathroom. We recommend all leaks be repaired. (See Photo 33)

The general contractor replaced the faucet.

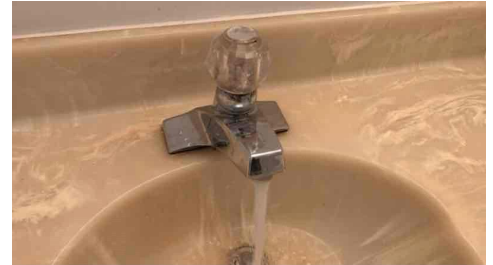
Photo 33

26. The hot water for the sink basin faucet at the hall bathroom was not functioning at the time of our inspection, possibly due to the water being turned off. We recommend the water be turned on and the function of the faucet verified. Repairs or replacement of the faucet is also recommended if found to be not functioning correctly or leaking. (See Photo 33)

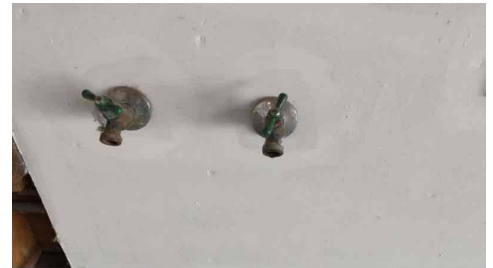
Photo 19

27. The hose bib is leaking at the laundry/garage. We recommend all leaks be repaired. (See Photo 19)

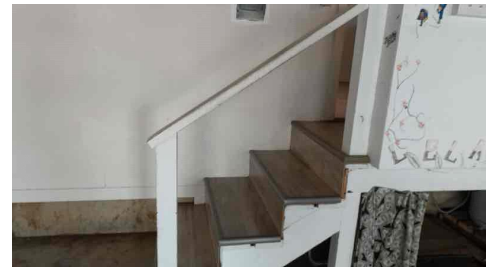
Photo 22

28. The openings in the garage stair railing are larger than 4". For improved safety it is recommended that the railing be altered for an opening of less than 4". (See Illustration 9K) (See Photo 22)

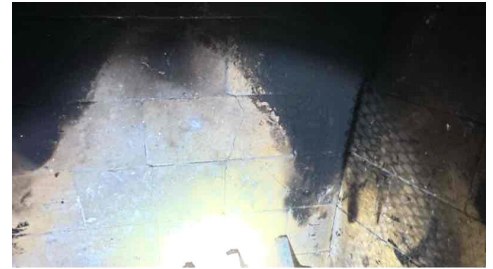
Photo 30

30. The interior of the fireplace firebox should be repaired where the bricks or mortar are cracked. We recommend the advice and servicing of a licensed masonry contractor or fireplace specialist. (See Photo 30)

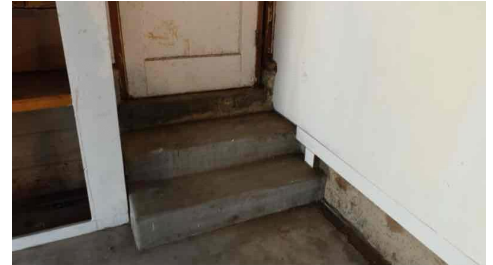
Photo 21

31. There is no railing where needed at the garage. For improved safety, it is recommended that appropriate railing be installed. (See Photo 21)

The sellers had the handyman install the handrail.

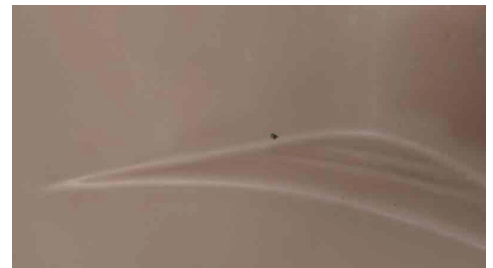
Photo 32

32. The fiberglass shower walls at the master bathroom are chipped. We recommend they be properly repaired or replaced to eliminate any moisture intrusion into these areas. Damage caused by water seepage cannot be determined by this visual inspection. (See Photo 32)

Chip was patched.

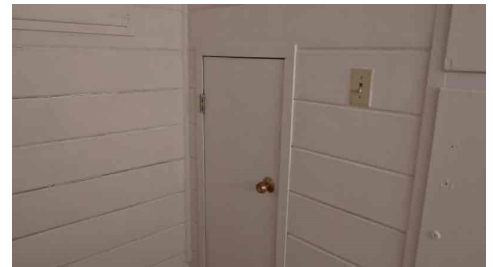
Photo 29

33. The door below the stairway is missing the stops and has loose hinges. We recommend repair of this door. (See Photo 29)

The hinges were tighten.

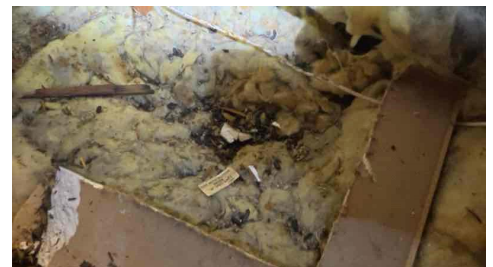
Photo 36

35. Evidence of vermin activity was observed within the attic and crawlspace. It is likely this evidence will extend into inaccessible areas. The owner is advised to contact the appropriate trade for further evaluation and remedial measures if necessary. (See Photo 36)

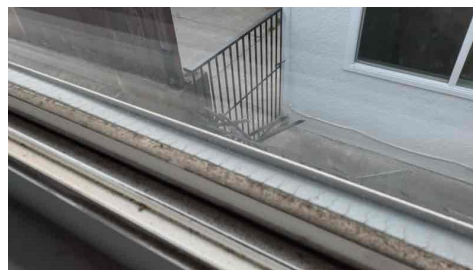
Photo 31

36. Several windows exhibit conditions and/or symptoms that indicate a possible breached seal or failed thermal pane. This has or can result in condensation and/or moisture developing between the panes of glass that will effect the cosmetic appearance of the windows and their insulating performance. We recommend all insulated glass units be further evaluated by a licensed glazier and repaired or replaced as required. (2 Living room, right side center bedroom, right rear bedroom, master bedroom) (See Photo 31)
