Sewer Lateral Inspection Report

2767 Winchester Drive, Hayward

Isaiah Press
February 14, 2026

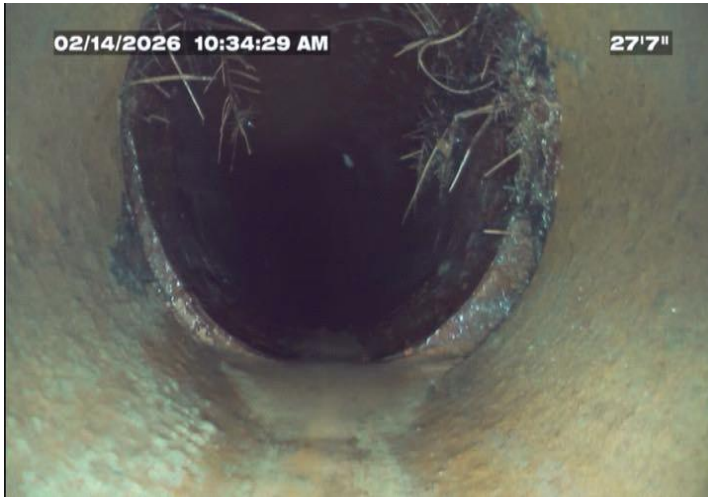
Photo 1

Distance	Code	Remarks	Photo
22 feet	RFJ	roots fine	2
28 feet	RFJ	roots fine	1

1. At 28 and 22 feet, fine root intrusion was noted inside the pipe causing less than 10% obstruction of the pipe.

The sewer lateral has PASSED inspection. Minor defects were noted in one or more segments of pipe. No repairs are currently recommended
