# Talavera Homeowners Association

## Level 2 Reserve Study

**Report Period - 1/1/2022 to 12/31/2022**

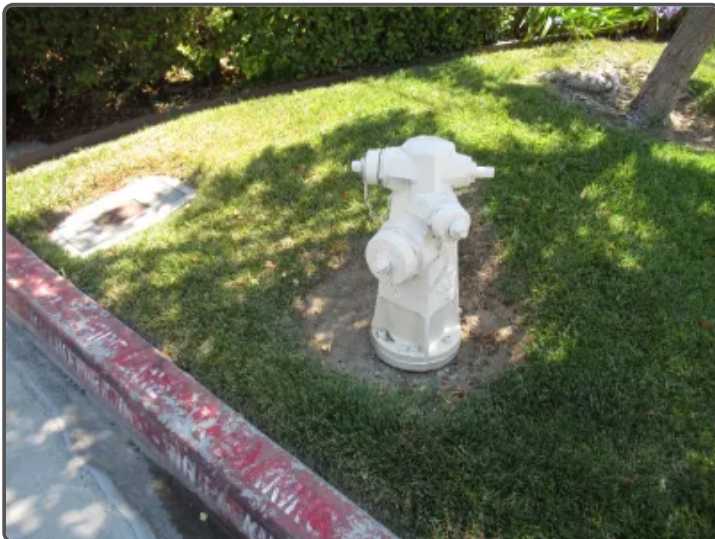
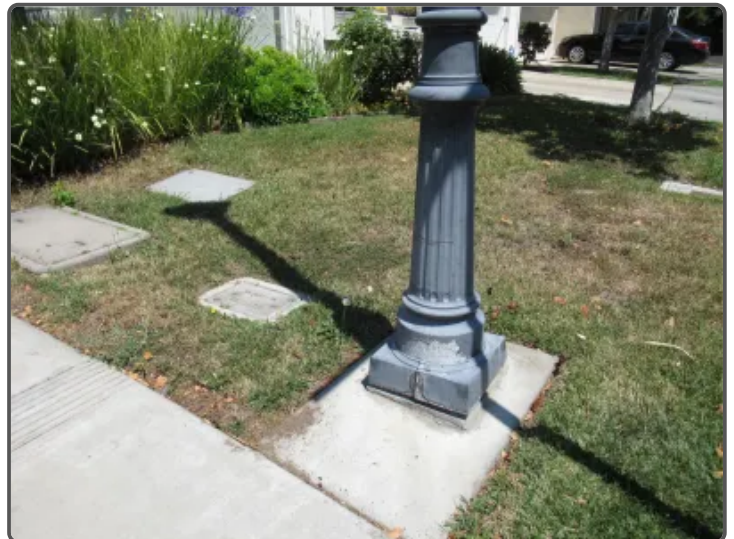
The light poles and fire hydrants were reportedly painted last in 2015. We recommend funding for regular cycles of treatment/sealant to help prevent rust and corrosion approximately every 5 years.

- (12) 15 ft. tall metal light poles
- (6) Fire hydrants

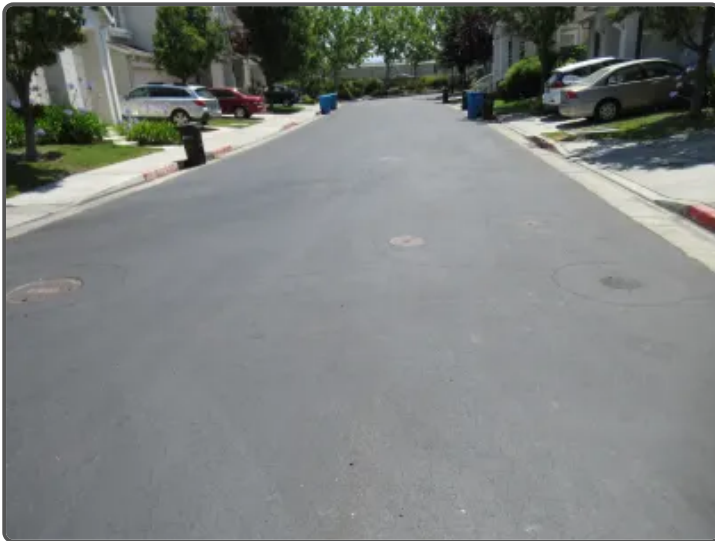
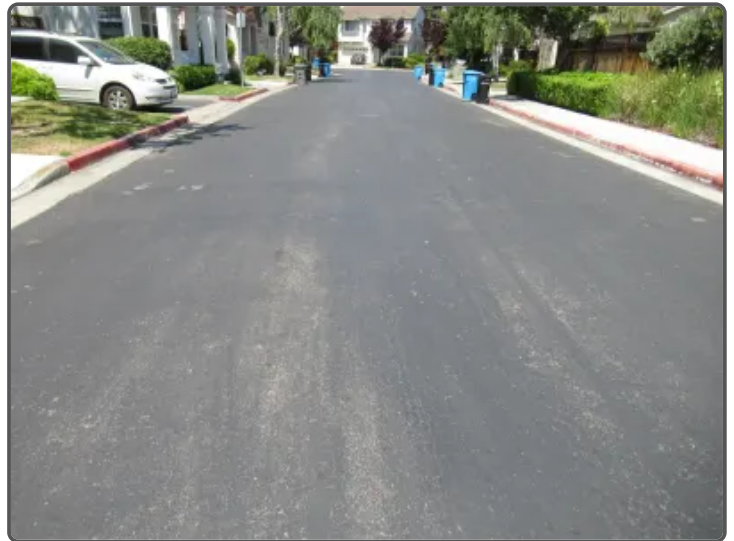
Asphalt surface is generally in fair condition. Noted moderate cracking throughout asphalt surface. With regular sealing and repairs (see Comp# 402 Asphalt - Preventive Maintenance) asphalt surface should reach a typical useful life of approximately 30 years before a major rehabilitation (overlay, R & R, etc.) is necessary.

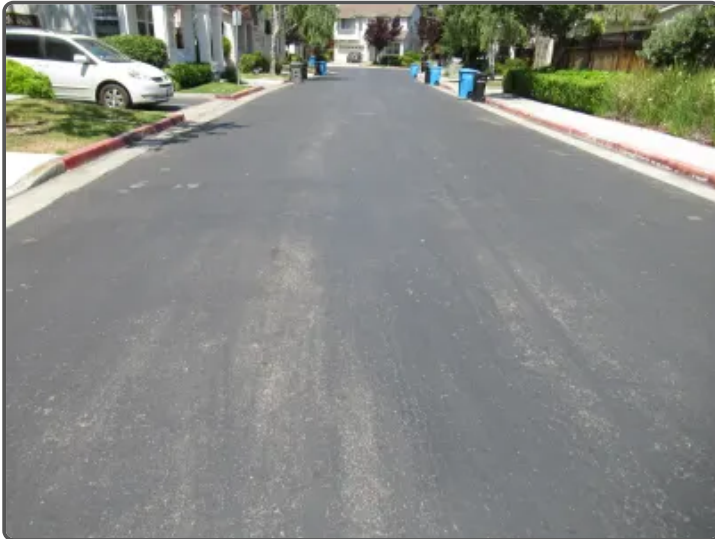
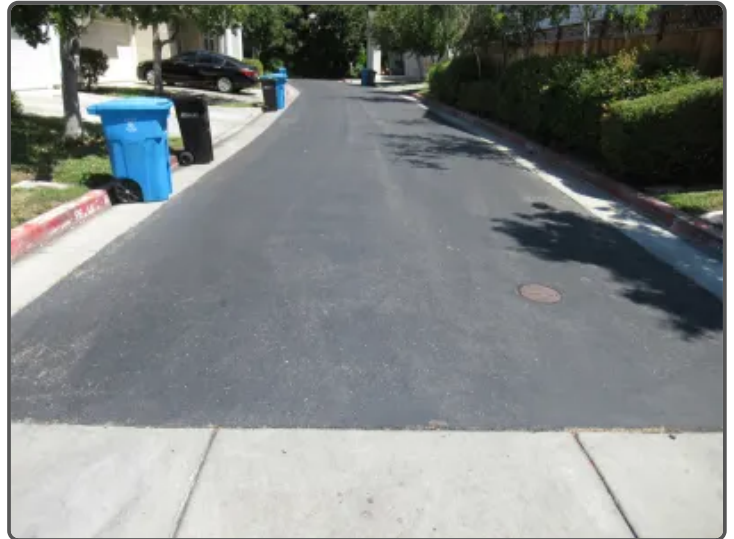
Noted seal loss throughout. Asphalt is generally in fair to poor condition and should be sealed in the near future. Typically asphalt surfaces should be sealed every 3 to 5 years depending on traffic to protect asphalt surface.

42,600 Square ft. of asphalt roadway  
2,330 Linear ft. of red curb  
145 Linear ft. of green curb  
160 Linear ft. white parking stall lines  
30 Linear ft. white crosswalk lines  
(1) Stop stencil

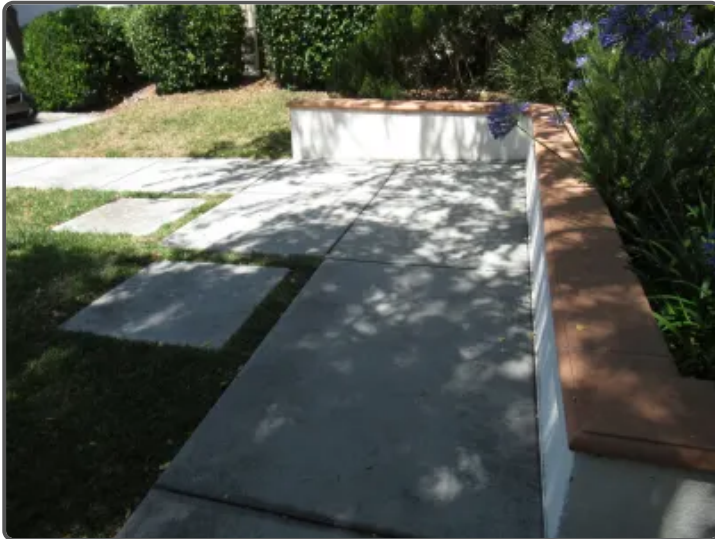
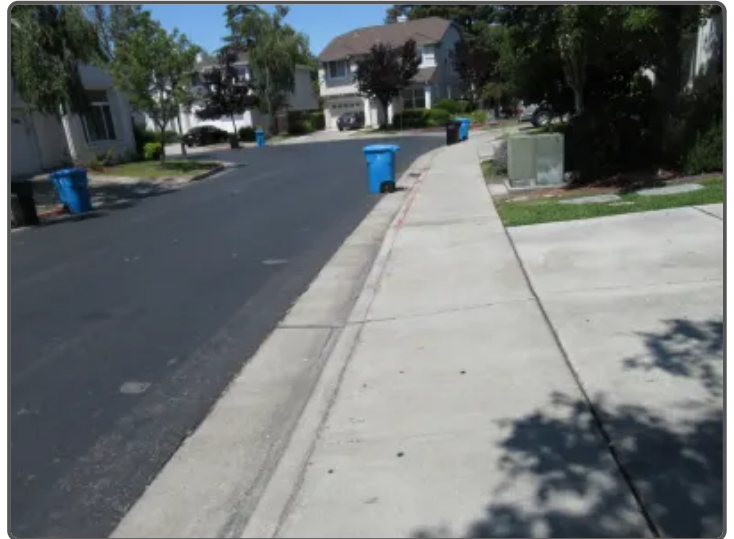
Comp # 403 Concrete - Repair

No expectation to completely replace the concrete surfaces. We recommend making local repairs as necessary as an operating expense and funding to make more significant repairs approximately every 10 years.

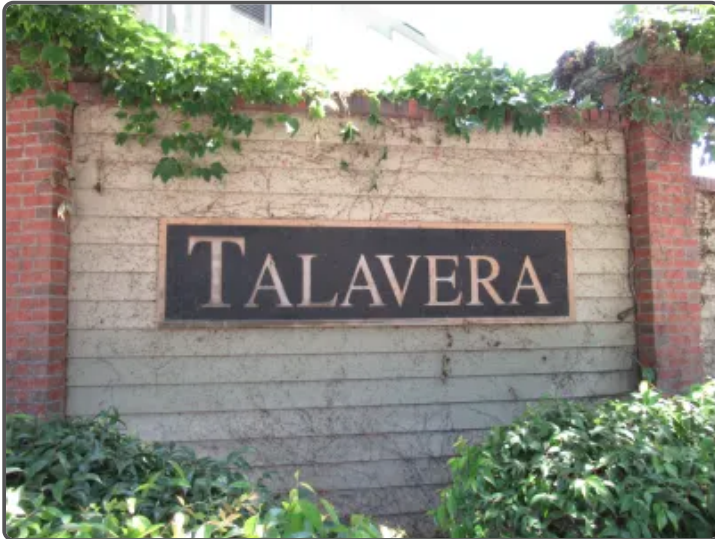
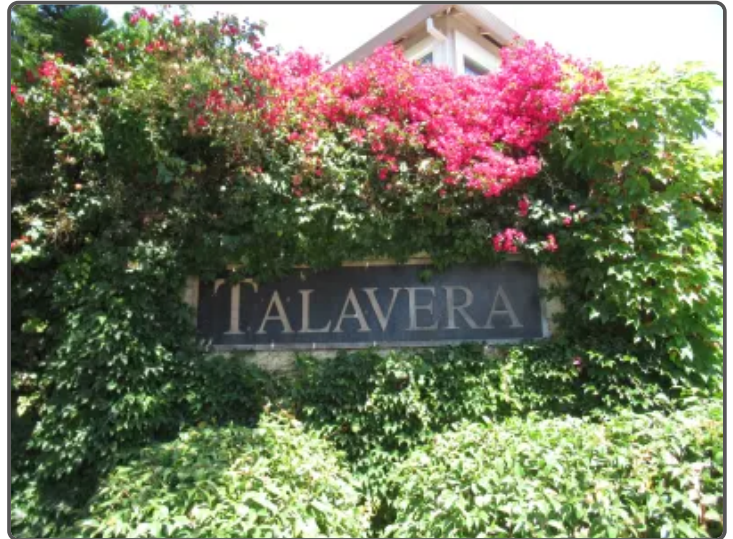
Comp # 801 Entry Monuments/Signs - Replace

Although long lasting material, the metal signage will eventually require replacement. This component has an approximate useful life of 30-40 years. The remaining useful life is based on the installation date.

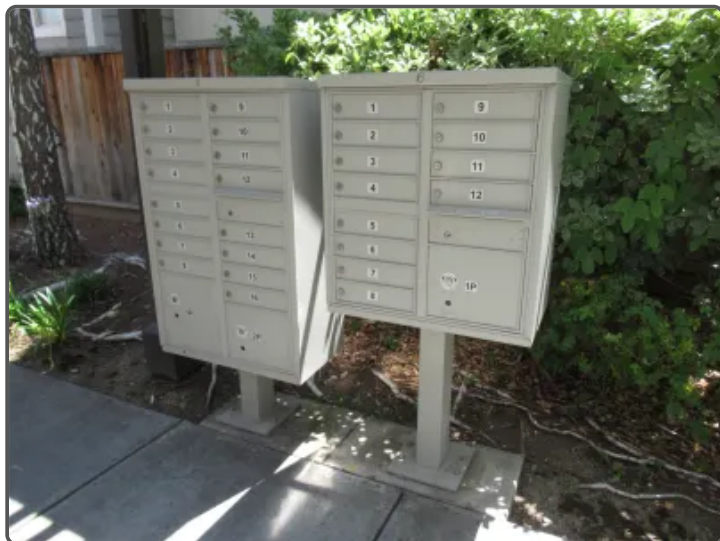
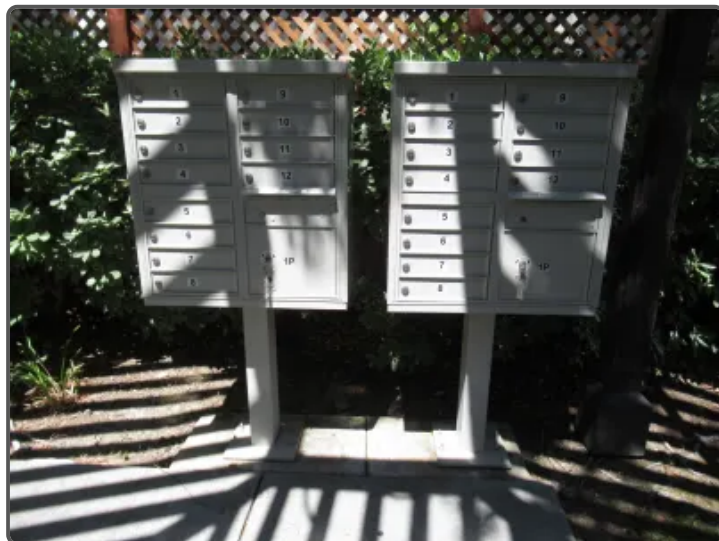
Comp # 803 Mailboxes - Replace

Boxes are in good condition. No signs of significant damage or wear. Expect to replace these mailboxes approximately every 20 to 25 years. Remaining life based on current condition.

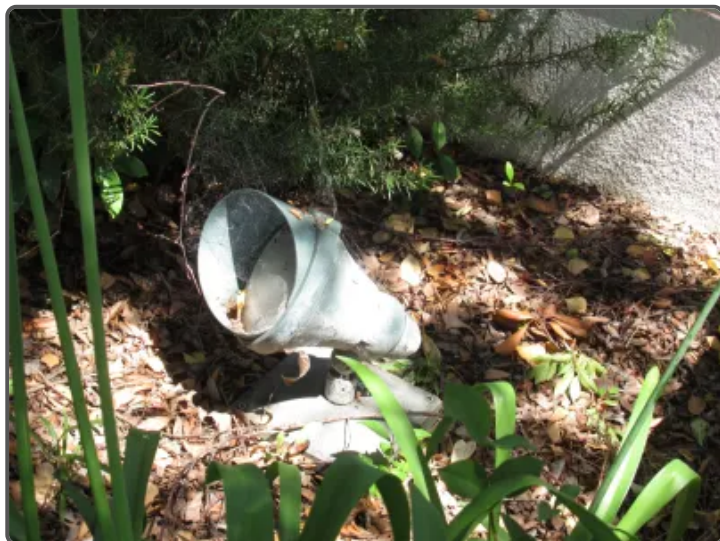
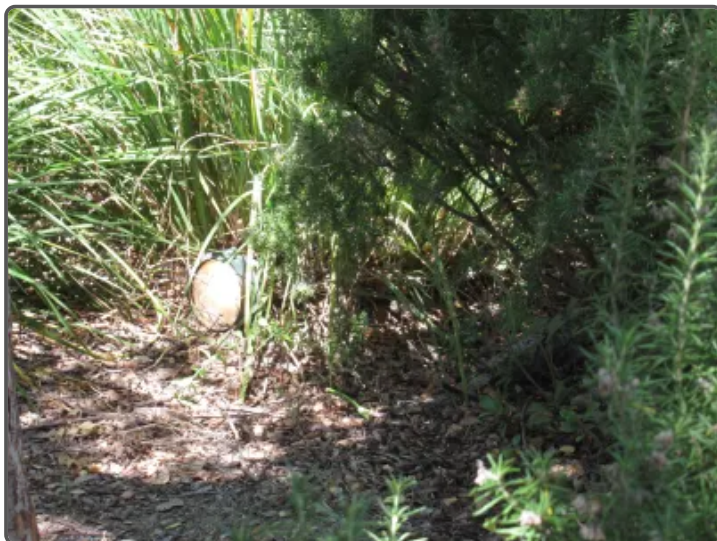
Comp # 1603 Landscaping Lights - Replace

No problems noted or reported. Although these lights may reach an extended life we recommend funding to replace them approximately every 15 to 20 years. Remaining life based on current condition.

- (2) Flood fixtures (courtyard)
- (3) Flood fixtures (mailboxes)
- (2) Flood fixtures (entry signs)

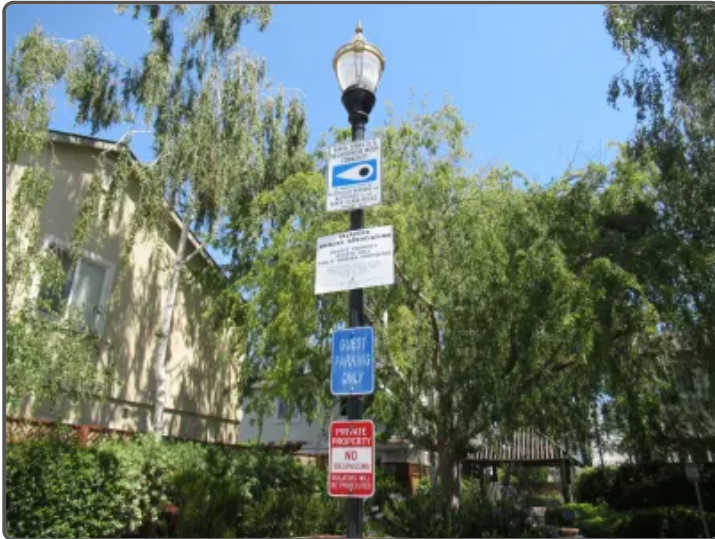
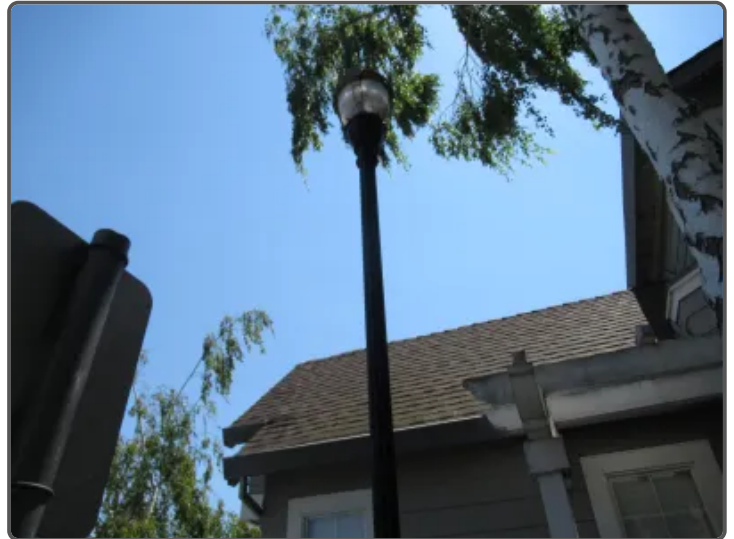
Comp # 1609 Pole Lights - Replace

No problems noted at time of visit. We recommend funding to replace these light poles approximately every 25 to 30 years.

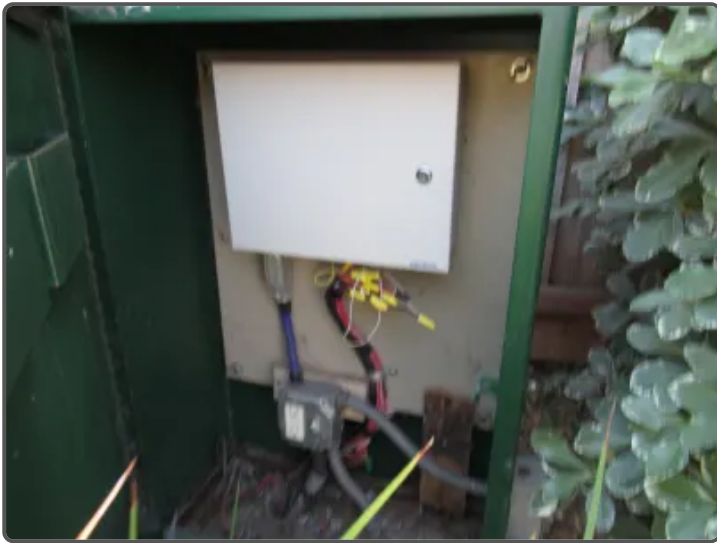
Comp # 1701 Irrigation Controllers - Replace

This component has an approximate useful life of 10 to 15 years. The remaining useful life is based on the assumed age.

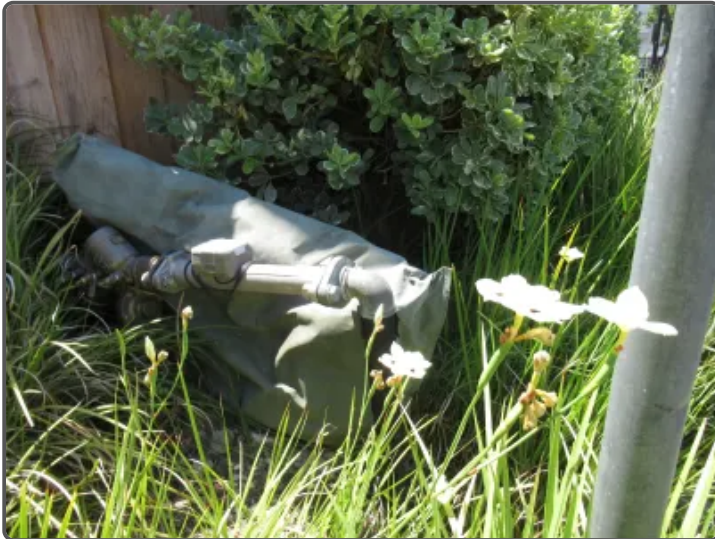
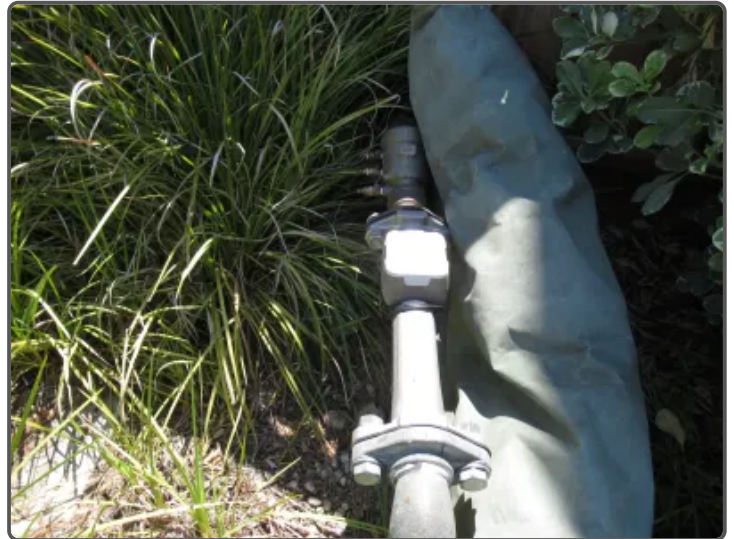
Comp # 1706 Backflow Devices - Replace

No problems noted at time of visit. This component has an approximate useful life of 30 years. The remaining useful life is based on the reported installation date.

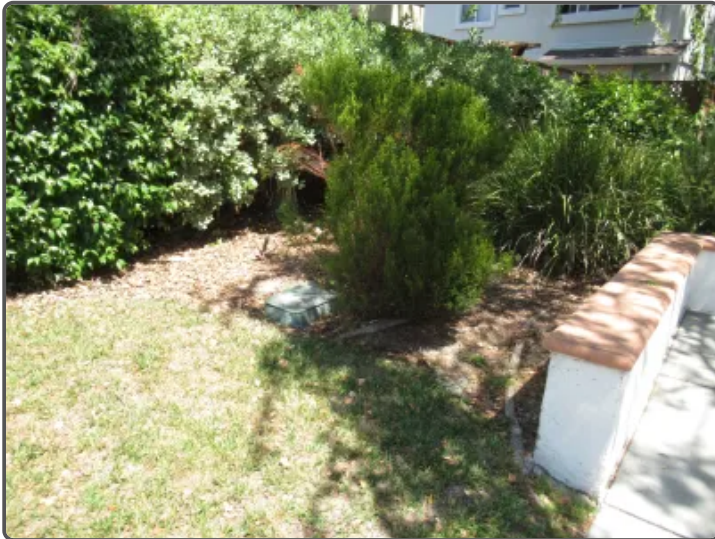
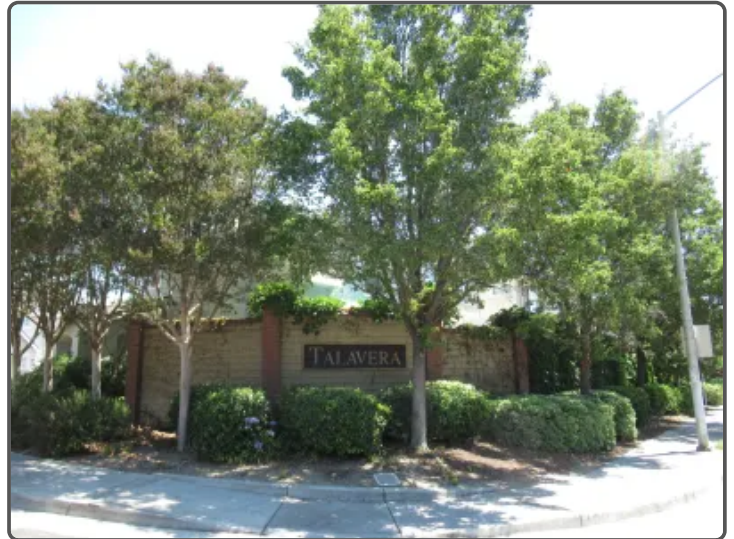
This component represent a reserve allowance for regular cycles of significant upgrades to landscaping outside the typical operating budget costs.

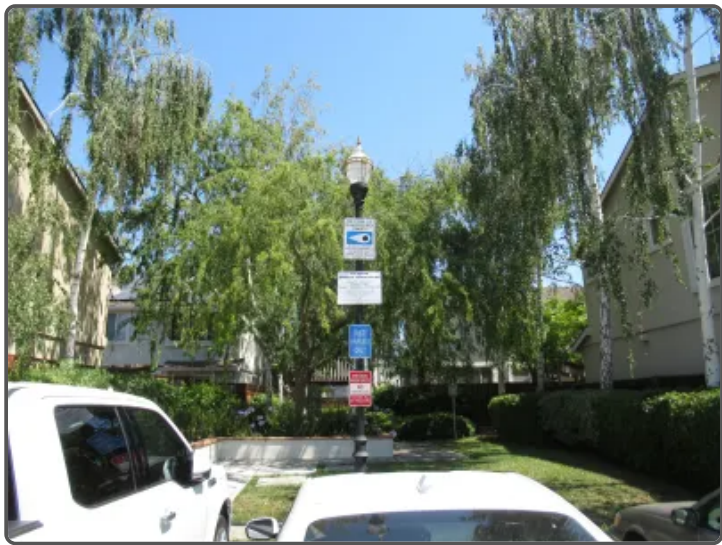
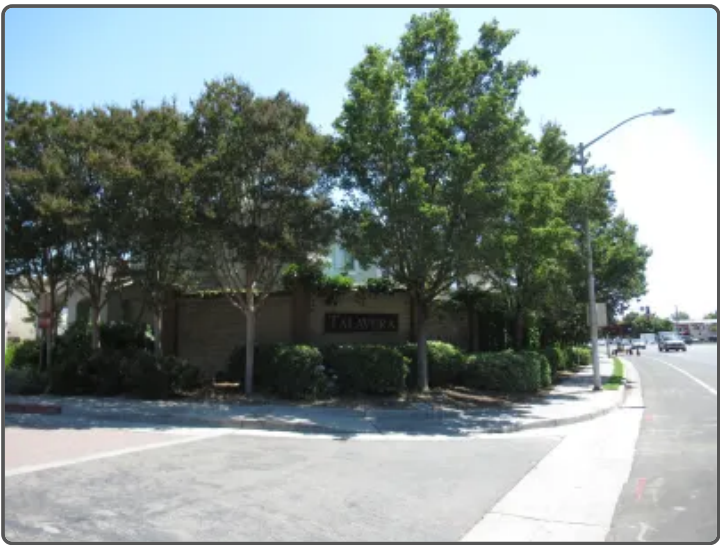
Trees should be trimmed periodically to maintain appearance and to ensure health of the trees.

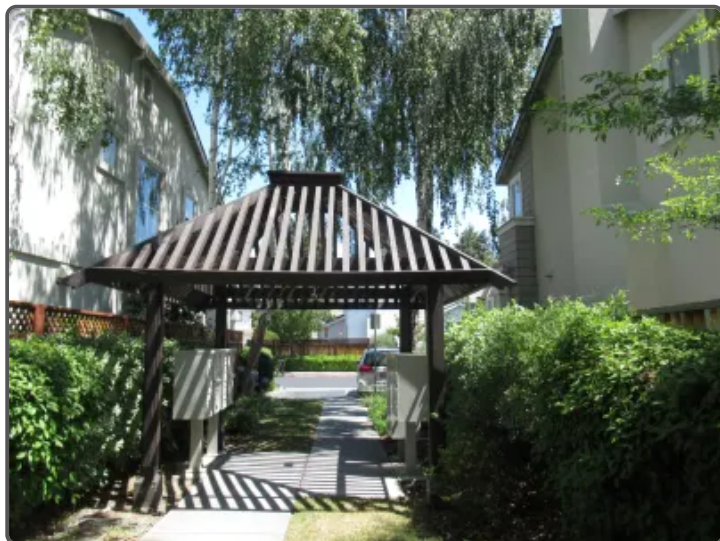
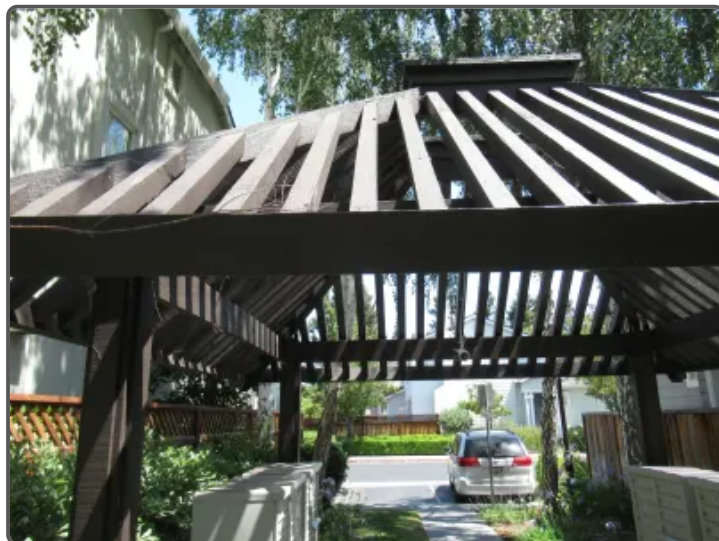
Comp # 2301 Wood Pergola - Replace

Although this component has reached an extended life we recommend funding to replace the pergola in the near future.  
Remaining life based on current age and condition.
