# WOOD DESTROYING PESTS AND ORGANISMS INSPECTION REPORT

Building No. 2222	Street, City, Zip Raspberry Lane, Mountain View, CA 94043	Date of Inspection 04/30/2026	No. of Pages 17
Bluebird Termite 533 Airport Boulevard #400 Burlingame, CA 94010 (650) 440-1130 info@bluebirdtermite.com

Property Address: 2222 Raspberry Lane, Mountain View, CA 94043

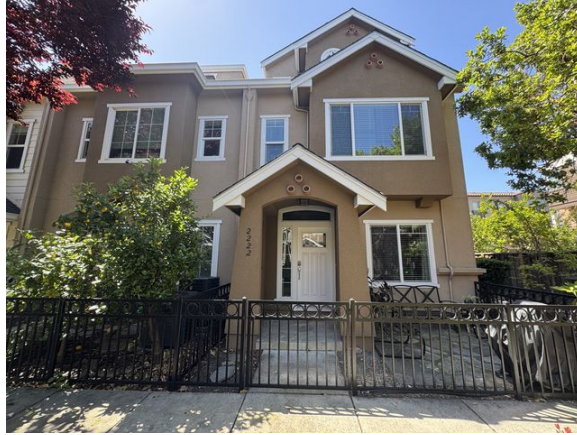
### 1A.

**FINDING:** Evidence of drywood termites were noted in the attic where indicated on the diagram. **Section I item.**

**PRIMARY RECOMMENDATION:** Fumigate the entire structure with sulfuryl fluoride for the eradication of drywood termites.

**SECONDARY RECOMMENDATION:** As the home is attached to or abuts neighboring structures, a secondary, substandard method of controlling the drywood termite infestation is given. Drill a series of holes through the exterior wall to allow for injection of BASF Termidor Foam into the interior cavity of the wall. Upon completion of treatment, we will fill the holes. Owner is to finish walls as desired.

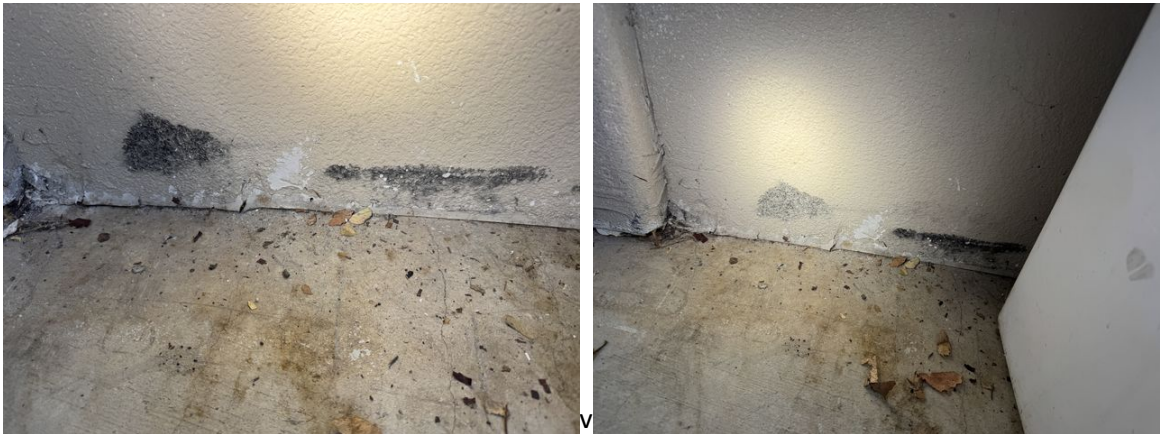
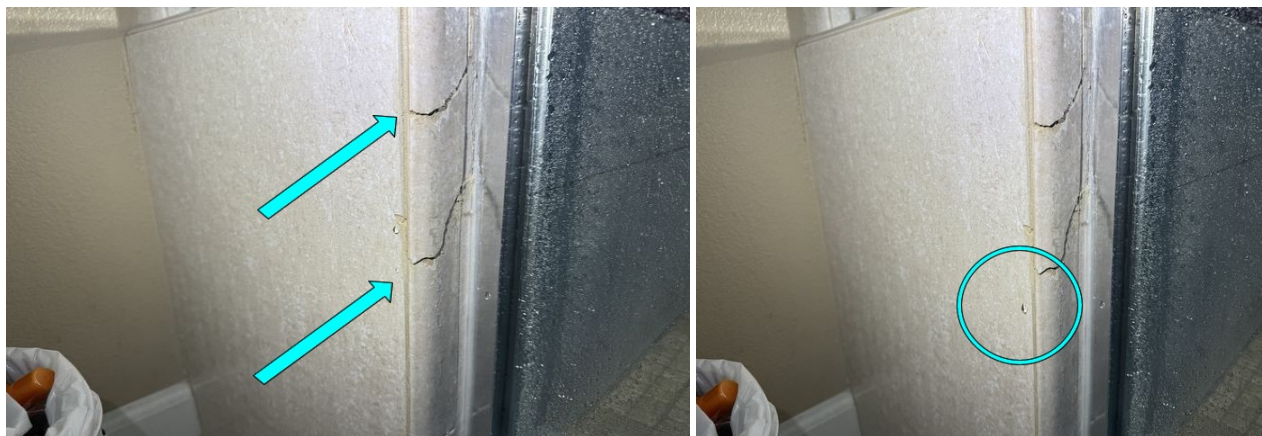
**1E.**

**FINDING:** Water has penetrated the tile wall at the stall shower in the third floor hall bathroom. This has caused moisture damage to the backing. **Section I item.**

**RECOMMENDATION:** Due to extent of water penetration, it is recommended to remove the shower tile floor and walls as needed. Replace any damaged wood members. Treat with an approved fungicide if needed. Install a new sheetrock or cement-board and Schluter waterproofing membrane. Re-tile the shower walls and floor (neutral or white color will be used) and grout. Install new sheetrock and baseboard. Painting is not included but can be added for an additional fee/upon request.

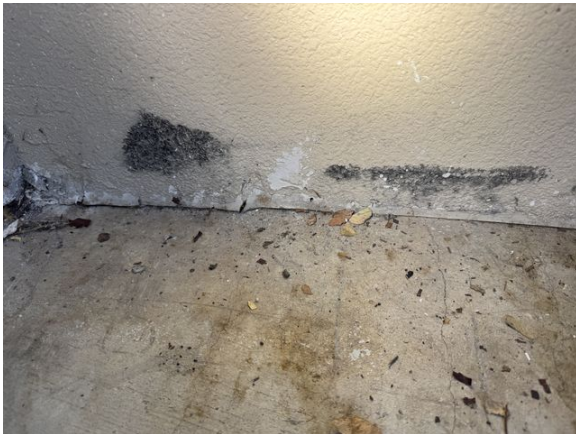
### 3B.

FINDING: The garage was partially inaccessible for inspection due to occupant's storage. **Informational/Further Inspection item.**

RECOMMENDATION: The owner should remove the storage where indicated and call for further inspection. For an additional charge not to exceed the cost of the original inspection, an inspection of the garage area will be made with any findings and recommendations listed on a supplemental report along with estimates for repair and/or treatment, if within the scope of this company's operations.
