PROPERTY INSPECTION REPORT

192 Barranca Terrace, Sunnyvale, CA 94086

August 13, 2025

File #: 20250813-24

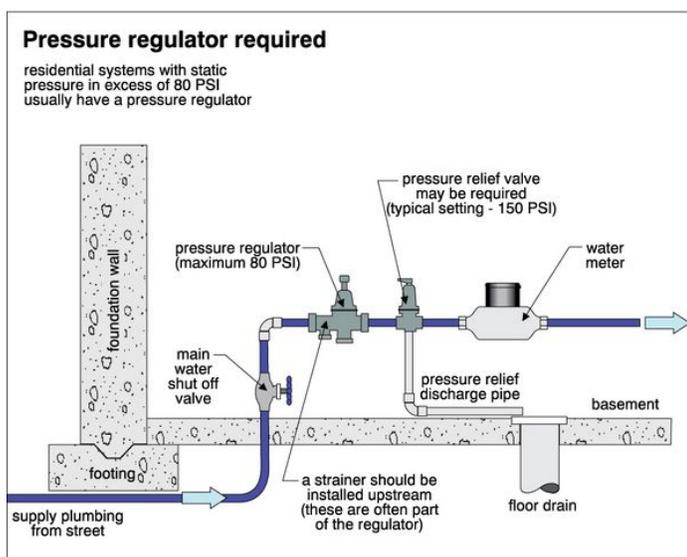
1. **Further Evaluation/Correct:** The water pressure was noted to be above 80 pounds per square inch (PSI). Check for a regulator (not visible) and/or correct as necessary. Modern standards call for a pressure regulator to be installed along with an associated expansion device to protect the building pipes and fixtures (from valve/faucet leakage and solenoid valve failures) when the supply pressure exceeds 80 PSI.
