256 E. Charleston Road  
Palo Alto, CA, 94306

680311

# HOME INSPECTION REPORT

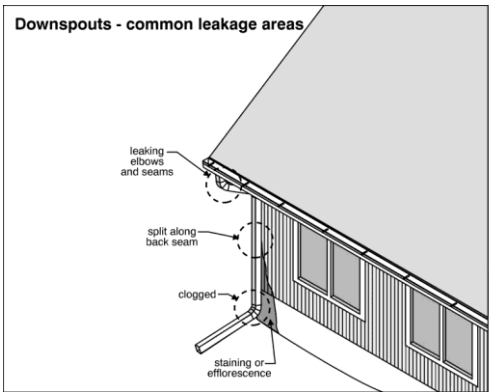
Illustration 2D

3. Leaks were noted in the downspouts and/or gutters at the rear and right. During wet weather conditions these areas are more obvious and during dry weather conditions they are noted from the stains at the areas where the leaks have occurred. We recommend all leaks be repaired.

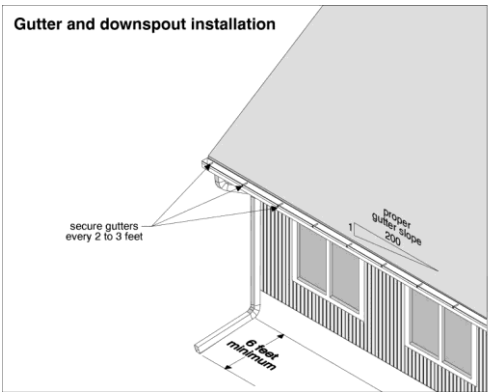
Illustration 2K

- ! 3. Loose gutters at the right area should be repaired or replaced.  
(See Photo 26)
- 4. The gutters are in serviceable condition but only portions of the roof are so equipped, depending upon the soil condition and drainage patterns it may be beneficial to add more gutters and downspouts.  
(See Illustration 2K)

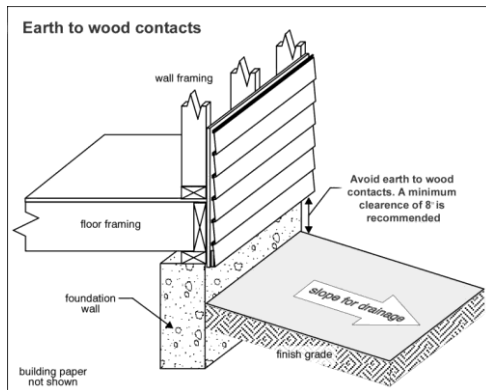
Illustration 3S

- ! 7. The wood fencing at the rear and left of the property is in need of repairs.  
([See Photo 20](#)) ([See Photo 24](#))
- ! 8. Wood/soil contact at the base of the wood siding at the rear wall should be eliminated. If rotted or damaged siding is found consult a licensed structural pest control operator regarding repairs.  
([See Illustration 3S](#)) ([See Photo 15](#))

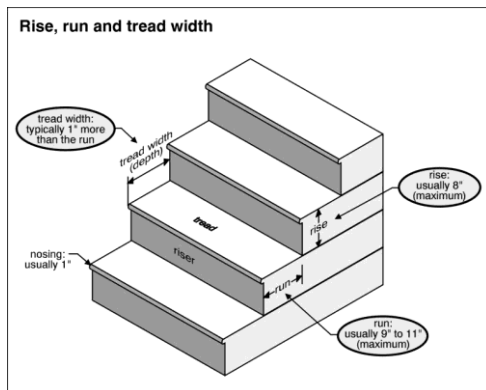
Illustration 3R

- ! 15. The steps at the rear appear to be non-conforming. This could create a potential fall hazard. We recommend the services of a licensed general contractor.  
[\(See Illustration 3R\)](#) [\(See Photo 22\)](#) [\(See Photo 33\)](#)

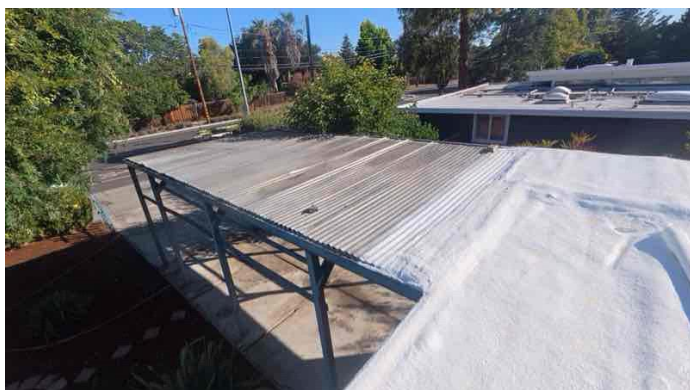
Photo 01

2. Repairs to the carport roof covering are recommended. Damaged, loose or missing roofing material should be repaired or replaced. All roof penetrations should be examined and sealed as necessary. For further evaluation of the condition of the roof we recommend you consult a licensed roofing contractor.

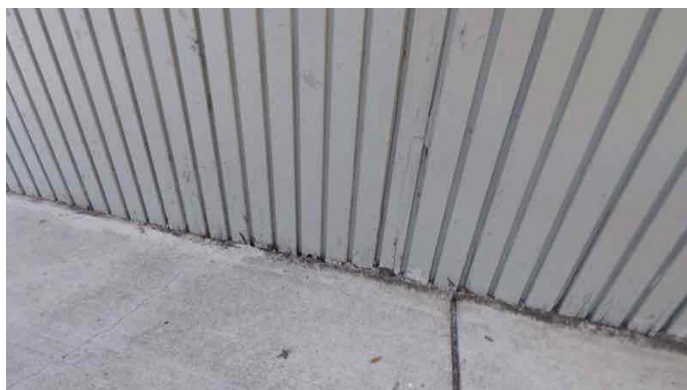
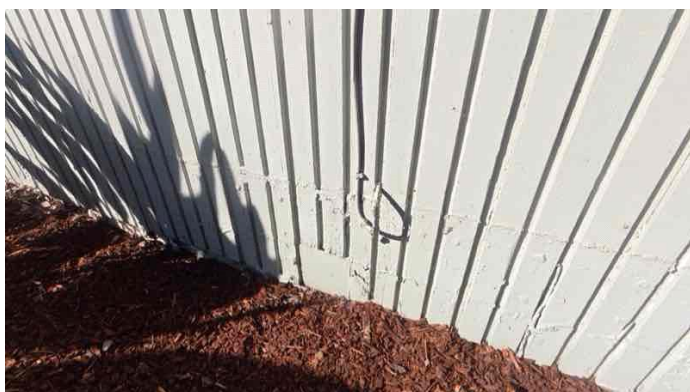
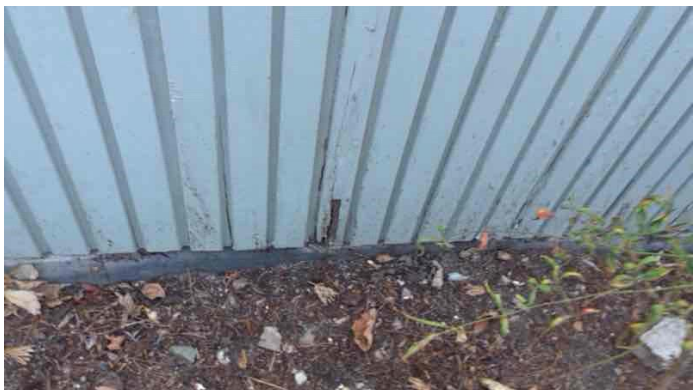
- ! 9. Water damage was observed to the wood siding at the front, rear and left exterior walls. We recommend the services of a licensed general contractor and/or structural pest control company.  
([See Photo 2](#)) ([See Photo 3](#)) ([See Photo 14](#))

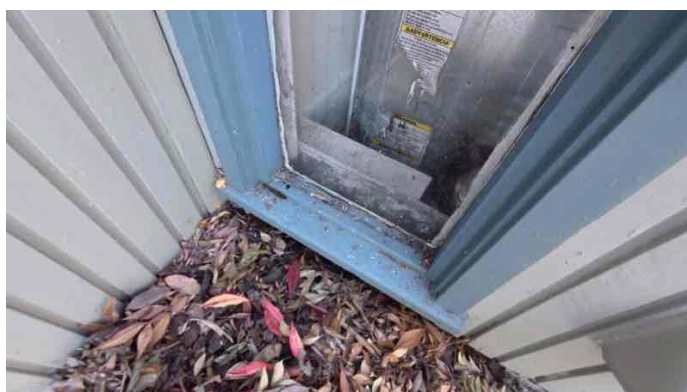
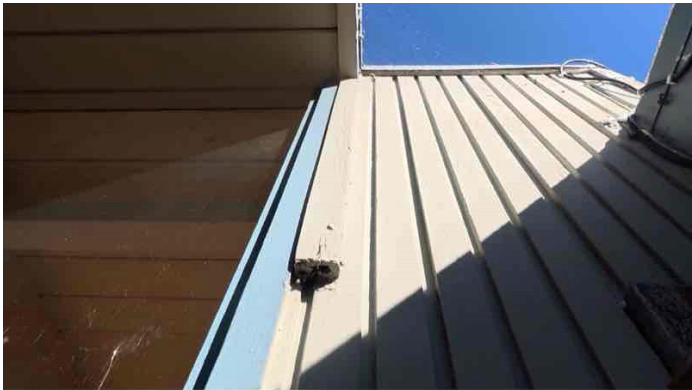
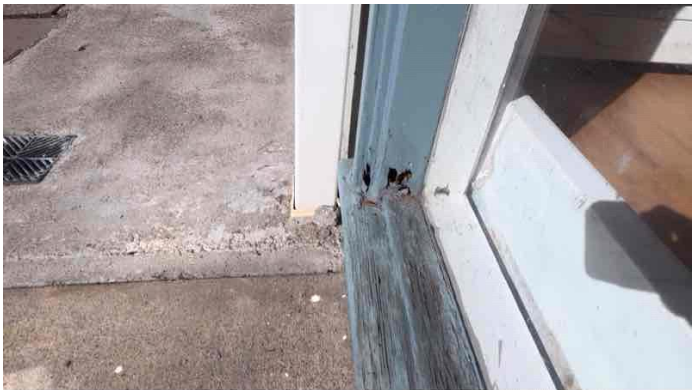
- ! 10. Water damage was observed to the exterior trim at the front right window, rear wall and window, right wall door. We recommend the services of a licensed general contractor and/or structural pest control company.  
([See Photo 6](#)) ([See Photo 16](#)) ([See Photo 17](#))

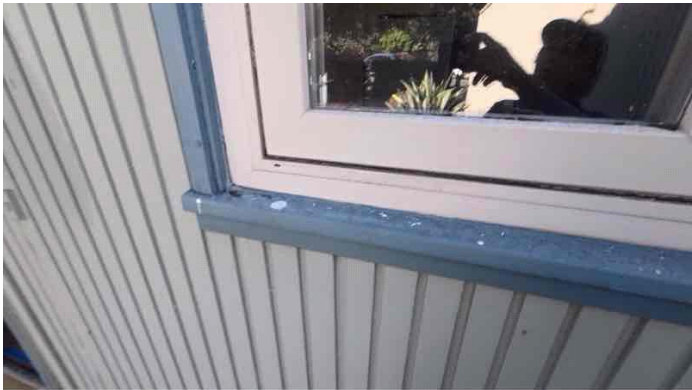
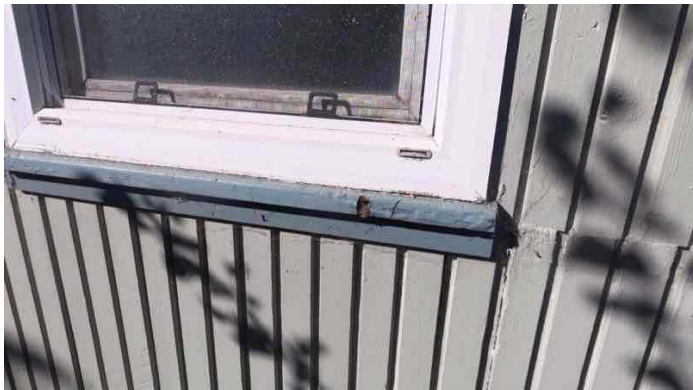
- ! 3. The window at the front, left and rear wall shows evidence of water damage to the sill/jamb. We recommend the advice and services of a general contractor and/or structural pest control company regarding repairs.  
([See Photo 7](#)) ([See Photo 12](#)) ([See Photo 17](#))

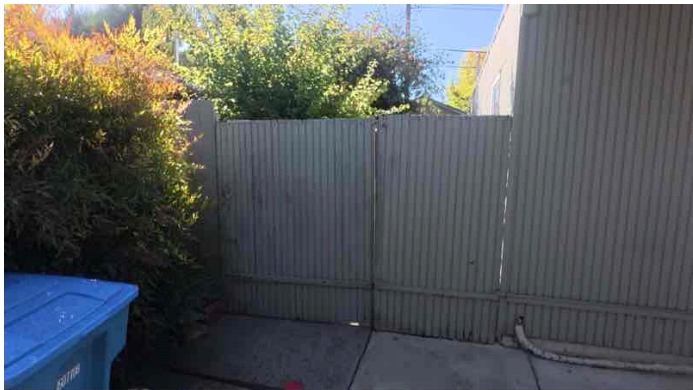
Photo 10

18. The fence posts are loose at the front left area. We recommend all loose, damaged or deteriorated posts be reinforced or replaced as necessary.  
([See Photo 10](#))

- ! 14. The fence posts are loose at the front left area. We recommend all loose, damaged or deteriorated posts be reinforced or replaced as necessary.  
[\(See Photo 10\)](#)

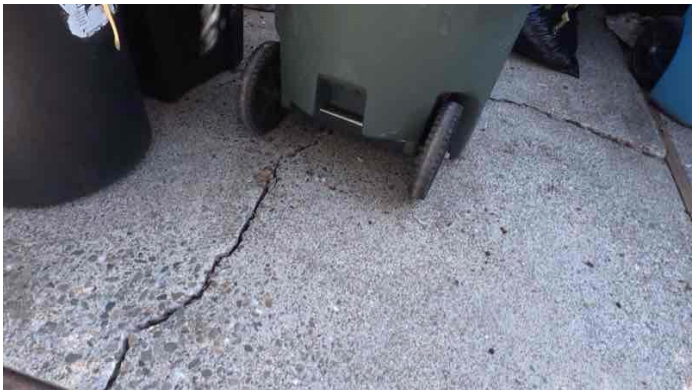
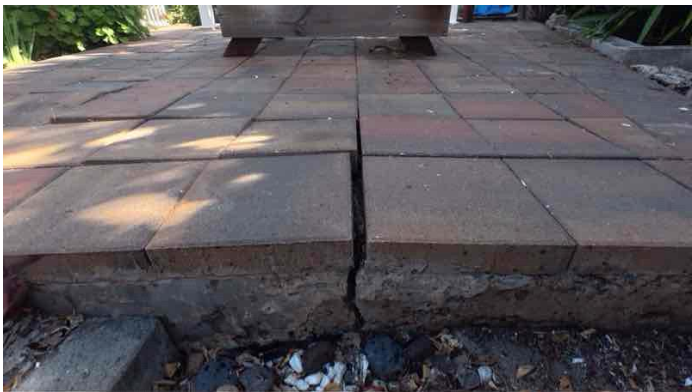
- ! 11. The concrete is badly cracked at the front left and rear middle patio. The cracks could be sealed for a better appearance and to prevent moisture intrusion. Replacement will ultimately be necessary.  
([See Photo 11](#)) ([See Photo 23](#))

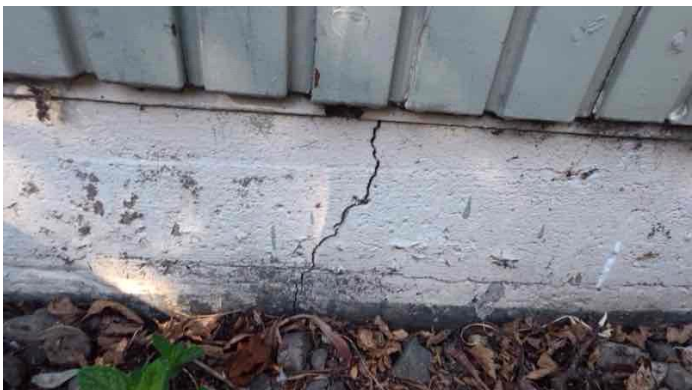
Photo 13

1. Vertical cracking was observed in the exposed exterior portions of the slab foundation left wall of the structure indicating movement and/or settlement of the structure may have occurred. The rate of movement cannot be predicted during a one-time inspection. A thorough evaluation of this condition is beyond our qualifications. For additional information we recommend contacting a licensed foundation contractor for further evaluation.

- ! 1.** Vertical cracking was observed in the exposed exterior portions of the slab foundation left wall of the structure indicating movement and/or settlement of the structure may have occurred. The rate of movement cannot be predicted during a one-time inspection. A thorough evaluation of this condition is beyond our qualifications. For additional information we recommend contacting a licensed foundation contractor for further evaluation.  
[\(See Photo 13\)](#)

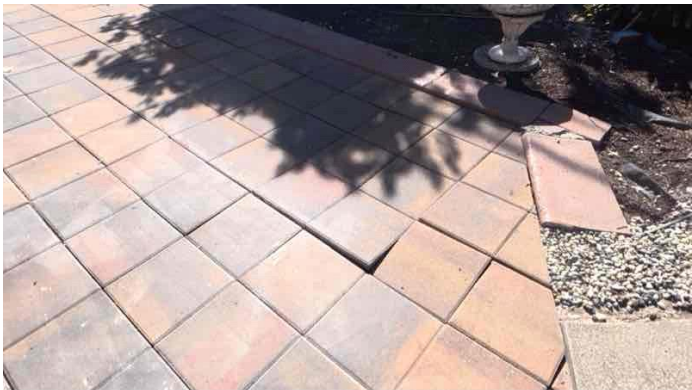
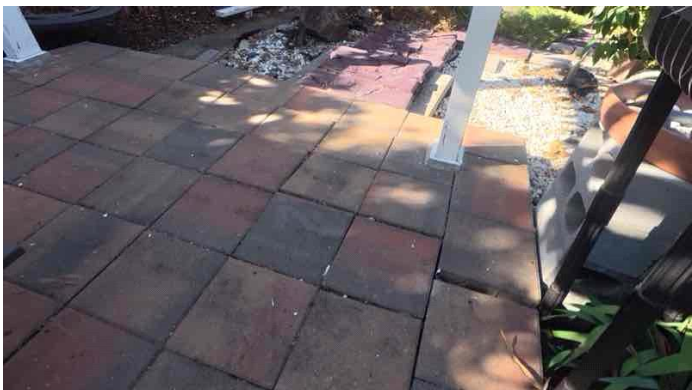
- ! 1. The rear right and rear middle patio surface has cracked, heaved, or uneven sections that create a potential trip hazard. We recommend addressing these conditions to improve safety and prevent potential injuries.  
([See Photo 19](#)) ([See Photo 21](#))

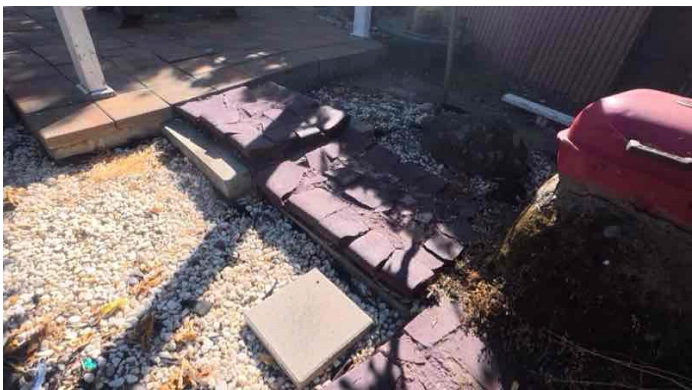
Photo 22

19. The steps at the rear appear to be non-conforming. This could create a potential fall hazard. We recommend the services of a licensed general contractor.  
([See Illustration 3R](#)) ([See Photo 22](#)) ([See Photo 33](#))

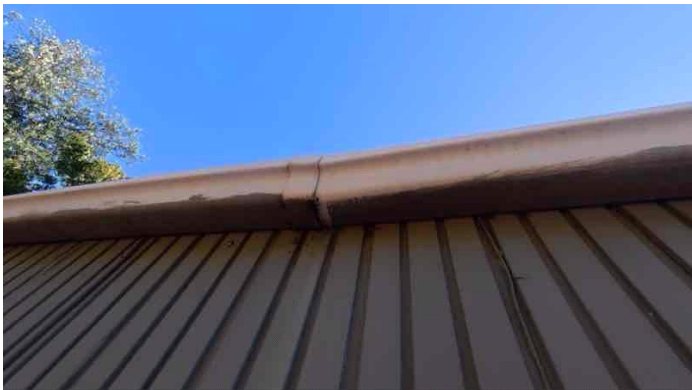
Photo 26

4. Loose gutters at the right area should be repaired or replaced.

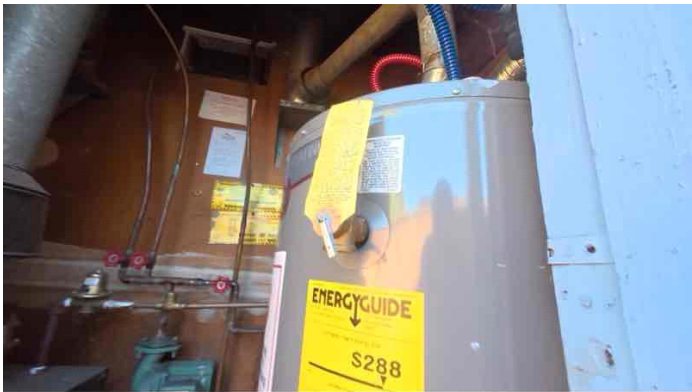
Photo 27

- ! 4. The sink drain at the ADU hall bathroom is leaking. We recommend all leaks be repaired.  
(See Photo 49)
- ! 5. The temperature and pressure relief valve for the water heater lacks a proper discharge pipe. We recommend the installation of approved piping to an approved location.  
(See Photo 27)

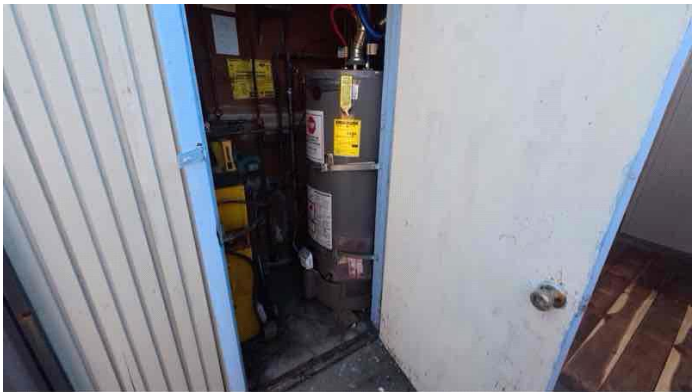
Photo 28

- ! 3. The water heater seismic straps are loose, this will allow movement of the tank in an earthquake. We recommend tightening the straps and/or adding bracing between the tank and wall to improve safety.  
(See Photo 28)

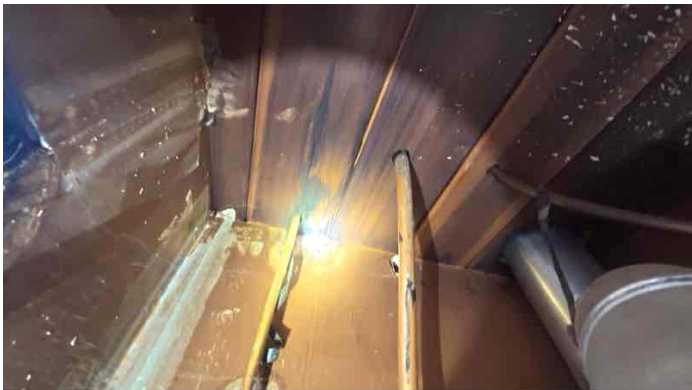
Photo 29

- ! 2. The ceiling at the water heater closet, house main entrance hall closets and living room shows evidence of water stains. It is recommended that the source of these stains be identified and corrected and the surface be refinished.  
(See Photo 29) (See Photo 39) (See Photo 60)

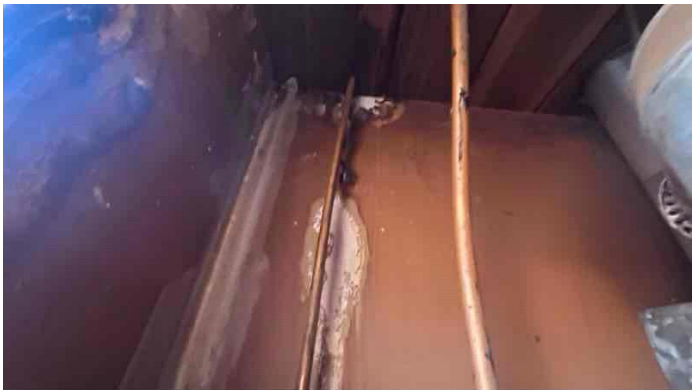
Photo 30

- ! 8. The wall at the water heater closet shows evidence of water stains. It is recommended that the source of the moisture be identified and corrected and the surface be repaired and refinished to restore its appearance.  
(See Photo 30)

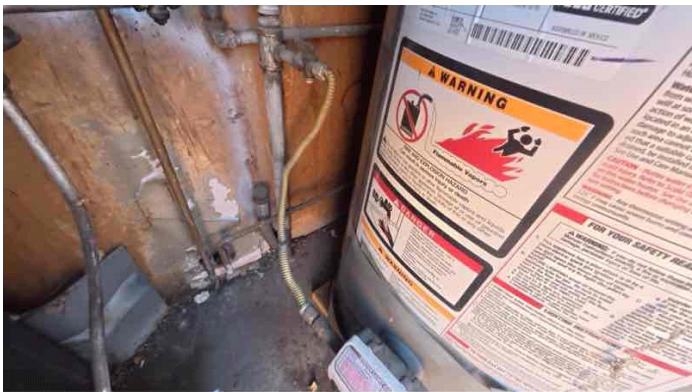
Photo 31

- The toilet at the ADU hall bathroom is loose and should be properly re-secured, tightened and caulked.  
(See Illustration 8J)
- ! The gas line/connector at the water heater is flexible and made of brass. Brass is no longer approved for this use because it is prone to deterioration. We recommend the gas line/connectors be replaced with a line/connector meeting present standards.  
(See Photo 31)

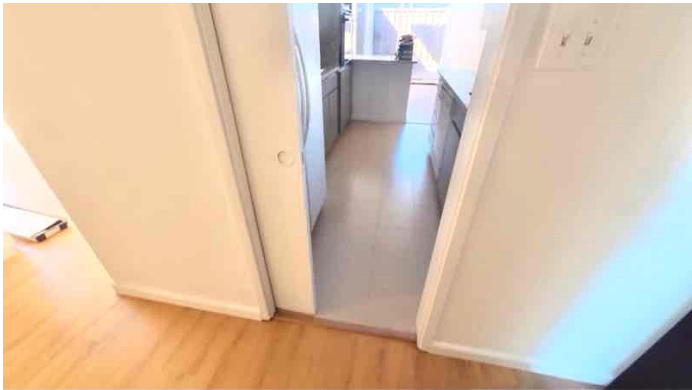
Photo 40

- ! 6. The interior door knob, latch or hinge hardware is missing at the kitchen. We recommend all missing hardware be replaced to restore full operation.  
(See Photo 40)

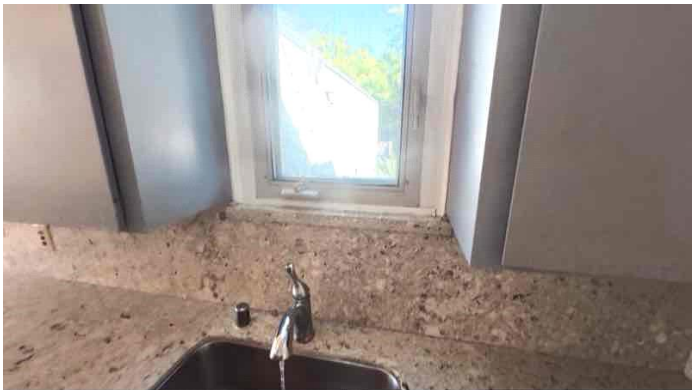
Photo 41

- ! 3. The fireplace damper is damaged and/or not operational. We recommend it be repaired or replaced.  
(See Photo 56)
- ! 4. Hardware is damaged or missing at the kitchen windows. We recommend a general tune-up of the windows as necessary to restore their proper function.  
(See Photo 41)

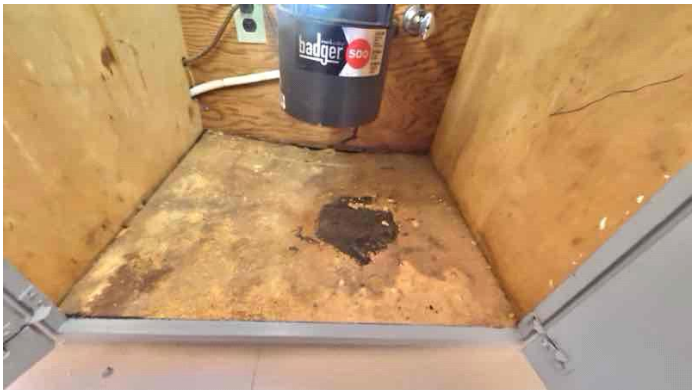
Photo 43

- ! 15. The base and/or side of the kitchen cabinet sink shelf is water damaged. We recommend the services of a licensed structural pest control operator for investigation of this condition.  
(See Photo 43)
  - ! 16. At the time of our inspection the dishwasher was inoperative or did not respond to normal operating controls. For attention to the conditions noted and/or cost estimates, if necessary, we recommend the advice of a qualified appliance technician.  
(See Photo 42)
  - ! 17. The latch at the dishwasher door is loose or damaged. We recommend it be repaired or replaced by a qualified appliance technician.  
(See Photo 44)
18. The kitchen cabinets are in serviceable condition. Several of the doors and drawers need adjustment or minor repairs for smoother operation and proper fit.

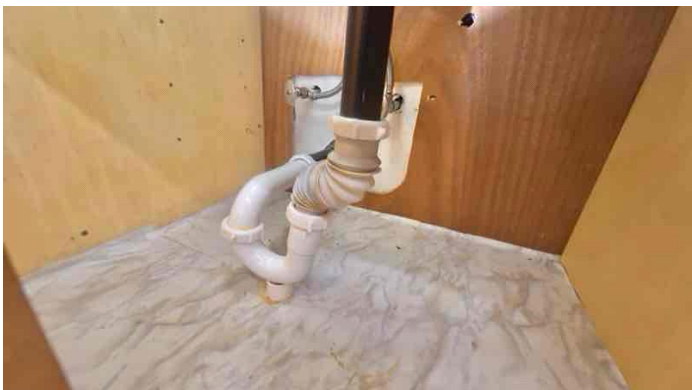
Photo 45

- ! 6. A plastic corrugated flex material has been used at the ADU kitchen and hall bathroom sink drain. This is not an approved configuration. We recommend an approved drain be installed.  
(See Photo 45) (See Photo 48)

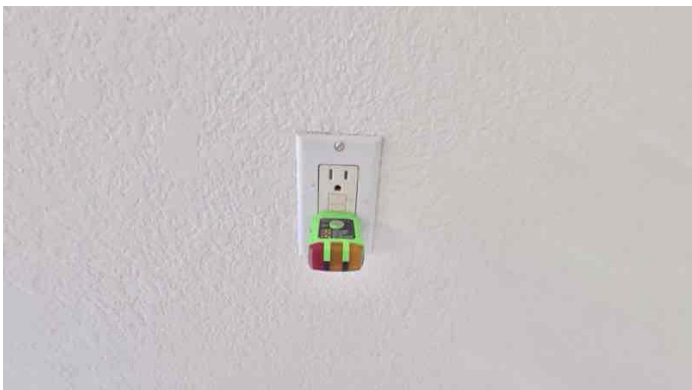
Photo 46

- ! 7. During our inspection and subsequent testing of electrical outlets we noted that a "GFCI" outlet in the ADU dining room has tripped however we could not find the outlet to reset, possibly due to owner storage or unknown location of the "GFCI". We recommend consultation with the owner in regards to this inaccessible "GFCI" and to reset the unit for full use of all outlets.  
([See Photo 46](#))

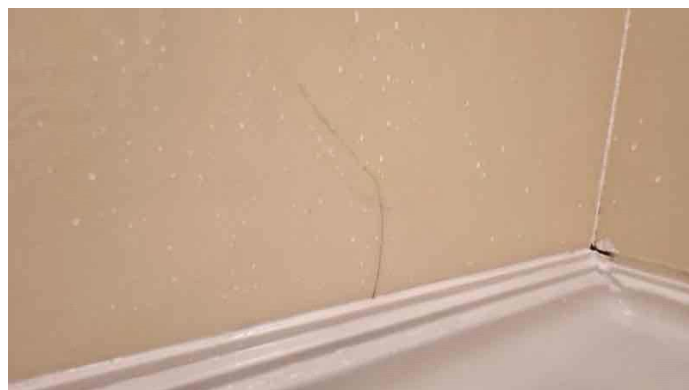
Photo 50

24. The shower wall in the ADU hall bathroom is missing or not high enough to provide a proper moisture barrier. We recommend the wall covering be installed to a height above the shower head.  
(See Photo 50)

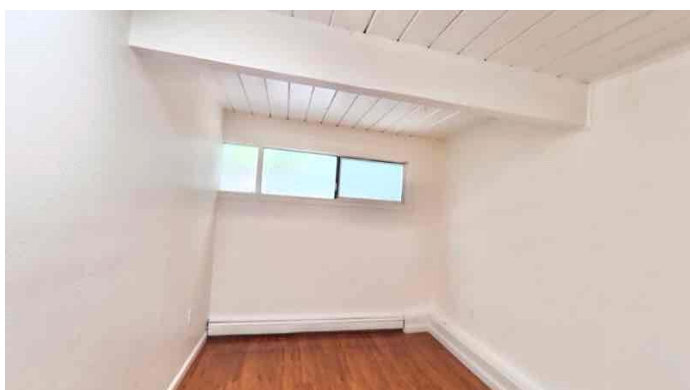
Photo 53

- ! 1. The height or size of the window in the ADU bedrooms does not conform to proper standards for egress. We recommend contacting the local building department to confirm if this installation conforms to specifications for escape openings in bedrooms.  
(See Photo 53)

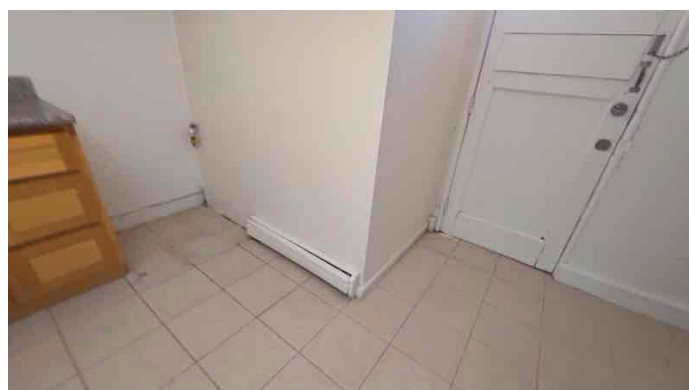
Photo 54

1. The house and ADU have only one heater thermostat that controls the heating system in all areas. We recommend an individual thermostat be installed for each area.  
([See Photo 54](#))

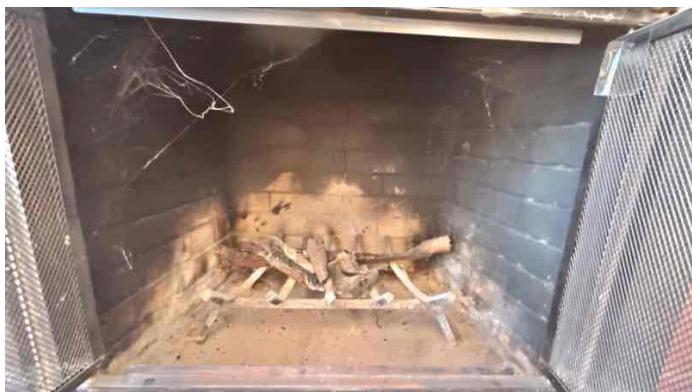
Photo 55

- ! 5. The interior of the fireplace firebox should be repaired where the bricks or mortar are heavily eroded, loose, or cracked. We recommend the advice and servicing of a licensed masonry contractor or fireplace specialist.  
(See Photo 55)

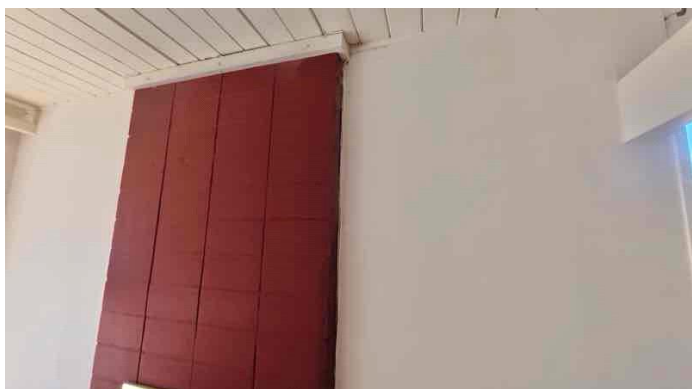
Photo 59

- ! 7. The wall in the living room is bulging and/or loose. It is recommended that the source of the bulging/loose wall be identified and corrected by the appropriate trades person.  
(See Photo 59)
