PROPERTY INSPECTION REPORT

2222 Raspberry Lane, Mountain View, CA 94043

April 30, 2026

File #: 20260430-24

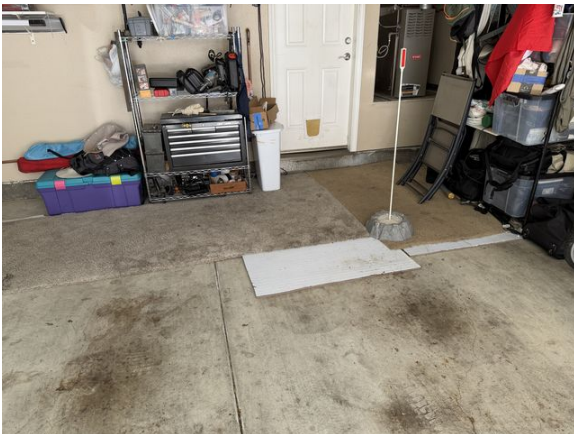
☑ Further Evaluation: There was storage observed in the garage at the time of the inspection. For further inspection (recommended), contact us after the area is cleared out (fee applies).

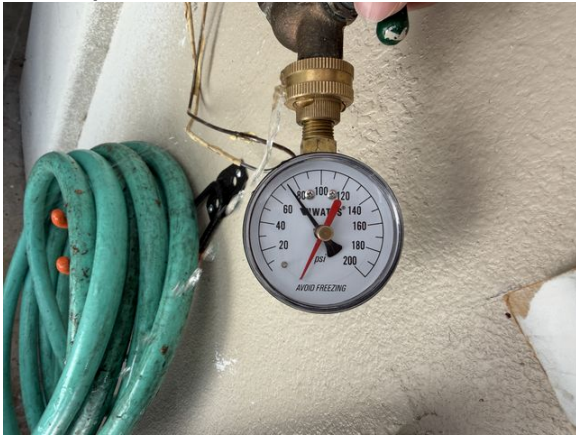
- Water flow throughout the home was average.
- Water pressure was tested at an outdoor sillcock and found to be 70-80 pounds per square inch. A regulator was not installed or visible. With too little water pressure, showering, rinsing dishes and even a glass of water can be a major annoyance. On the other hand, dishwashers, clothes washers and other household appliances can be damaged by water pressure exceeding 80 psi, and high pressure can void an appliance warranty as well.

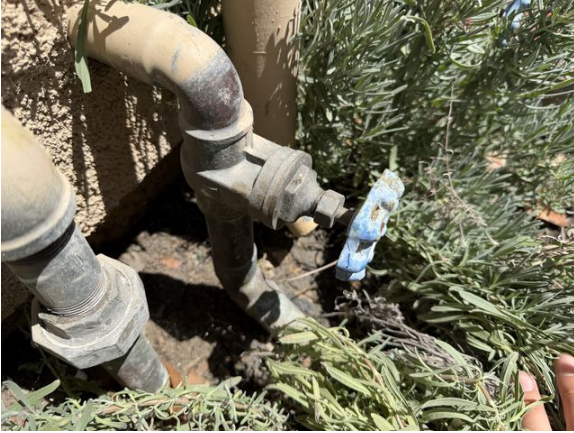
Main WATER disconnect

- The water meter was located in the left exterior.
- The main shut-off valve was checked for presence and accessibility only – no operational test was attempted. These valves are prone to leaks when turned off and back on. Main water shut-off valve was located on the rear wall.

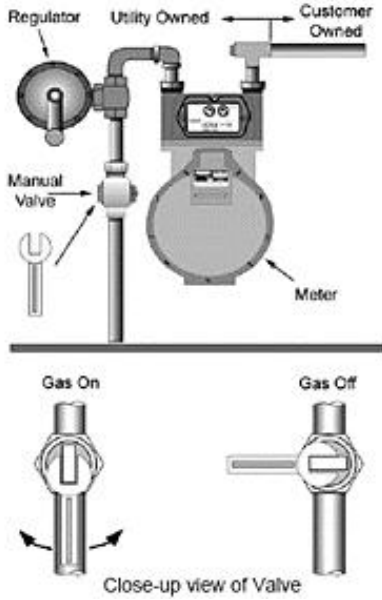
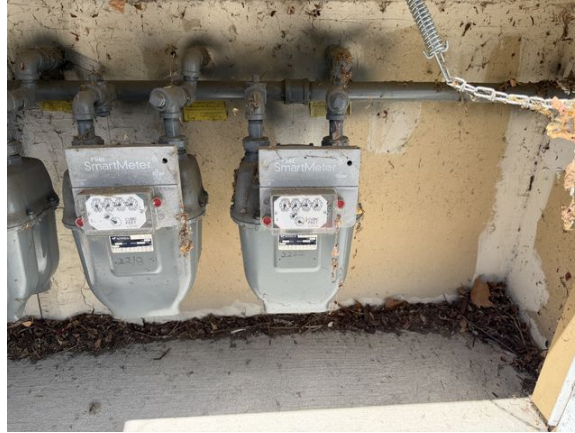
Main GAS disconnect:

- The gas meter was located on left exterior wall.
- SAFETY: We recommend keeping a wrench attached to the meter to turn off the gas for emergency needs (available in most hardware stores).
- An automatic gas shut-off device was not present.*

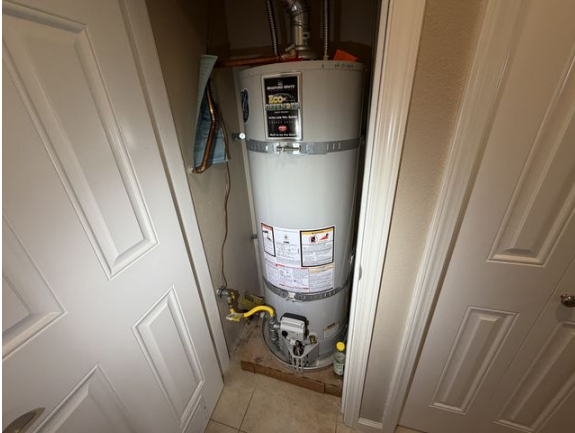
- There was a 40 gallon capacity, natural gas water heater which was located in the hallway closet.

- Information on the Bradford White water heater indicated that it was manufactured in 2021.
- This size tank is marginal for a typical home of this size.

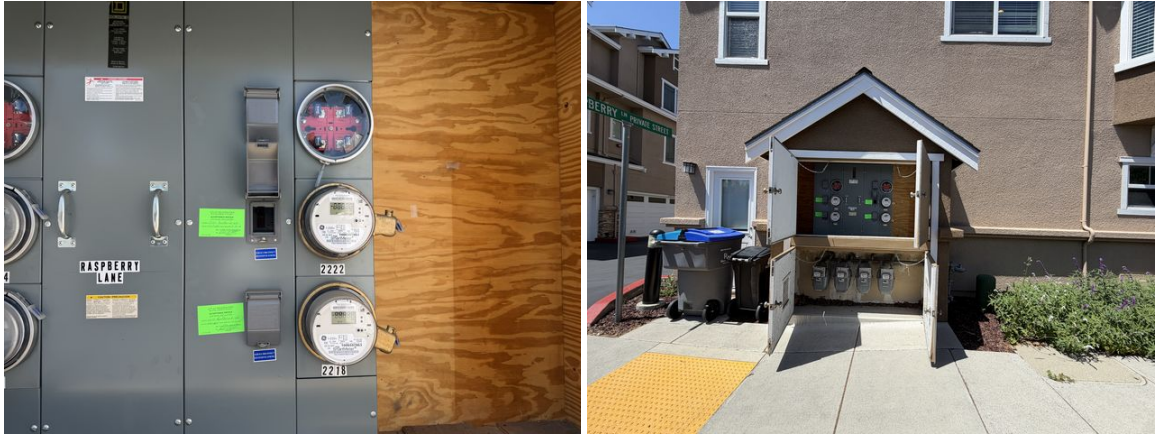
Main ELECTRIC disconnect

- The underground electric service wire entered the home on the left wall. The electric meter was located on the left exterior closet wall.
- The electric meter belongs to the local power utility company. If the meter is not functioning properly, contact the power company.
- The service wire entered a Square D service panel, located on the left exterior closet wall with a 200 amps and a 120/240 volt rated capacity. This service size is adequate for a typical home of this size. The branch circuits within the panel were (unknown).
- The service then entered a Square D sub-panel, located on the garage wall with 200 amps. The branch circuits within the panel were copper and aluminum.
- The visible house wiring consisted primarily of the Romex type(s).
- A grounding electrode was visible.
- A ground fault circuit interrupter was noted in the bathroom(s), exterior, garage and kitchen.

NOTE: The main shut-off was noted but not tested. The main disconnect switch serves as a safety device to permit convenient shutdown of the system for emergency or service. The main disconnect switch should always be kept accessible for use in emergencies.

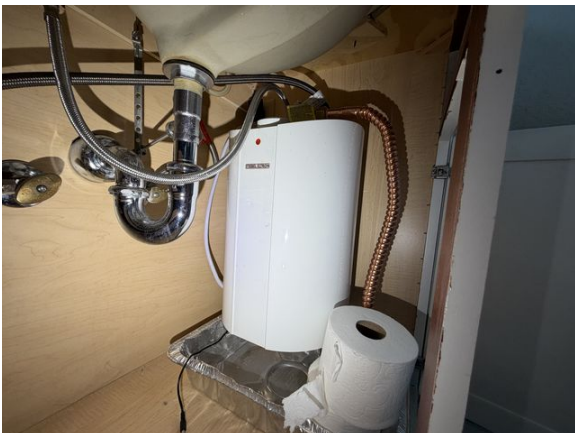
☑ Note: The tankless water heater in the sink cabinet is not within the scope of inspection. The system was functioning at the time of inspection. Have serviced/checked by the appropriate specialist.

Sellers installed the heater to boost the speed of getting the hot water.

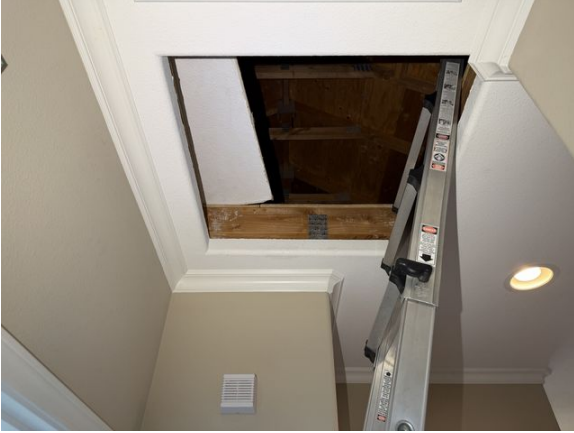
- The attic access was through a scuttle in the third floor hallway.

- The attic above the living space was insulated with batted insulation, approximately 5-10"-inches in depth. The insulation was evenly distributed.
- Ventilation throughout the attic was provided by roof vents.
- The roof structure consisted of 2x4-inch wood trusses spaced 24-inches on center and plywood sheathing.

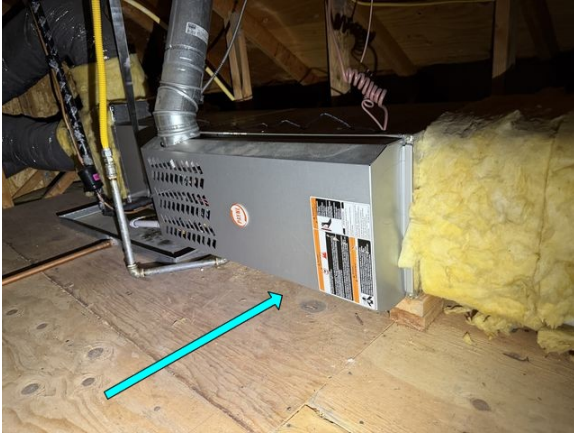
- **Third Level:** The home was heated by a Payne natural gas central heating heater.

- The furnace was manufactured in 2008.
- The unit was located in the attic of the home.
- It has an approximate net heating capacity of 44,000 BTUH.
- The control for the central heating system was a 24 volt thermostat located on the third level hallway wall of the home.
- The disposable filter was located in the third level hallway ceiling.
- **First/Second Level:** The home was heated by a Bryant natural gas central heater.

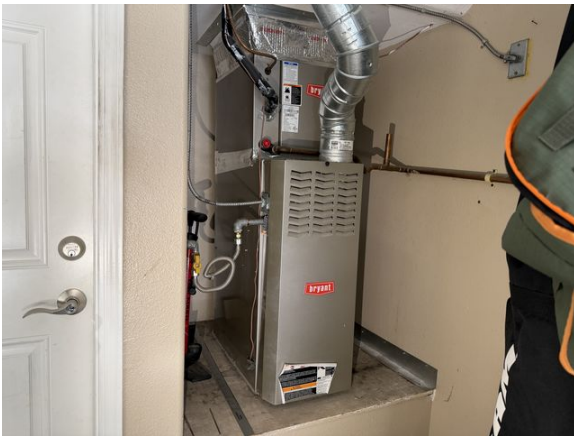
- The furnace was manufactured in 2007.
- The unit was located in the garage of the home.
- It has an approximate net heating capacity of 44,000 BTUH.
- The control for the central heating system was a 24 volt thermostat located on the kitchen wall of the home.

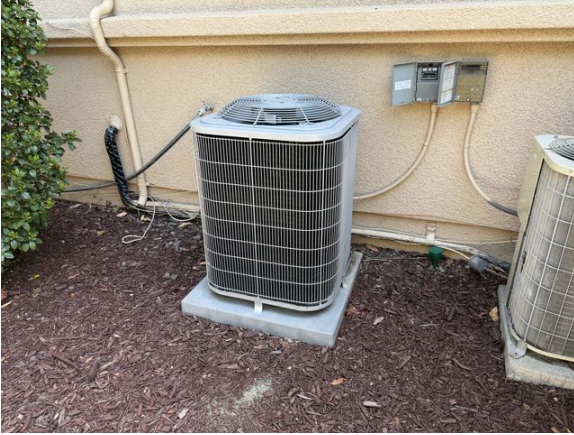
- Third Level: The electric outdoor air conditioner condensing unit was manufactured by Carrier. The unit is located at the right of the home. This unit was manufactured in 2023.

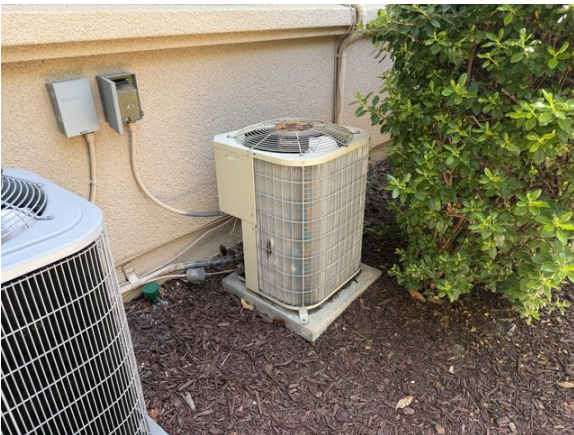
- First/Second Level: The electric outdoor air conditioner condensing unit was manufactured by Payne. The unit is located at the right of the home. This unit was manufactured in 2008.

- The condenser coils were clean. The condenser line serving unit were insulated with approved insulation.
