HOME INSPECTION REPORT

1177 Redrock Court, Sunnyvale

672540

March 27, 2026

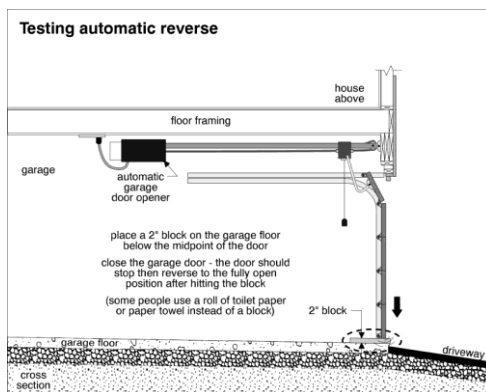
Illustration 3V

3. The automatic reverse safety feature of the garage door opener did not activate when the door made contact with a 2x2-inch block placed under the center of the door during testing. This feature is an important safety requirement designed to prevent injury or damage if an obstruction is present. The photo-eye sensors were tested separately and found to be operational. We recommend that the garage door opener be adjusted, repaired, or replaced as necessary to restore proper function of the automatic reverse mechanism. A qualified garage door service technician should evaluate and correct this condition for improved safety. (See Illustration 3V) (See Photo 23)

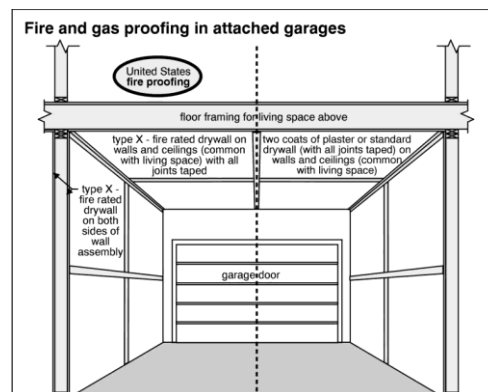
Illustration 3A

4. Damaged, open or missing wall and/or ceiling finishes of attached garages should be repaired and sealed where they abut the interior of a house. This reduces the potential of toxic automobile gases entering the house and serves as a fire break. Current standards require all walls/ceilings common to the finished living spaces be covered with 5/8" fire resistant sheetrock double taped at all seams. (See Illustration 3A) (See Photo 20)

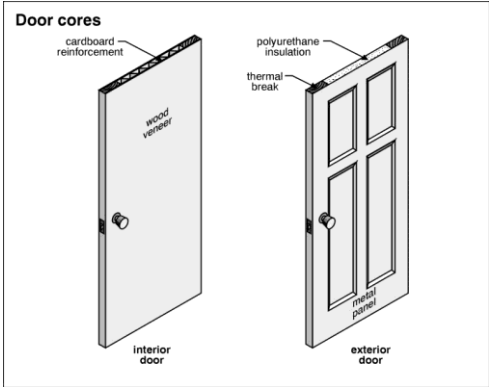
Illustration 3W

15. The exterior door at the rear of the garage is not a solid core exterior grade. Although the door may be functional, we recommend replacing the door for security reasons. Hollow core or interior grade doors do not meet this requirement. (See Illustration 3W) (See Photo 18)

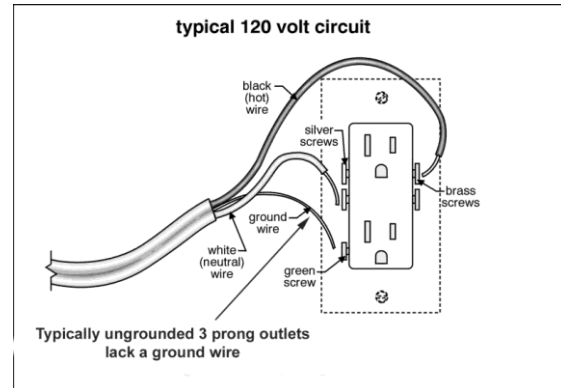
Illustration 4O

17. Ungrounded "3-prong" outlets should be improved. A grounded cable or ground wire could be installed at these outlets, the outlet labeled as ungrounded or the original "2-prong" receptacle could be replaced. Based upon our inspection of a representative number of outlets, we recommend testing of every outlet. Repairs or rewiring are recommended at all deficient locations. For additional information we recommend a licensed electrician be consulted. (See Illustration 4O) (See Photo 8)

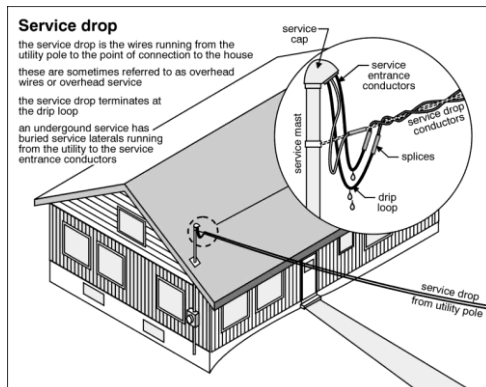
Illustration 4R

19. The service entrance wires have exposed metal visible at the mast splice connection. These should be repaired or replaced. Contact your local utility service provider. (See Illustration 4R) (See Photo 5)

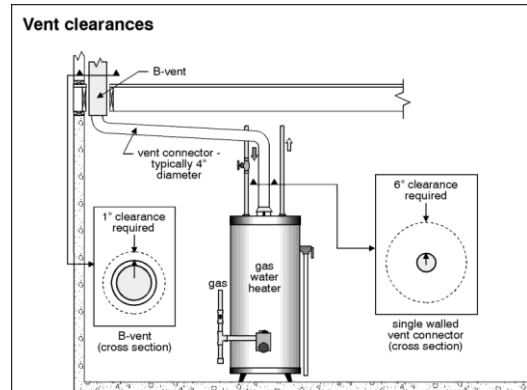
Illustration 8C

23. There is insufficient clearance between the water heater exhaust flue and combustible materials. This condition should be corrected. (See Illustration 8C) (See Photo 22)
