HOME INSPECTION REPORT

2767 Winchester Drive, Hayward

671100

February 13, 2026

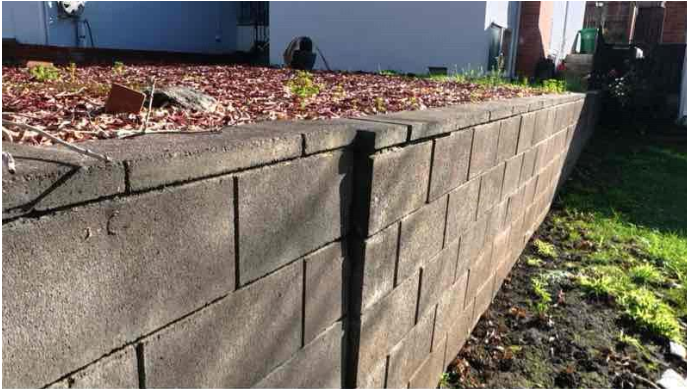
Photo 01

19. The retaining wall at the front right and rear shows evidence of movement. It is impossible to determine the rate of movement during a one time visit to the property. We recommend further evaluation by the appropriate trades for any recommendation deemed necessary to prevent further movement. (See Photo 1) (See Photo 10)

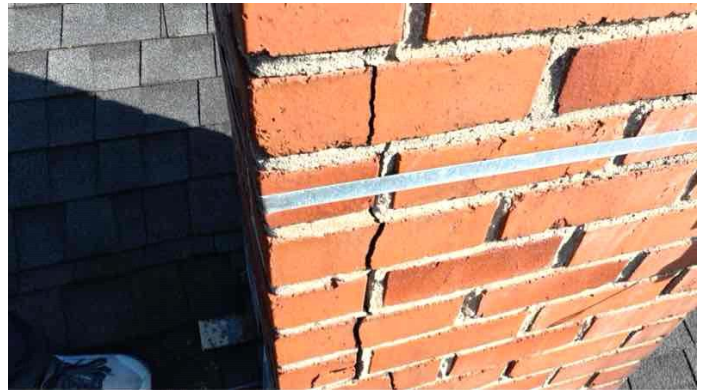
Photo 04

4. There is a large crack at the back of the chimney. This condition may indicate movement of the chimney. It is impossible to determine the rate of movement during a one time visit to the property. We recommend the advice of a licensed masonry contractor. (See Photo 4)

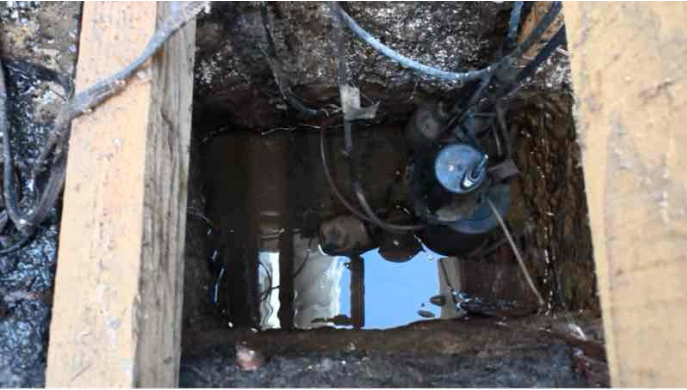
Photo 07

3. Both water sump pumps installed at the right exterior and basement to remove occasional water was inoperable or would not function properly at the time of our inspection. We recommend the pump be repaired or replaced. (See Photo 7) (See Photo 35)

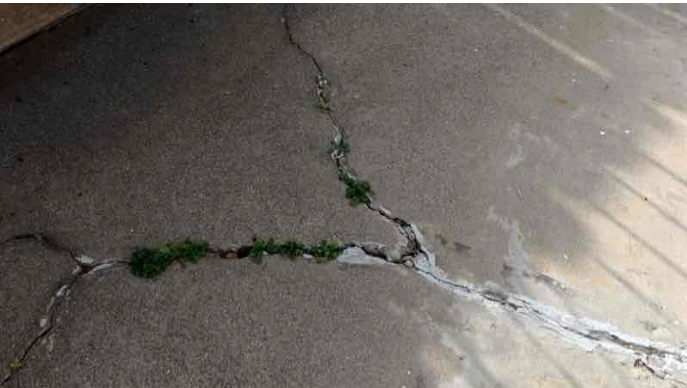
Photo 11

6. The rear patio surface has cracked, heaved, or uneven sections that create a potential trip hazard. We recommend addressing these conditions to improve safety and prevent potential injuries. (See Photo 11)

Sellers sealed the cracks and applied cement paint in last week of Feb. 2026.

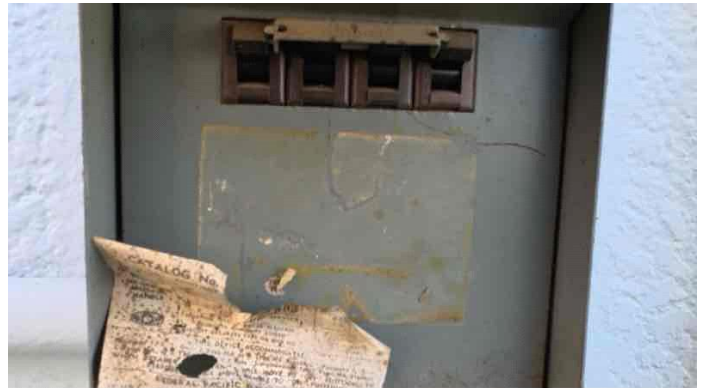
Photo 12

23. The "Federal Pacific" electrical panels (Main & 2 sub) on the property was not fully inspected due to inherent defects that are a potential safety hazard. A visual inspection of the front of the panel and breakers was performed, no covers were removed or internal components inspected. We recommend a licensed electrician be retained for further inspection and recommendations. An electrician is likely to recommend full replacement of this brand of panel. (See Photo 12) (See Photo 15) (See Photo 16)

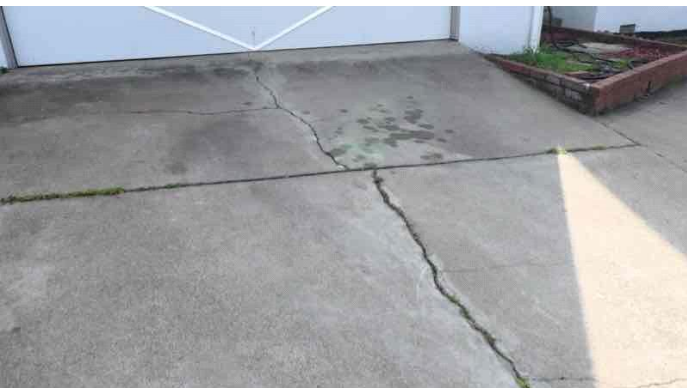
Photo 13

11. The driveway has cracked, heaved, or uneven sections, creating a potential trip hazard. We recommend repairing or resurfacing the affected areas to improve safety and prevent further deterioration. (See Photo 13)

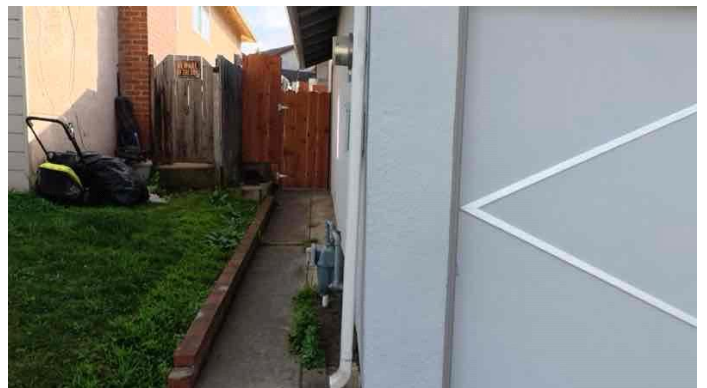
Photo 14

5. Loose downspouts at the front left corner should be repaired or replaced. (See Photo 14)

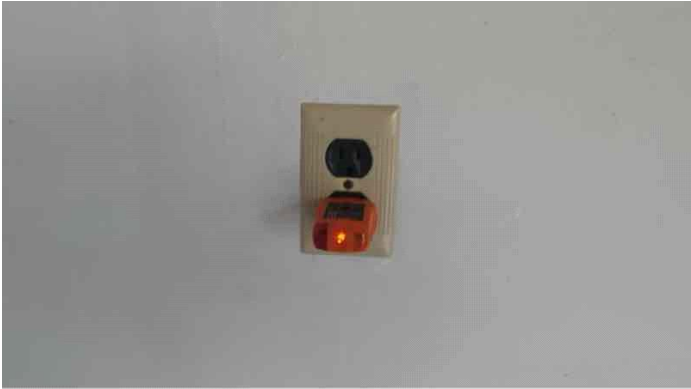
Photo 17

21. Ungrounded "3-prong" outlets at multiple locations should be improved. A grounded cable or ground wire could be installed at these outlets, the outlet labeled as ungrounded or the original "2-prong" receptacle could be reinstalled. Based upon our inspection of a representative number of outlets, we recommend testing of every outlet. Repairs or rewiring are recommended at all deficient locations. For additional information we recommend a licensed electrician be consulted. (See Illustration 4O) (See Photo 17)

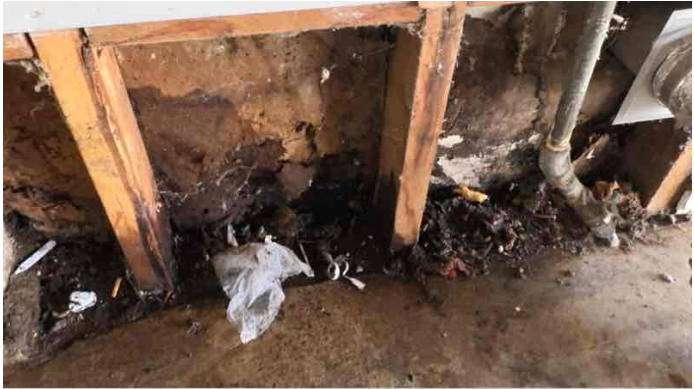
Photo 18

1. The wall framing and sheathing of the garage shows evidence of water damage. We recommend the advice and services of a licensed structural pest control operator. (See Photo 18)

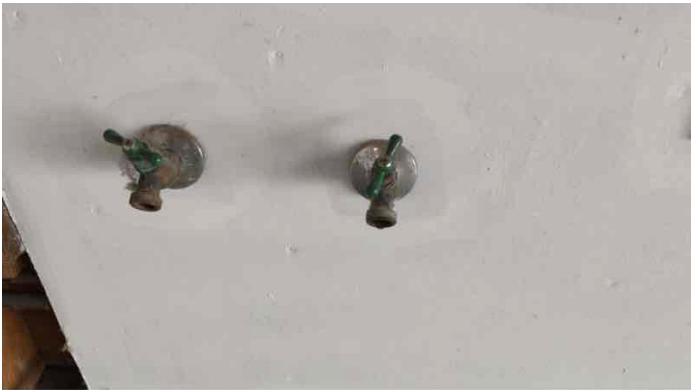
Photo 19

27. The hose bib is leaking at the laundry/garage. We recommend all leaks be repaired. (See Photo 19)

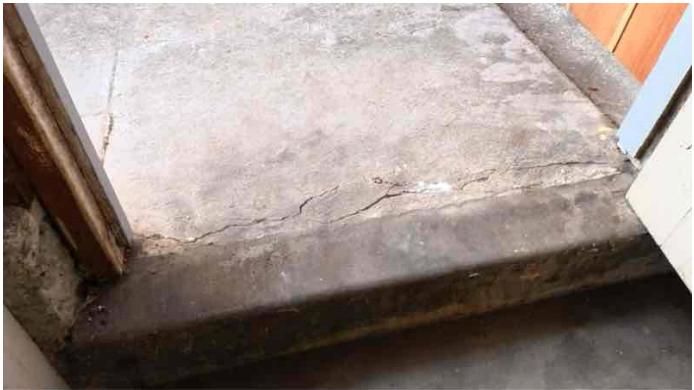
Photo 20

17. A missing threshold was noted at the garage side door. We recommend the installation of a threshold that conforms to present building standards. This will also help to avoid possible trip hazards and limit moisture intrusion. (See Photo 20)

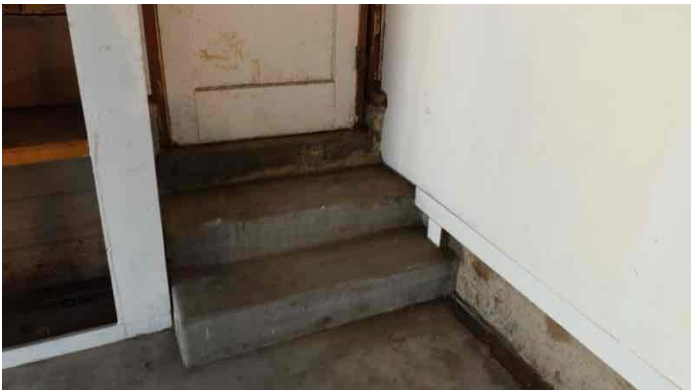
Photo 21

31. There is no railing where needed at the garage. For improved safety, it is recommended that appropriate railing be installed. (See Photo 21)

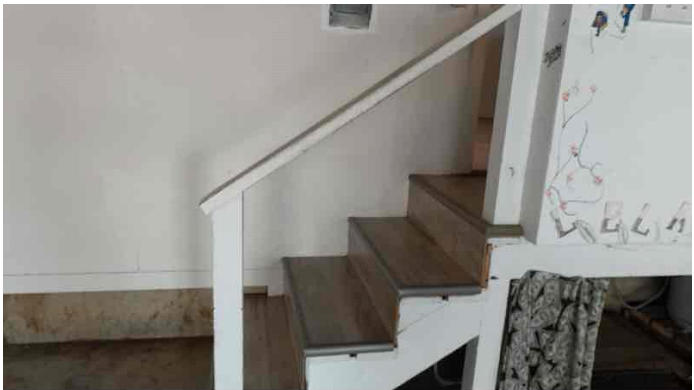
Photo 22

28. The openings in the garage stair railing are larger than 4". For improved safety it is recommended that the railing be altered for an opening of less than 4". (See Illustration 9K) (See Photo 22)

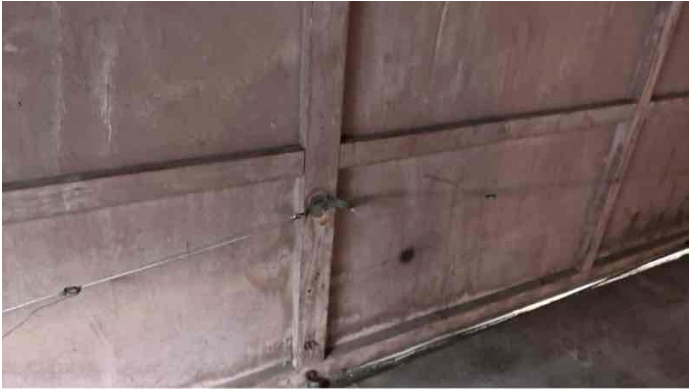
Photo 23

7. Damaged, loose and/or non-functional garage door hardware should be corrected. (See Photo 23)

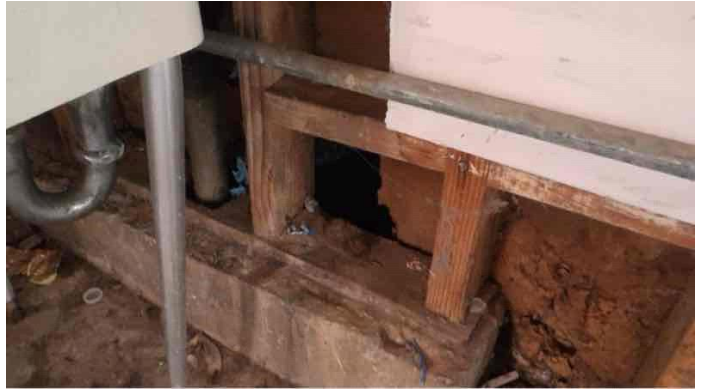
Photo 24

8. Damaged, open or missing wall and/or ceiling finishes of attached garages should be repaired and sealed where they abut the interior of a house. This reduces the potential of toxic automobile gases entering the house and serves as a fire break. Current standards require all walls/ceilings common to the finished living spaces be covered with 5/8" fire resistant sheetrock double taped at all seams. (See Illustration 3A) (See Photo 24)

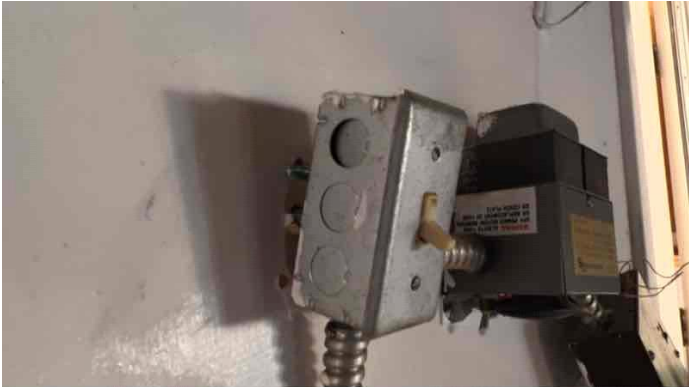
Photo 25

20. The switch housing at the garage is loose. Based upon our inspection of a representative number of outlets we recommend testing of every outlet. All loose outlets and receptacles should be repaired as necessary. (See Photo 25)

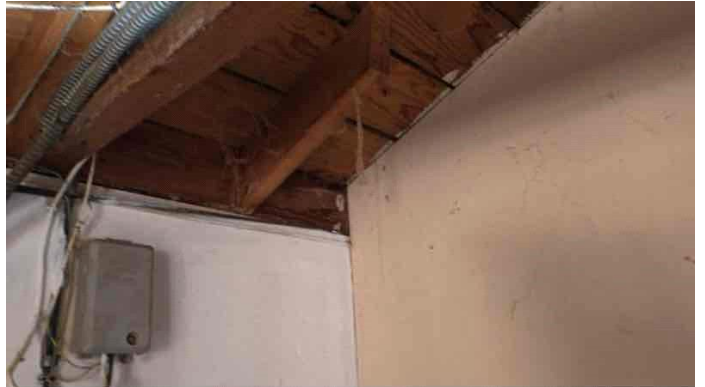
Photo 26

2. Water stains were evident in the garage and attic. This could indicate leakage through the roof covering. We recommend the services of a licensed roofing contractor to further evaluate this condition. (See Photo 26)

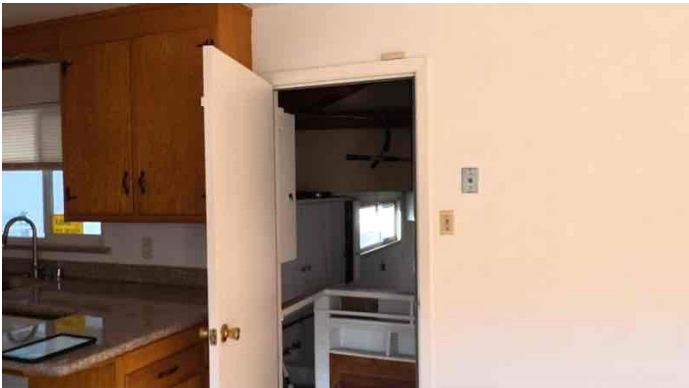
Photo 27

15. The door between the garage and the interior of the house should be a fire rated door as per local codes. Hollow core, windowed or interior grade doors do not meet this requirement. We recommend this door be replaced with a approved door for this location. (See illustration 3K) (See Photo 27)

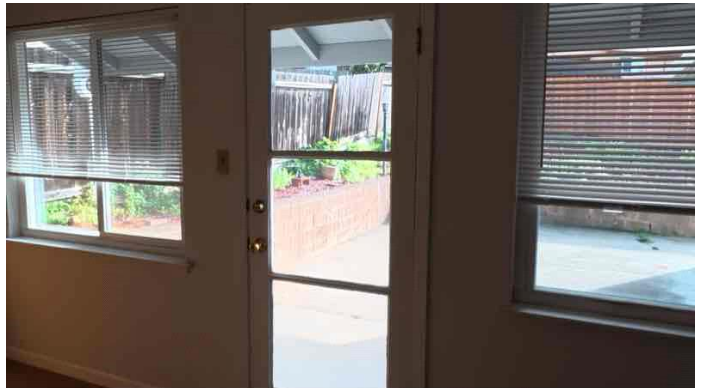
Photo 28

14. The rear patio door was locked at the time of our inspection. Therefore, the door is considered inaccessible and was not inspected. With access and a opportunity for complete inspection, conditions in need of attention may be discovered. (See Photo 28)

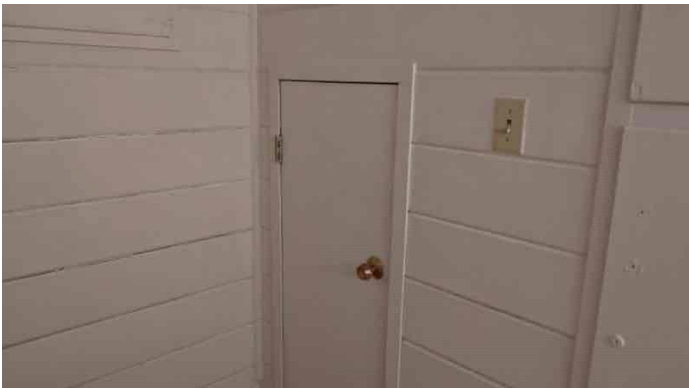
Photo 29

33. The door below the stairway is missing the stops and has loose hinges. We recommend repair of this door. (See Photo 29)

- ! 3. There is no railing where needed at the garage. For improved safety, it is recommended that appropriate railing be installed. (See Photo 21)
- ! 4. The door below the stairway is missing the stops and has loose hinges. We recommend repair of this door. (See Photo 29)

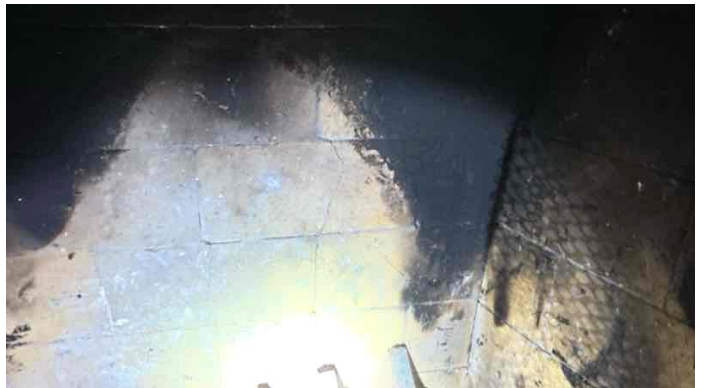
Photo 30

- ! 2. The interior of the fireplace firebox should be repaired where the bricks or mortar are cracked. We recommend the advice and servicing of a licensed masonry contractor or fireplace specialist. (See Photo 30)

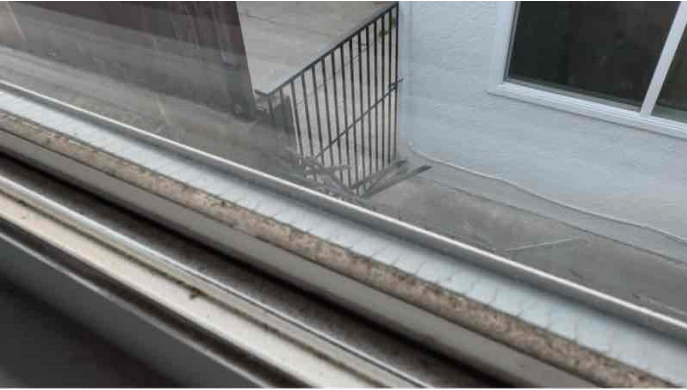
Photo 31

- ! 6. Several windows exhibit conditions and/or symptoms that indicate a possible breached seal or failed thermal pane. This has or can result in condensation and/or moisture developing between the panes of glass that will effect the cosmetic appearance of the windows and their insulating performance. We recommend all insulated glass units be further evaluated by a licensed glazier and repaired or replaced as required. (2 Living room, right side center bedroom, right rear bedroom, master bedroom) (See Photo 31)

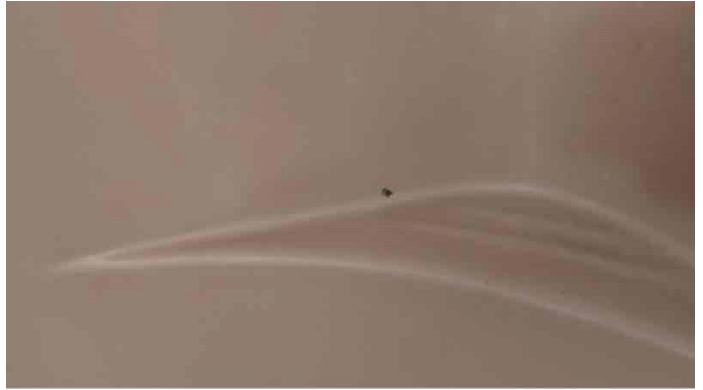
Photo 32

- ! 21. The fiberglass shower walls at the master bathroom are chipped. We recommend they be properly repaired or replaced to eliminate any moisture intrusion into these areas. Damage caused by water seepage cannot be determined by this visual inspection. (See Photo 32)

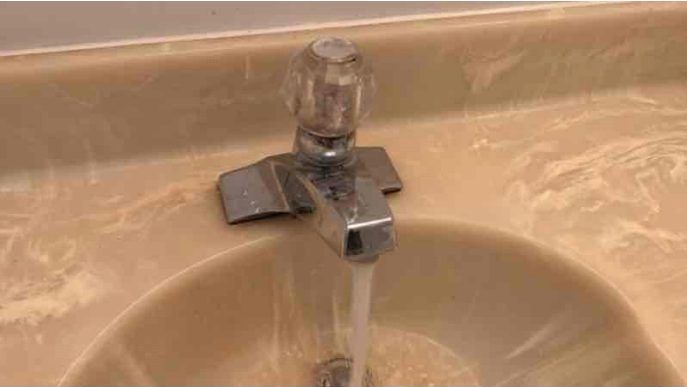
Photo 33

- ! 3. The hose bib is leaking at the laundry/garage. We recommend all leaks be repaired. (See Photo 19)
- ! 4. The sink faucet is leaking at the hall bathroom. We recommend all leaks be repaired. (See Photo 33)

- ! 5. The hot water for the sink basin faucet at the hall bathroom was not functioning at the time of our inspection, possibly due to the water being turned off. We recommend the water be turned on and the function of the faucet verified. Repairs or replacement of the faucet is also recommended if found to be not functioning correctly or leaking. (See Photo 33)

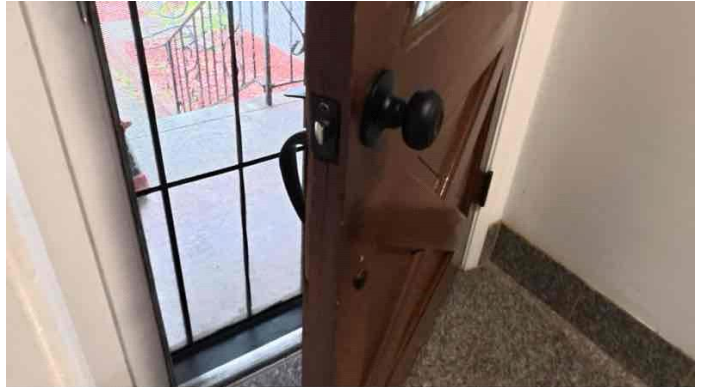
Photo 34

- ! 12. The front door is cracked or split. We recommend it be repaired or replaced. (See Photo 34)

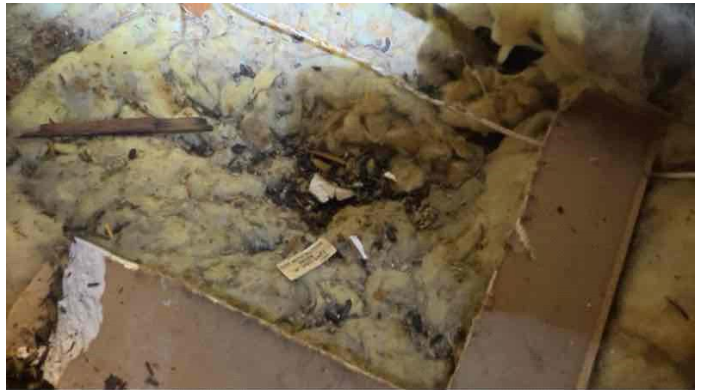
Photo 36

- ! 5. Evidence of vermin activity was observed within the attic and crawlspace. It is likely this evidence will extend into inaccessible areas. The owner is advised to contact the appropriate trade for further evaluation and remedial measures if necessary. (See Photo 36)

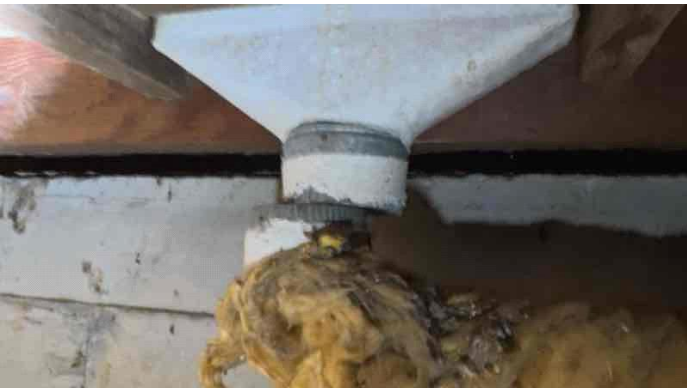
Photo 37

- ! 1. One or more sections of HVAC ductwork were observed disconnected at the left side of the crawlspace. Disconnections allow conditioned air to escape and can draw unfiltered air into the system, reducing efficiency and comfort. We recommend a qualified HVAC technician fully evaluate all ductwork, reconnect and properly seal joints, replace damaged sections as needed, and restore secure support and continuous, airtight duct runs throughout. (See Photo 37)
