WOOD DESTROYING PESTS AND ORGANISM INSPECTION REPORT

Building No. 2767	Street Winchester Drive	City Hayward	ZIP 94541	Date of Inspection 2/13/2026	Number of Pages Page 1 of 10

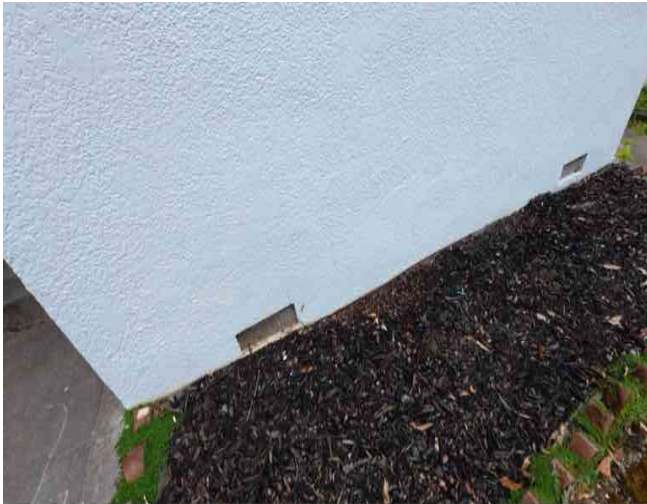
Photo 01

3A. FINDING: This home was constructed without the use of a weep screed at the base of the stucco. Although this was an accepted construction method it does create an area that can allow subterranean termites to access the home without being detected. This area can also allow condensation to build up and not drain properly. (See Photo 1)

RECOMMENDATION: If further information is desired it will be necessary to install a series of test holes to allow for further inspection. All findings, recommendations and bids will be issued in a supplemental report. If no additional damage is noted, the test holes in the stucco will be patched back up. We will attempt to match the texture as close as possible, however the texture may differ from the existing.

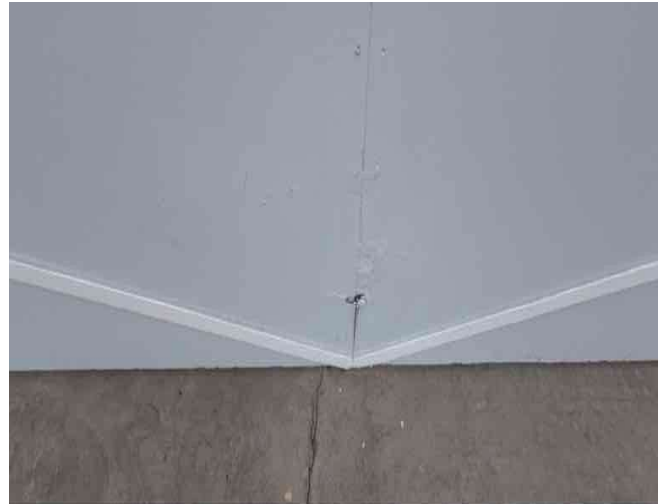
Photo 02

1A. FINDING: The main garage door was found to be damaged by fungus. It appears the damage is a result of exposure to the weather. [\(See Photo 2\)](#)

RECOMMENDATION: Remove and replace this door with a white non-insulated roll up garage door.

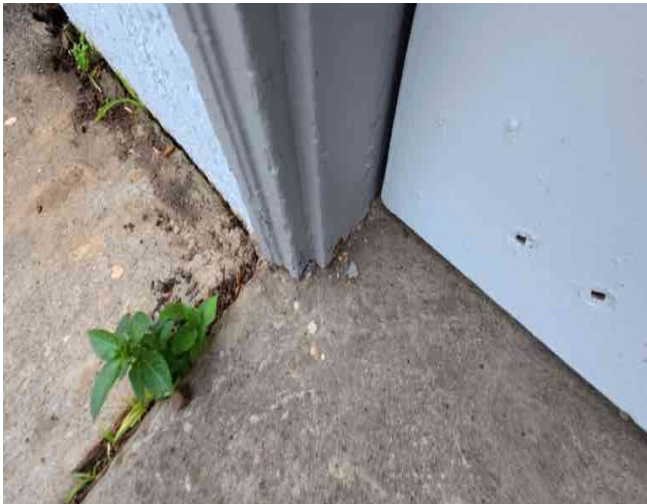
Photo 03

1B. FINDING: The overhead garage door jamb at the left side was found to be fungus damaged. [\(See Photo 3\)](#)

RECOMMENDATION: Remove and replace the door jamb to correct this condition. The contributing *Estimated Cost* moisture source appears to be exposure to the weather.

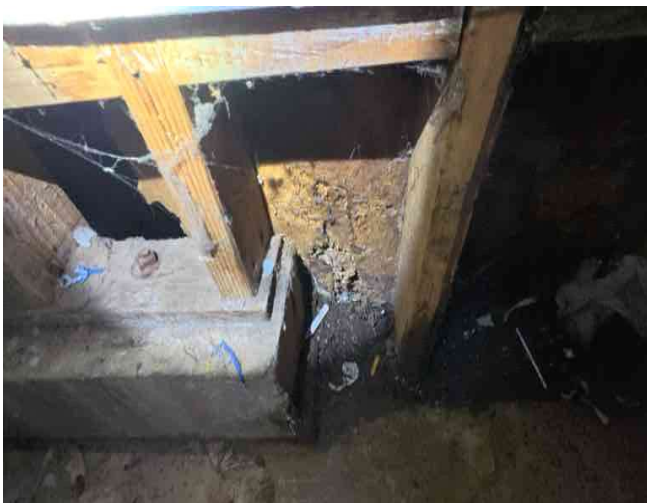
Photo 05

- 1D.** FINDING: The stucco backing and framing has been damaged by fungus and subterranean termites at the garage wall. The contributing moisture source appears to be a plumbing leak at the laundry hose bib and/or leakage through the exterior stucco. (See Photo 5) (See Photo 6)

- 1F.** FINDING: Subterranean termites were noted at the garage wall framing and stucco backing. (See Photo 5) (See Photo 6)

RECOMMENDATION: Remove a sufficient amount of exterior stucco to affect repairs. Remove and dispose of the damage stucco backing and framing. Install new materials where removed. Install new paper and wire. Re-stucco the exterior where removed. The new stucco texture will vary from the existing. HomeGuard will apply one coat of primer paint to the repaired area. If any damage is found to extend into any enclosed areas, a supplemental report and bid will be issued.

RECOMMENDATION: Chemically treat the entire structure at probable termite entry points for the control of Subterranean termites with Termidor HE (Fipronil:5-amino-1-(2,6-dichloro-4-(trifluoromethyl) phenyl)-4-((1,R,S)-trifluoromethyl)sulfinyl)-1-H-pyrazole-3-carbonitrile and break down and brush away all subterranean termite migratory tubes. In conventional construction, this may include, but is not limited to, rodding or trenching the soil around the foundation walls, piers, and plumbing pipes in the subarea; rodding or trenching the soil around the exterior foundation; drilling attached slabs such as patios, porches, sidewalks, or driveways that abut the structure; drilling brick or stone veneer that extends below grade level; treating voids in the foundation walls or piers. The holes drilled into any concrete slab, while performing the treatments, will be plugged with mortar. It will be the owners responsibility to have these areas repaired to match the existing surfaces as desired. HomeGuard Inc. assumes no liability for any damage to concealed pipes, finished floors, tiles or bricks. NOTE: In order to perform this treatment the property must be vacant for the period during and 3 hours after the treatment has been completed. HomeGuard will use a ground fault device to hopefully prevent drilling through any pipes, conduit or electrical wiring however if this were to happen it will be the owners responsibility and expense to repair any damage done.

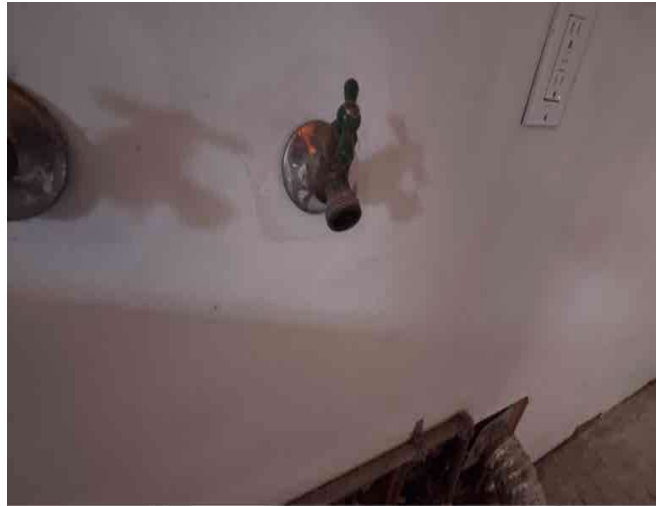
Photo 08

- 1E.** FINDING: There is a plumbing leak at the laundry hose bib. This has contributed to the damage noted in the previous item. (See Photo 8)

RECOMMENDATION: The owner should have a licensed plumber repair the leakage. All guarantees desired should be secured from the persons or firm that performed the repairs.
