INSPECTION REPORT IN ACCORDANCE WITH CALIFORNIA CIVIL CODE SECTION 5551

For Woodlake Association
900 Peninsula Avenue,
San Mateo, CA 94401

Fifteen Buildings – 974 Units

April 19, 2023

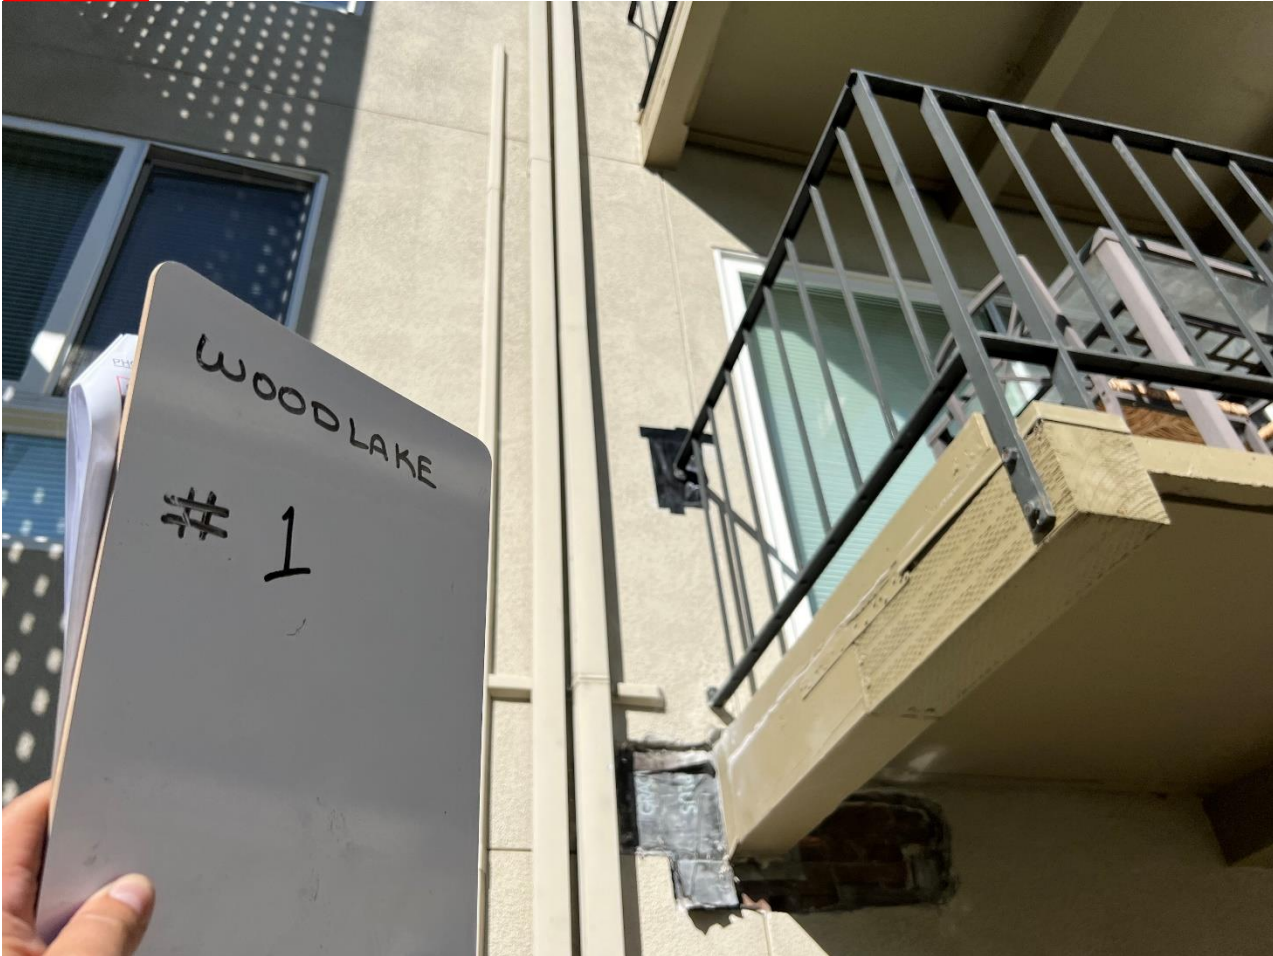
10

Location # 1

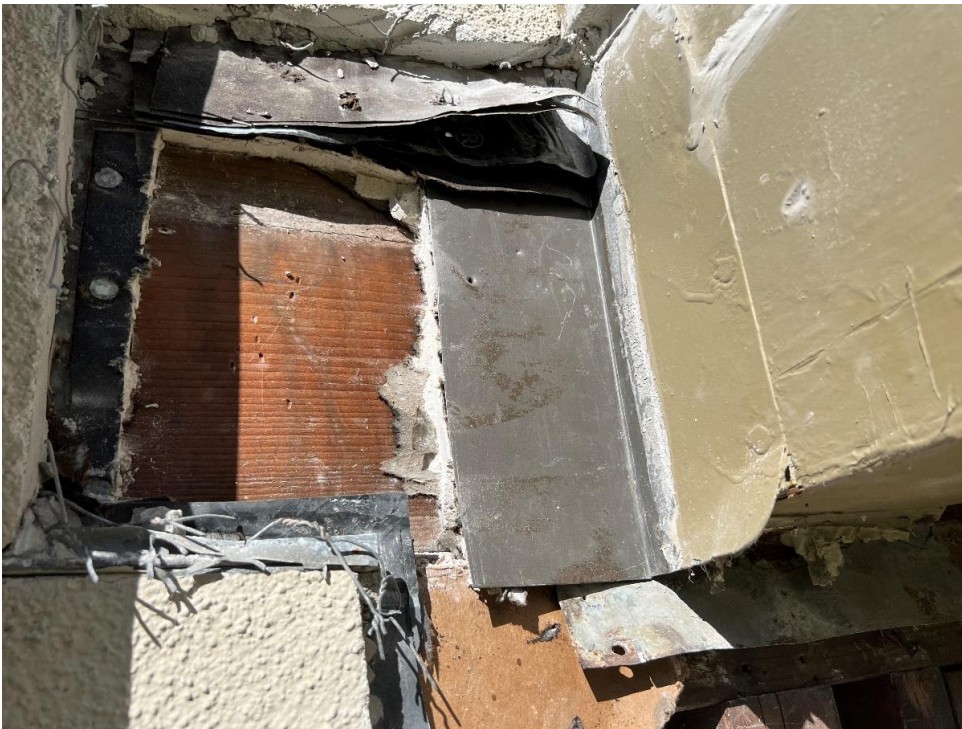
17

Location # 1 ; Note: Additional stucco removed along exterior side of joist/beam. cantilever joist/beam flashing is adequate. No signs of water damage to framing observed.

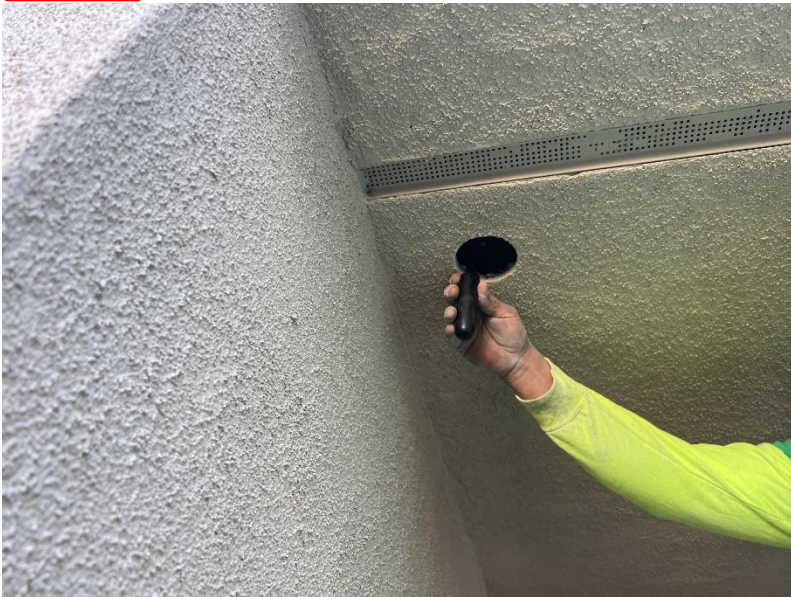
19

Location # 2
Two 3" holes bored through stucco soffit.
No signs of water infiltration observed.

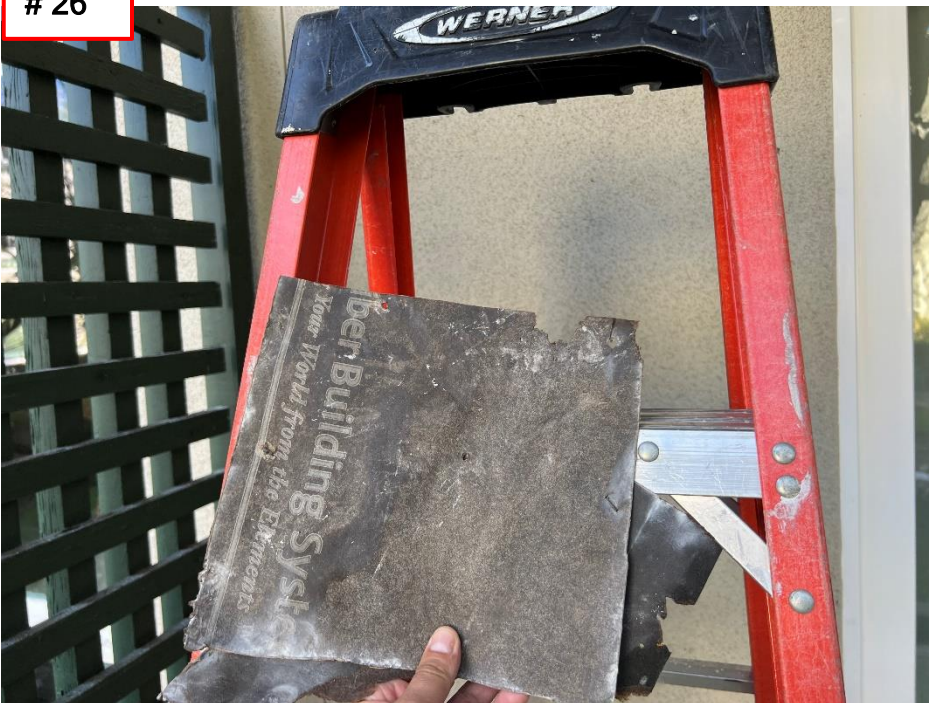
26

Location # 3 No signs of water damage/deterioration to building paper

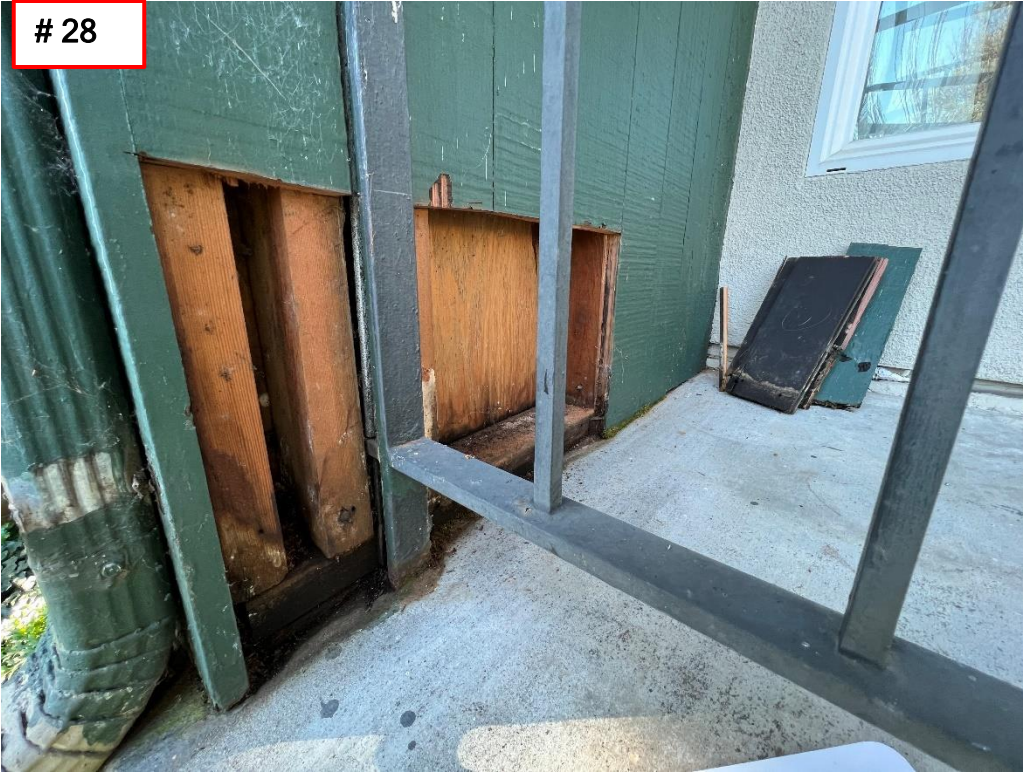
28

Location # 4. Damaged siding on both sides of wall. Mudsill is not pressure treated and shows signs of water damage.

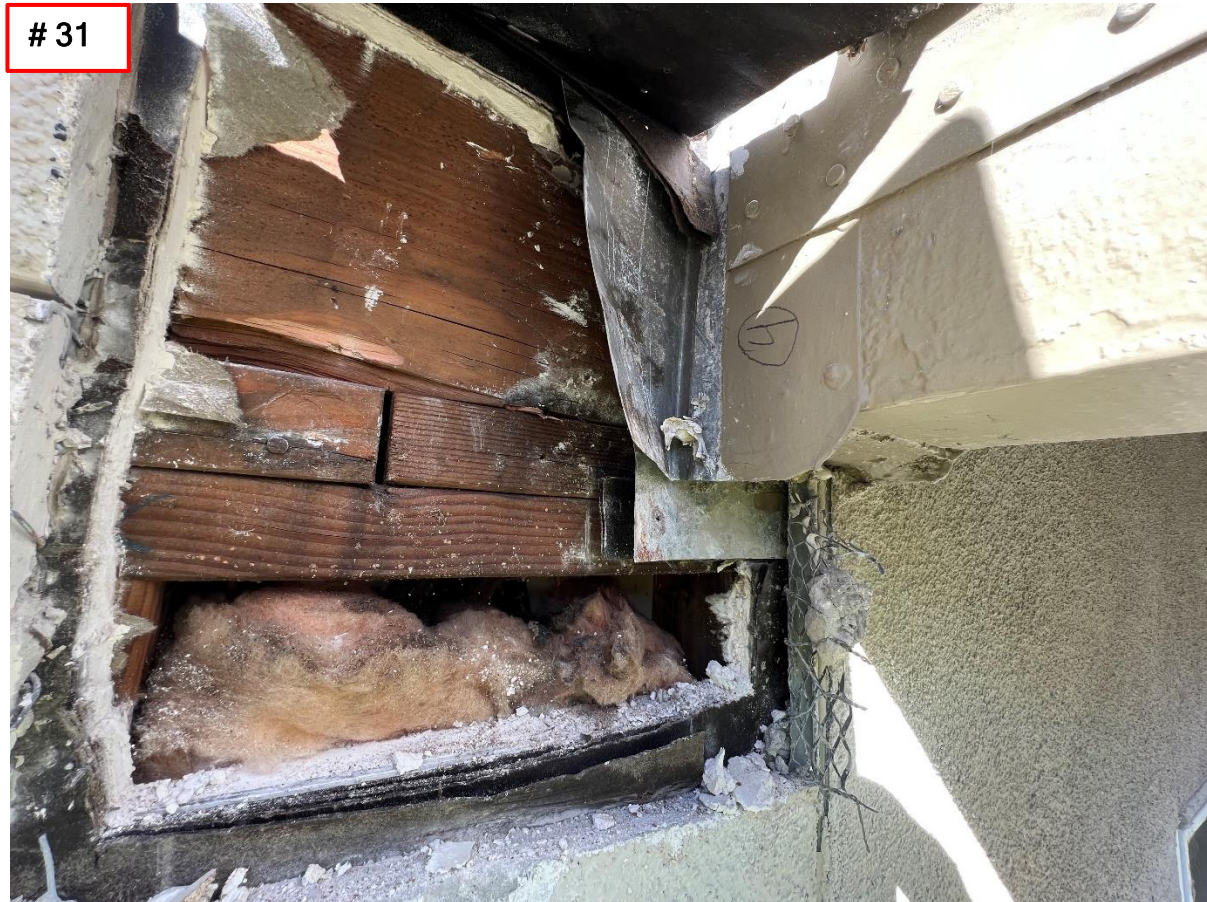
31

Location # 5 No signs of water damage to framing around cantilever joist/beam

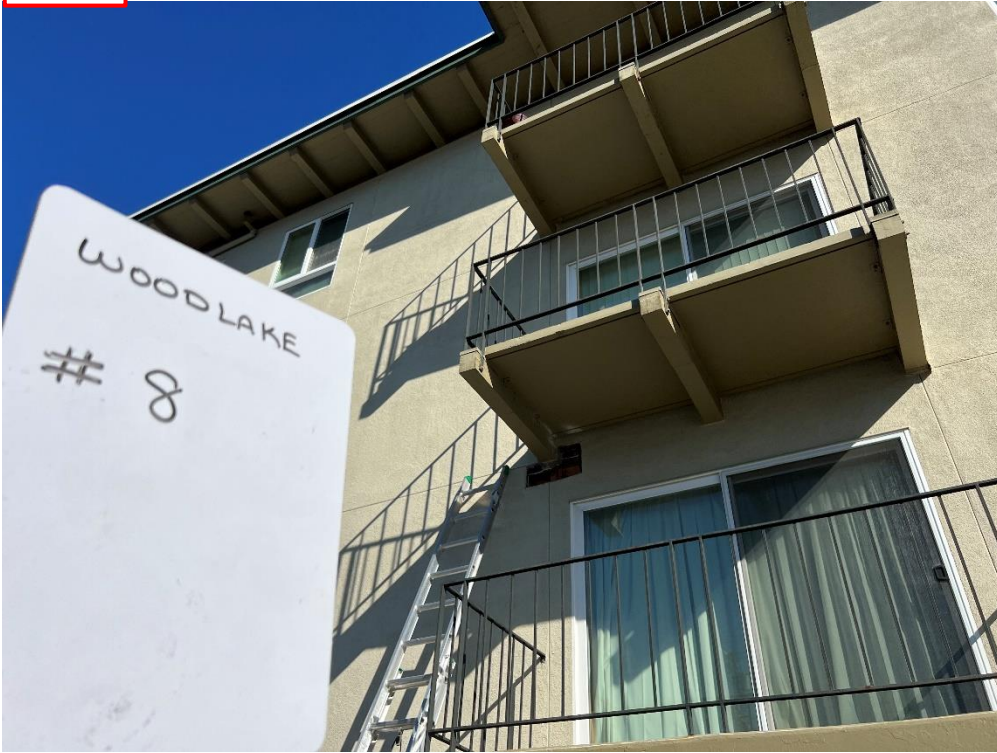
Location 8

Location # 8
No water damage
observed to framing
around cantilever
joist/beam.

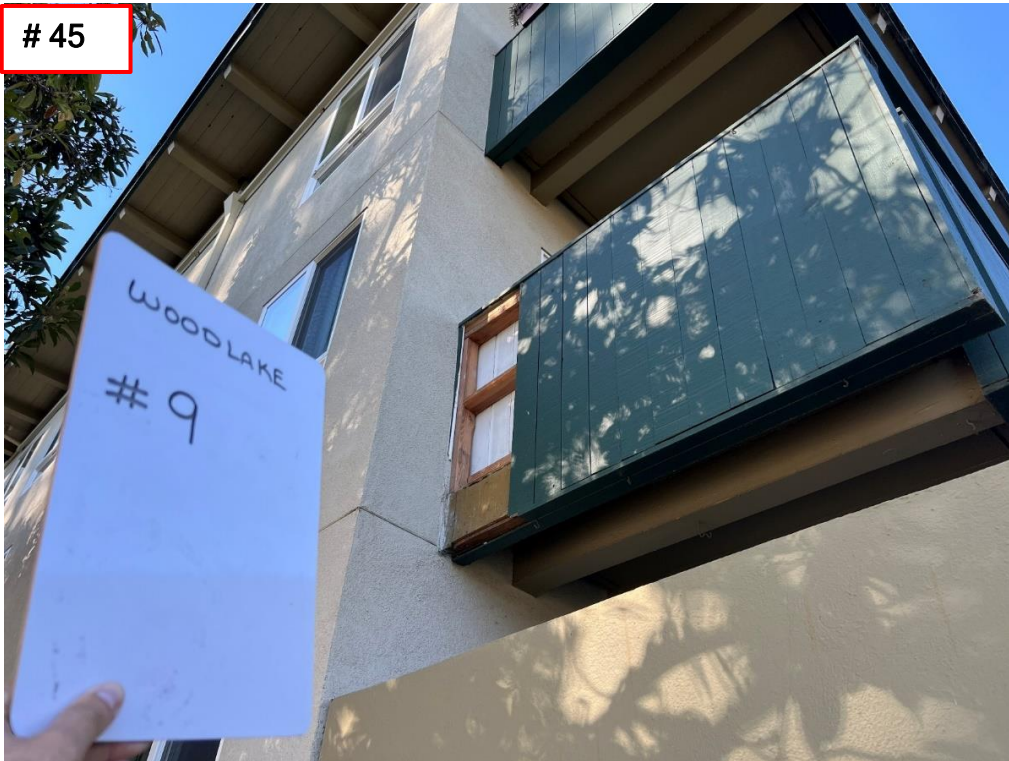
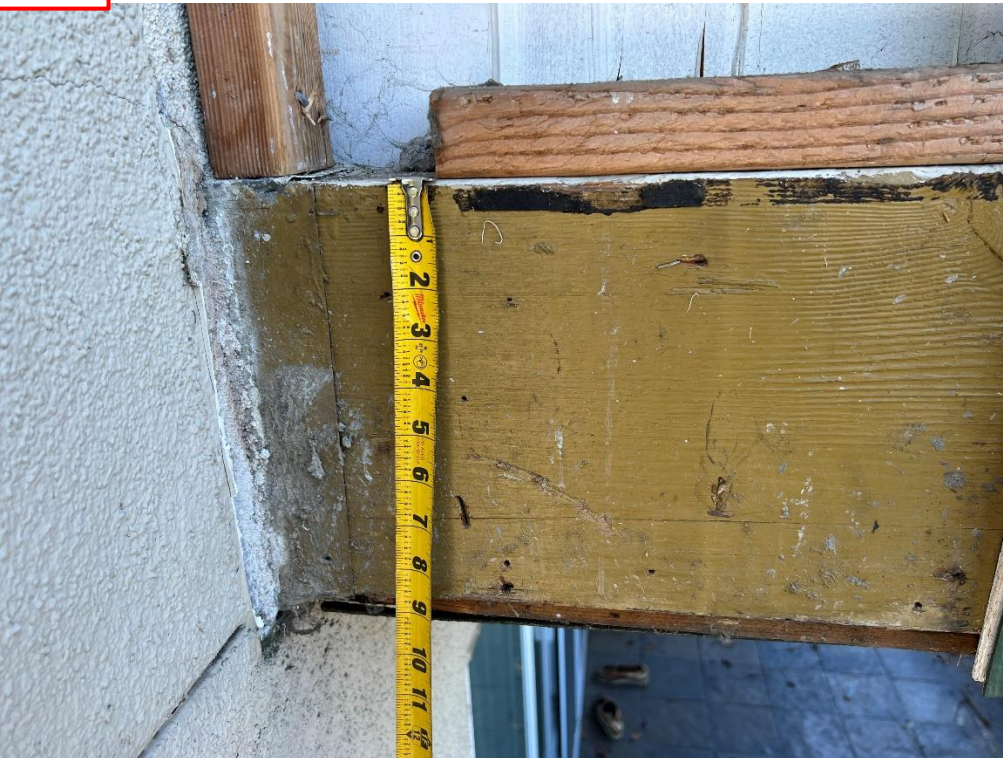
Location 9

Location # 9
Guardrail wall
supported on 4x10
cantilevered beam.

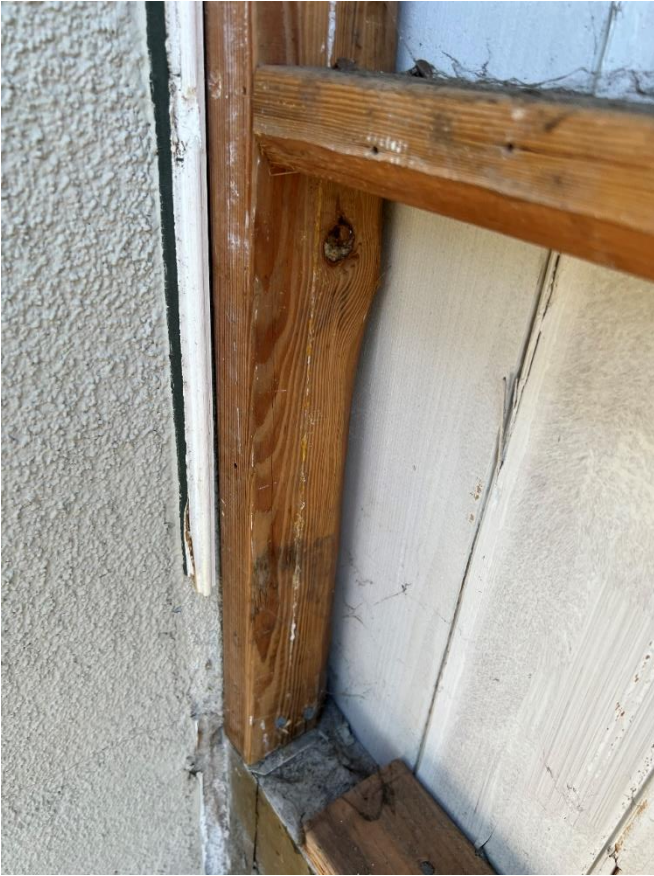
48

Location # 9
2x4 wall plate
attached to wall
beam with 2 nails.
Trim set in sealant
at wall.

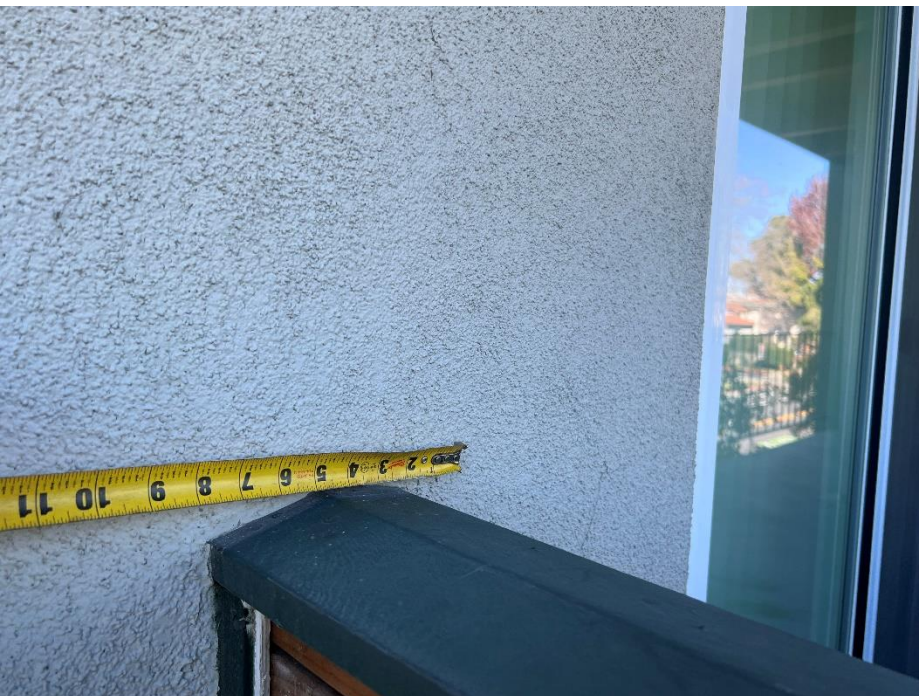
49

Location # 9
2x6 rail cap

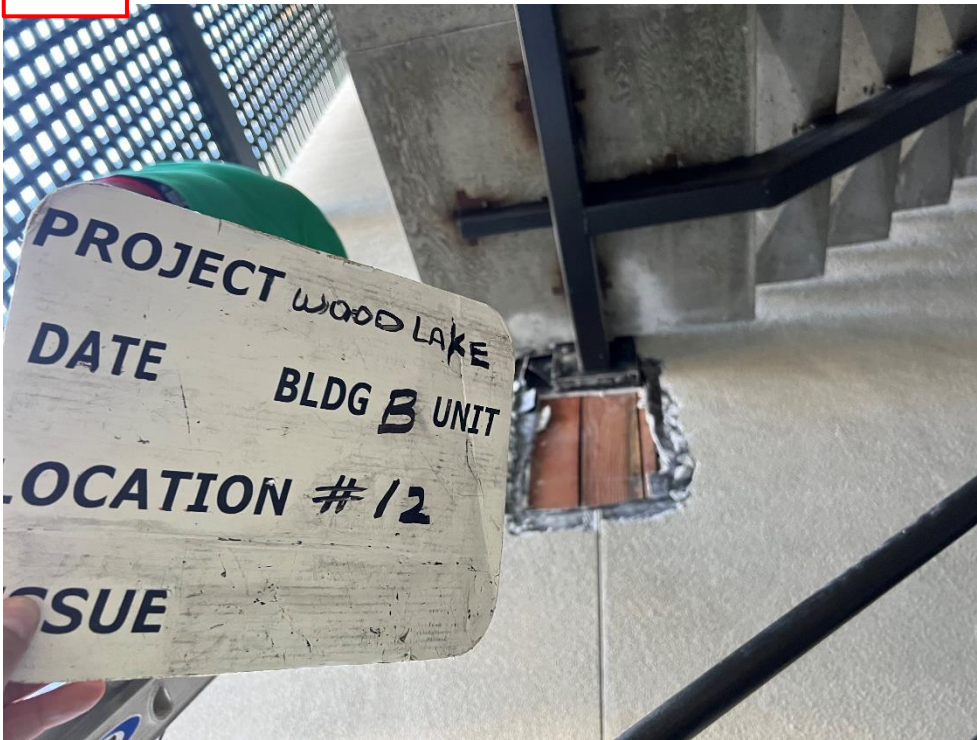
58

Location # 12
Staircase

Steel plate attached
to Two 2x10 vertical
wall studs.

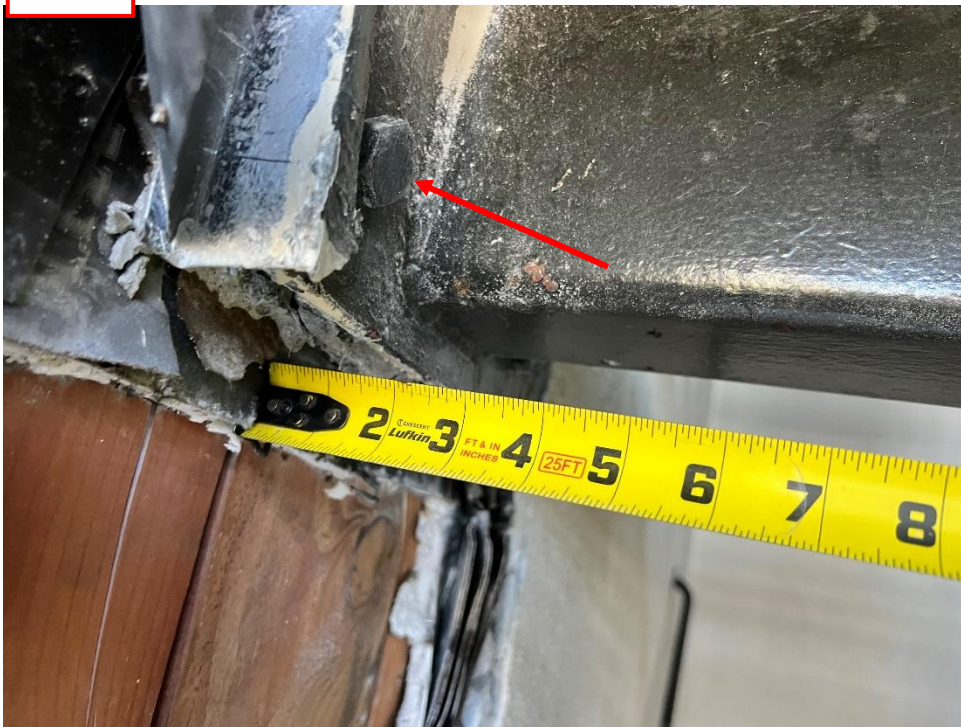
59

Location # 12
Staircase

Steel plate bearing
directly on stucco in
lieu of framing.
Through bolt
cantilevers ~ 2" from
exterior to framing.

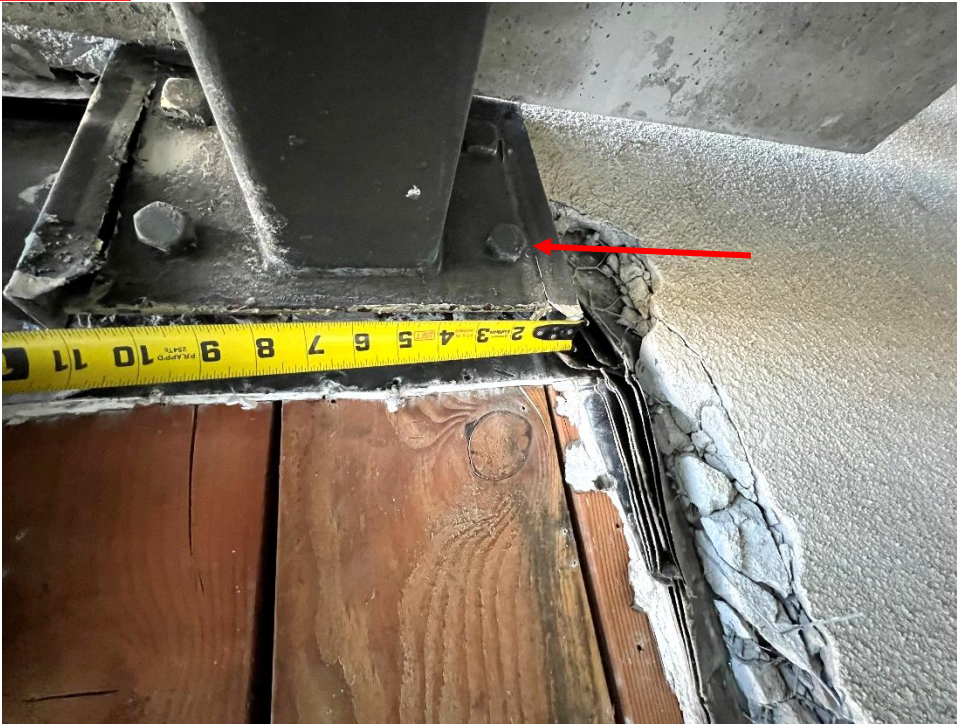
60

Location # 12
Staircase

Right through bolt
penetrates edge of
wall framing.

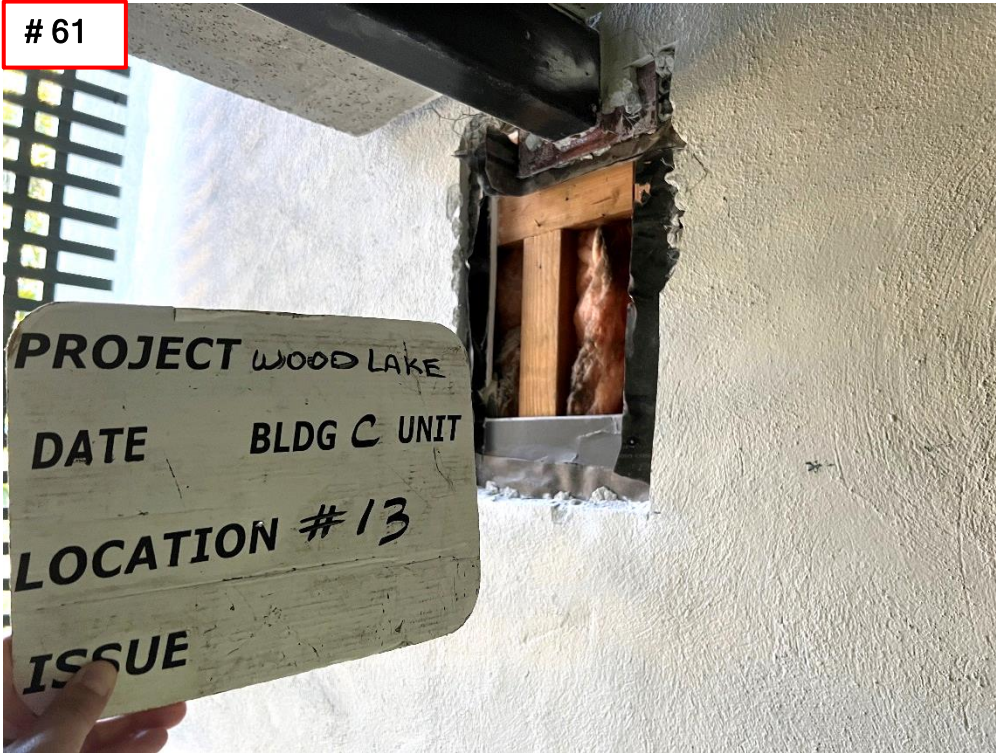
61

Location # 13
Staircase

Steel plate attached to 2x10 blocking. Blocking attached to adjacent wall stud framing with nails.

Blocking supported below by 2x4 vertical framing.

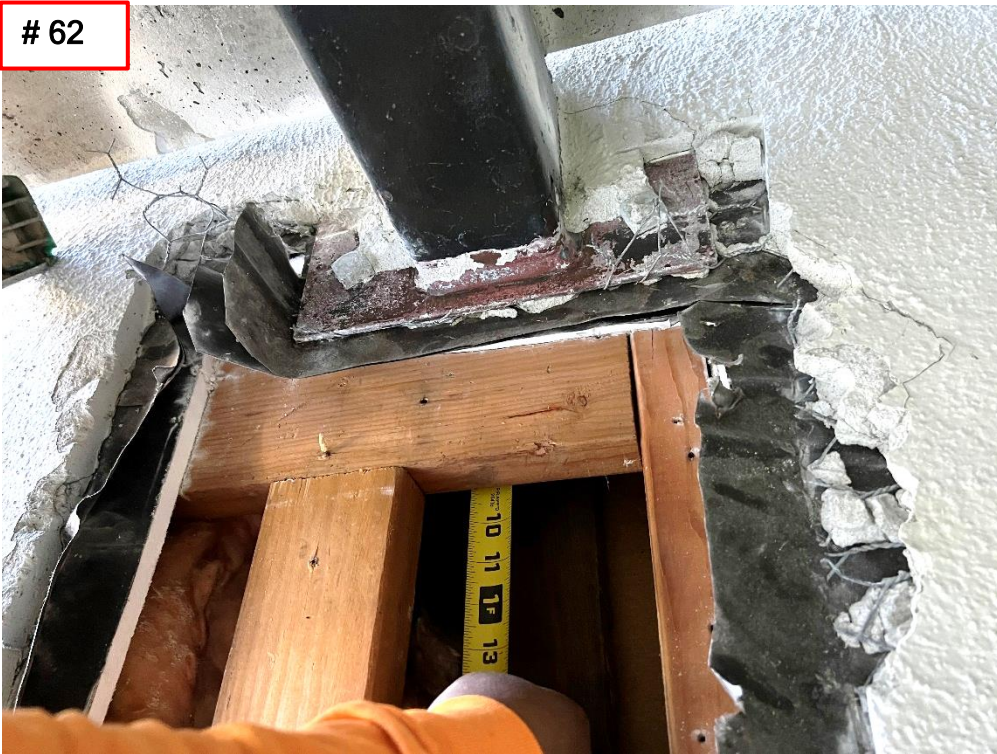
62

Location # 13
Staircase

Steel plate attached to 2x10 blocking. Blocking attached to adjacent wall stud framing with nails.

Right through bolt penetrates directly through a 2x stud.

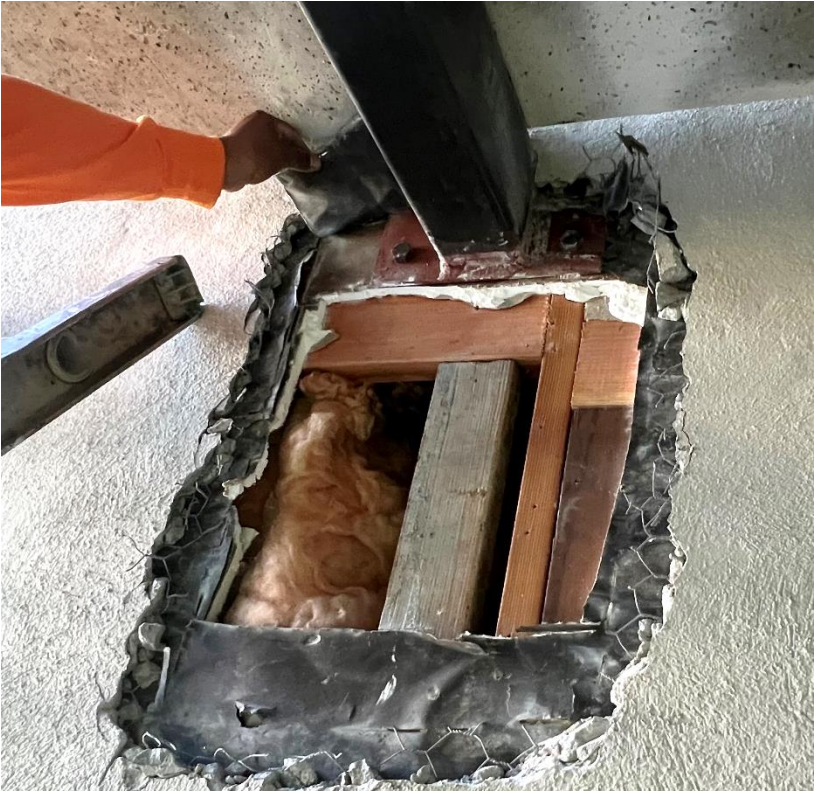
66

Location # 14
Staircase

Right through bolt
penetrates directly
through a 2x stud.

Wall stud not
properly sized for
this attachment.

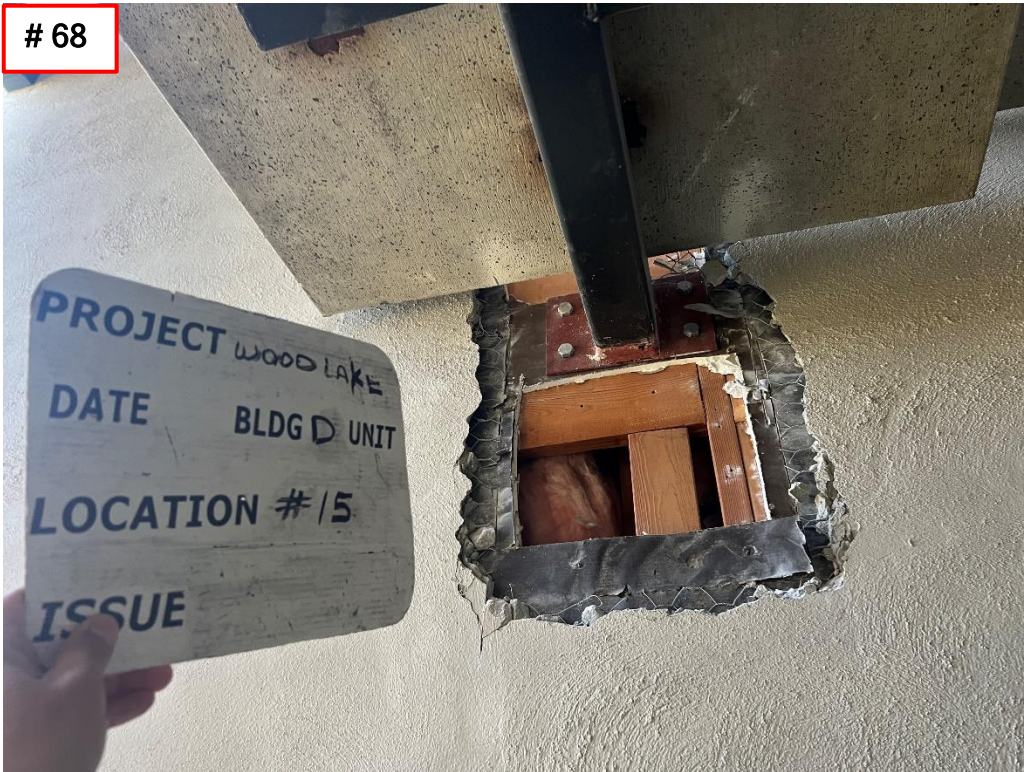
68

Location # 15
Staircase

Right through bolt penetrates directly through a 2x stud.
